**NITRO-GLYCERINE WASHING HOUSE, SOUTH SITE, WALTHAM
ABBAY ROYAL GUNPOWDER FACTORY, ESSEX**

SURVEY REPORT

JUNE 1996

FIELD ARCHAEOLOGY GROUP

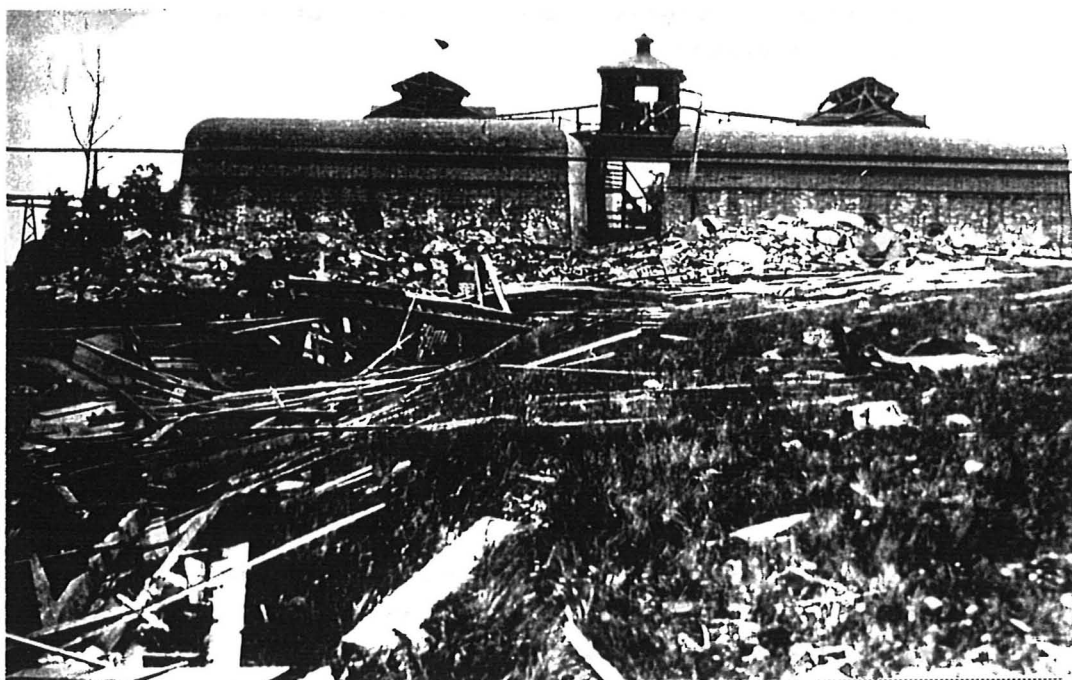
Plate 1

Damage to the original Washing House (built 1891), in the aftermath of the explosion of 7th May 1894 (looking north). In the background are the two Nitrating Houses, with the Charge House mounted between them, on top of the brick traverses. The original Washing House was surrounded by a similar traverse. When the Washing House was rebuilt after the explosion, the brick traverse was replaced by an earthwork one (MOD photograph).

K (cont)
As the Nitro-Glycerine store was locked and unoccupied at the time of the explosion, the subsequent court of enquiry concluded that the Washing House had blown up first. Although no definite cause could be found, a number of working practises were immediately changed, and the explosion added impetus to the search for safer production processes (Macdonald 1991, RCHME 1993).

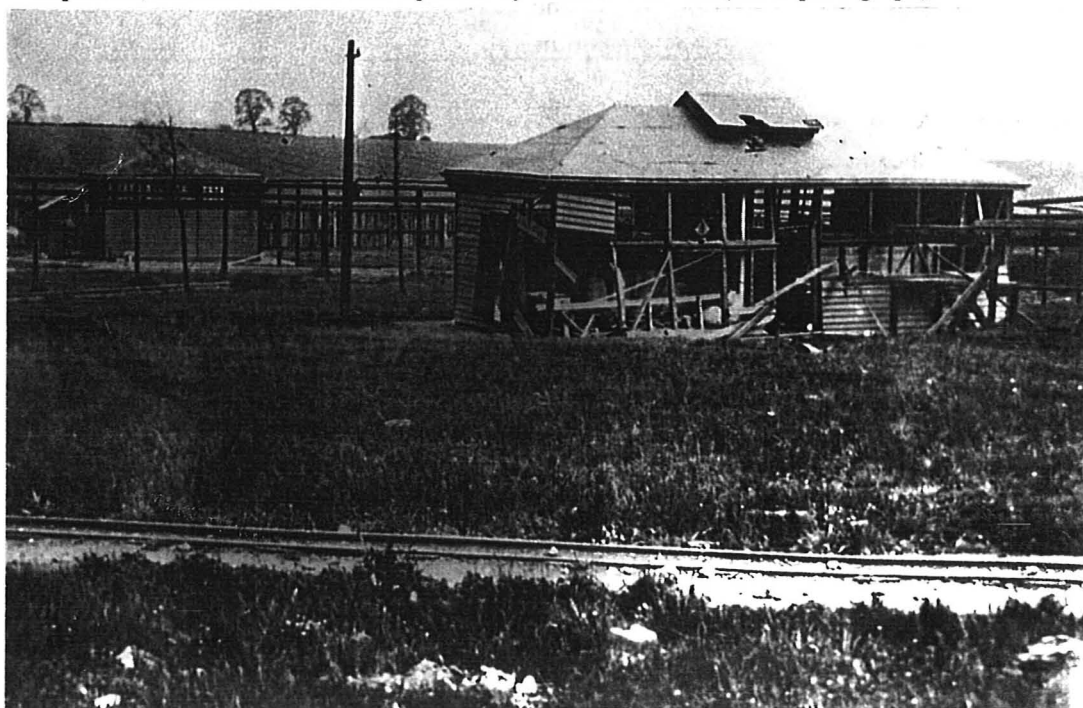
Plate 2

Damage to the Wash Water Settling House, in the aftermath of the explosion of 7th May 1894 (looking SE). Part of the guttering used to carry the wash waters from the Washing House can be seen on the extreme right of the picture. (MOD photograph).

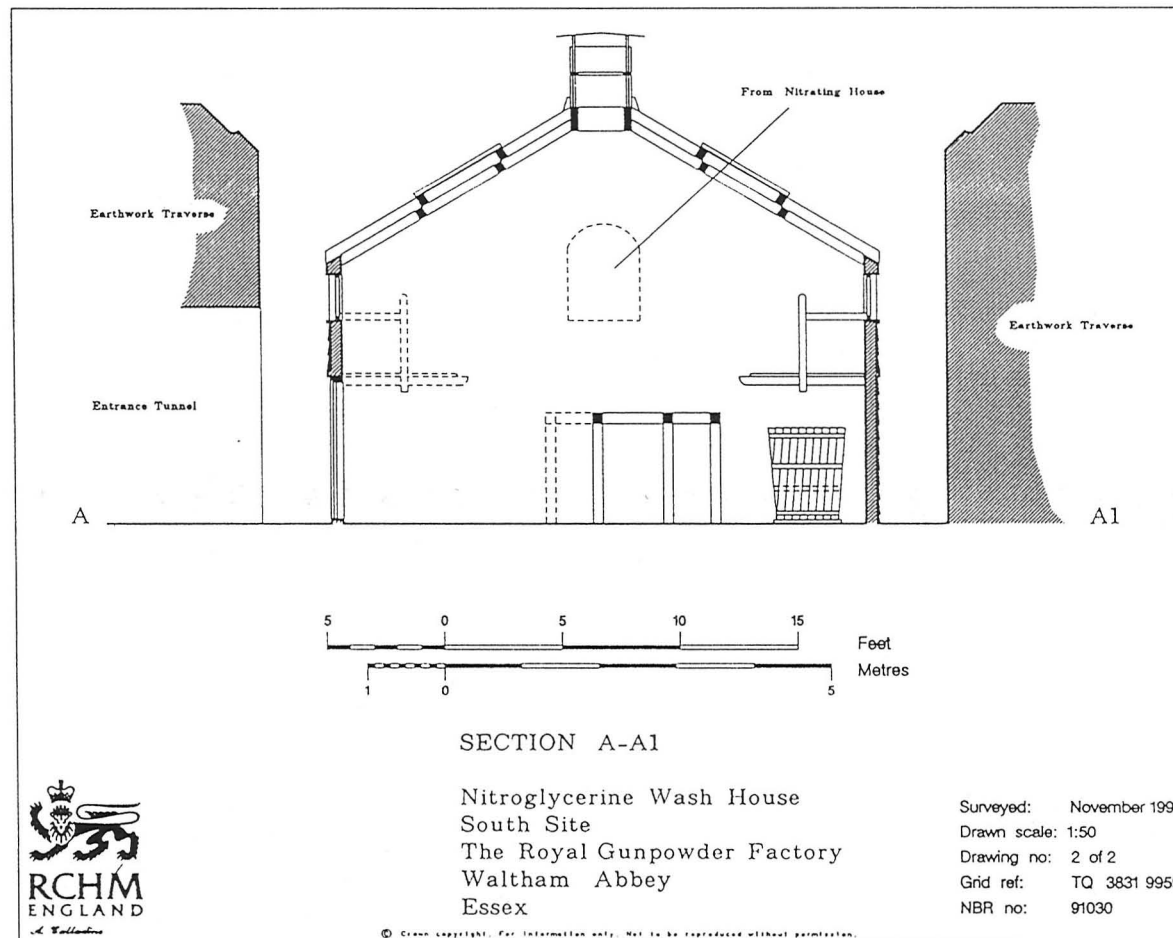
Fig.4 Nitroglycerine wash house. Section A-A1

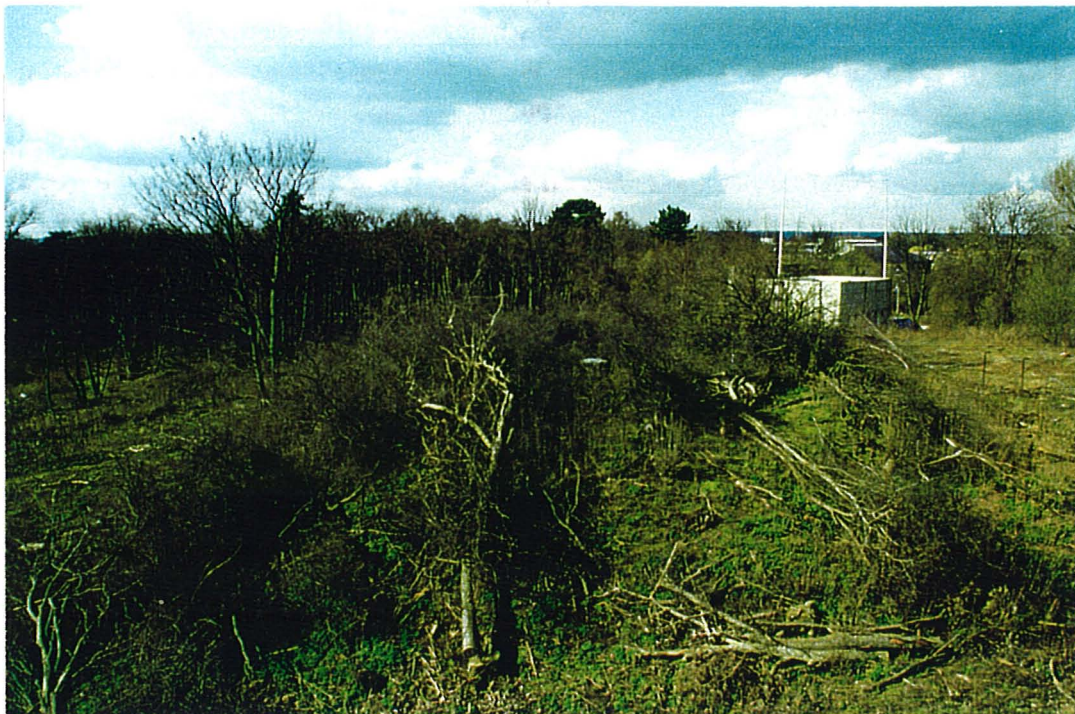
Plate 3

View of the Washing House in March 1996 (looking north-west). This building, which was constructed in 1894, was built on the site of the original Washing House, following the disastrous explosion of the same year.

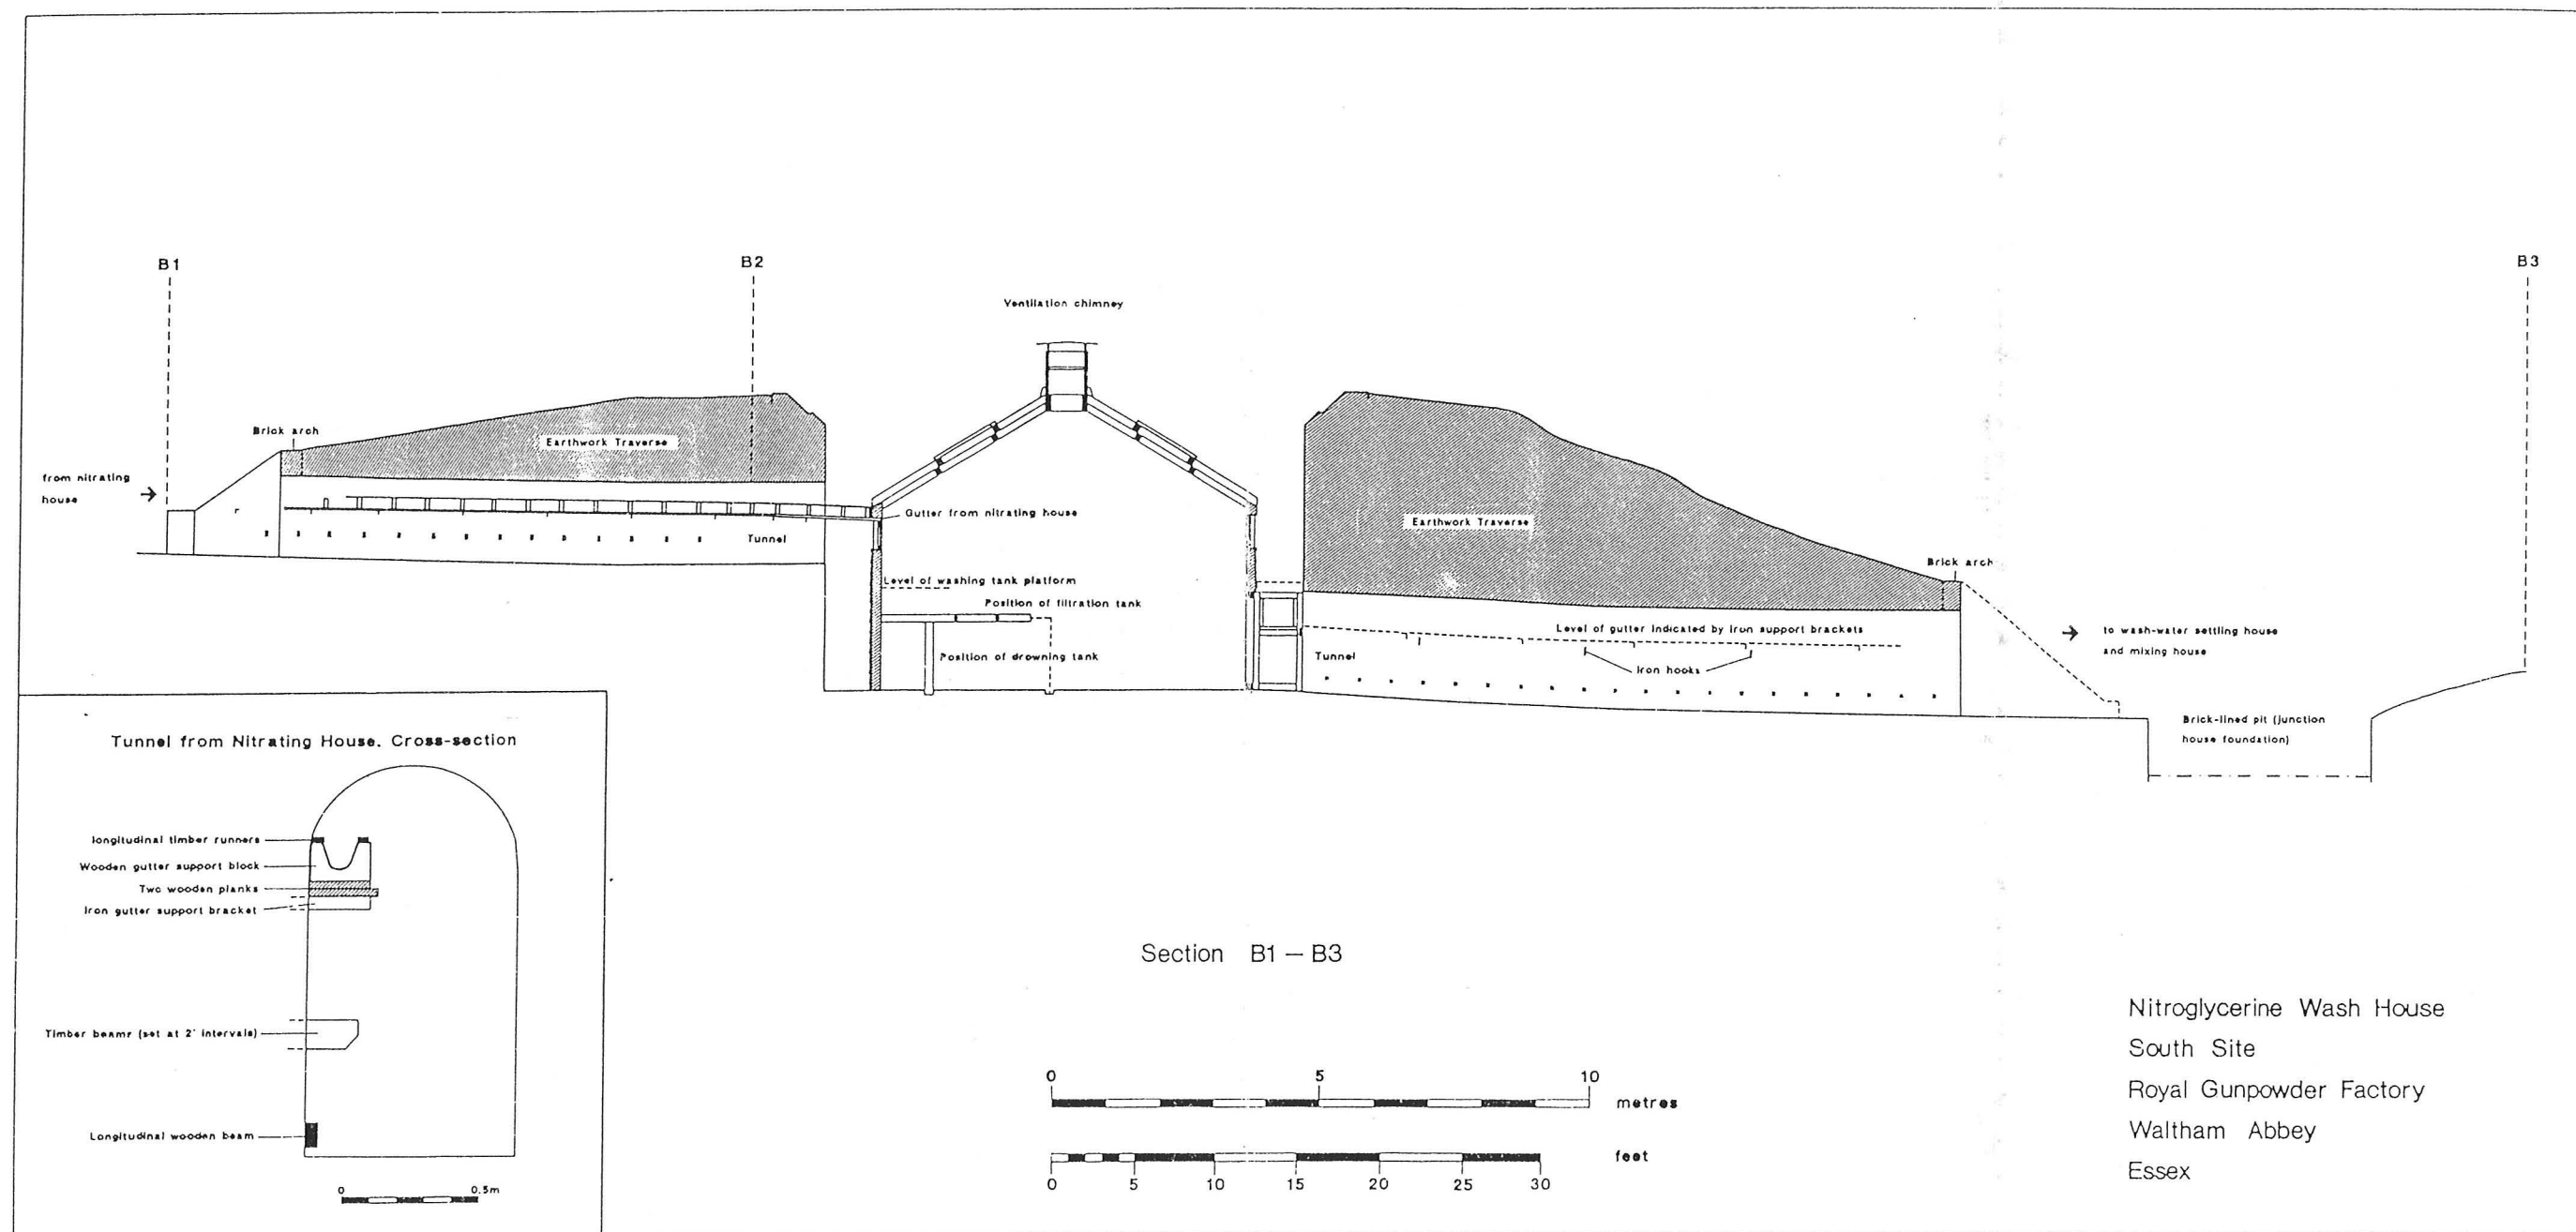
Fig.5 Nitro-glycerine Wash House. Section B1-B3

The absence of surviving gutter fittings in the north-eastern conduit tunnel may date from the demolition of Nitration house No.2 in 1907-8 (Macdonald 1991, RCHME n.d.). A row of square sectioned beams, embedded in the brickwork and sawn off at the wall, 0.45m above the floor, probably served a similar function to the rectangular sectioned beams in the western tunnel, possibly as pipe supports. It should be noted that there is no indication of iron wall brackets in the north-eastern tunnel, suggesting that the gutter support arrangements surviving in the north-western tunnel are a late adaptation, post-dating the demolition of Nitrating House No.2 in 1903.

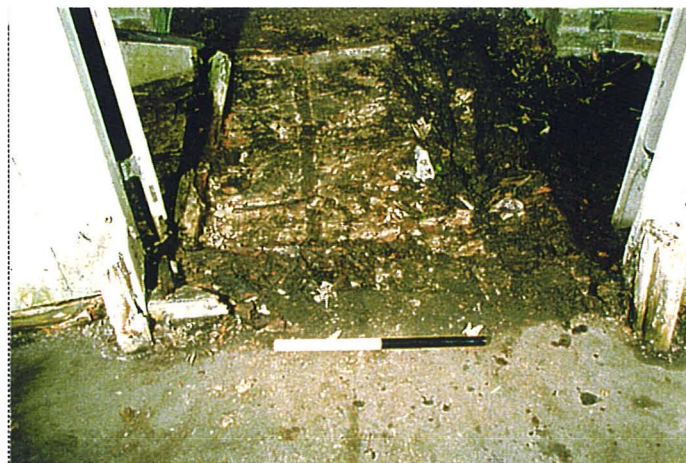
Plate 17
Detail of the roundhouse doorway (looking west), showing
the remains of the footplate (foreground) and debris from the
collapsed shoeroom roof (background)

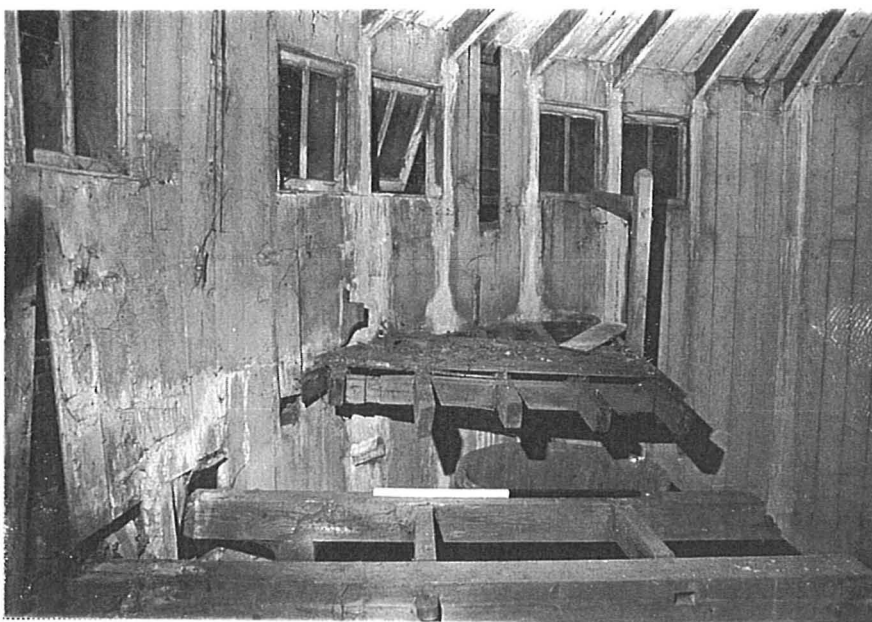
Plate 22

The washing tanks were supported at a higher level than the filtration tank, directly below the skimmer dish suspension points. This places them close together, against the north wall of the roundhouse. They were originally linked to the gutter from the Nitrating House by an india-rubber pipe which connected to a fixed brass socket on the inside of the roundhouse wall, just below the level of the wall plate. The socket remains *in situ*, c.0.6m west of the gutter terminal (plate 30). It passes through the roundhouse wall and is connected to a broken lead pipe (Plate 29). The pipe presumably linked to the gutter terminal via a 0.05m diameter hole drilled through the bottom of the gutter shelf (Plate 28). The square mark on the interior wall of the roundhouse, immediately above the brass socket, probably marks the position of a nitro-glycerine warning sign.

View of the raised platforms at the N end of the Washing House from above (looking E). The platforms were formerly at two levels, the upper supporting the washing tank, the lower the Filtration tank

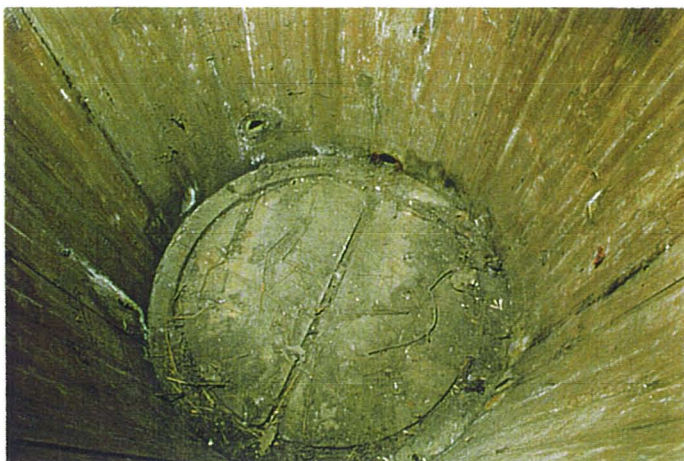
the wash waters, was probably injected through this pipe. The base of each tank slopes down towards the nitro-glycerine drainage cock. A groove, running around, and bisecting the base of the tank, was probably intended to facilitate drainage of the nitro-glycerine, but may also have housed the movable pipe through which compressed air was injected into the wash waters (Plate 27).

Plate 27
Interior detail of a washing tank, showing nitroglycerine
and wash water drainage outlets and grooves in the base of
the tank. The lead lining has been removed

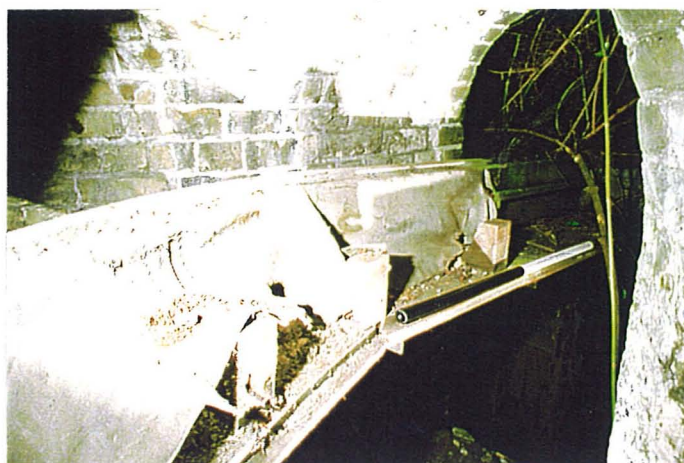
Plate 31

A section of the nitroglycerine gutter at the junction of the tunnels from the nitrating houses (looking SE). The surviving section of canvas gutter cover seen here, protected the gutter from the elements in the gap between the traverse revetment wall and the Washing House

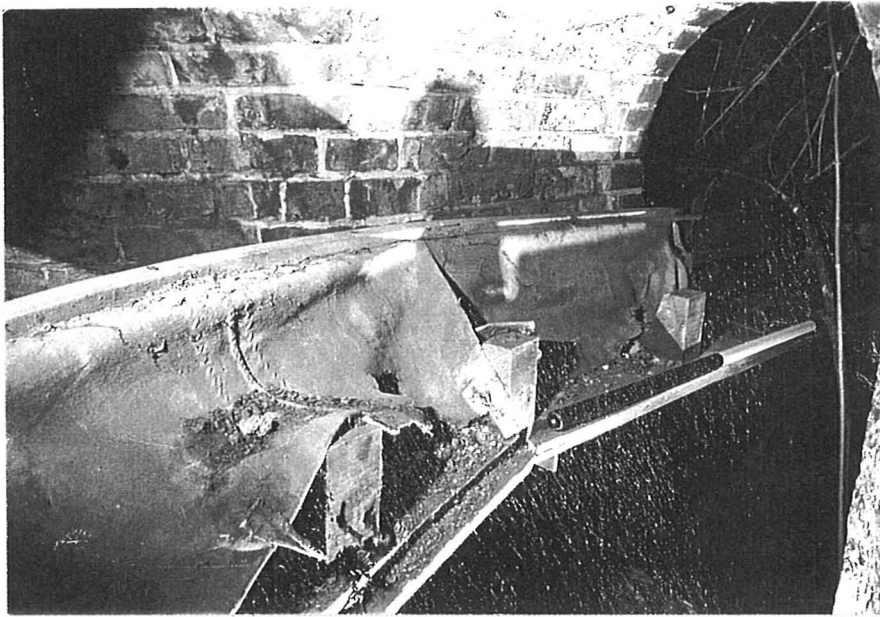
Plate 34

Remains of a short length of canvas cover survive at the junction of the northern conduit tunnels, still attached to the gutter shelf (Plate 34). This cover protected the gutter at the point where it crossed the gap between the traverse wall and the roundhouse, which was open to the sky. It is undoubtedly of the same type as the later form of cover used to protect the guttering in the open ground between the Nitrating and Washing Houses (see above) (Nathan and Rintoul 1908, diagram no.7). In

Detail of gutter shelf at the junction of the tunnels from the nitrating houses (looking SE), showing a surviving section of canvas gutter cover. One of the straps by which one side of the cover was laced down can be seen in the foreground

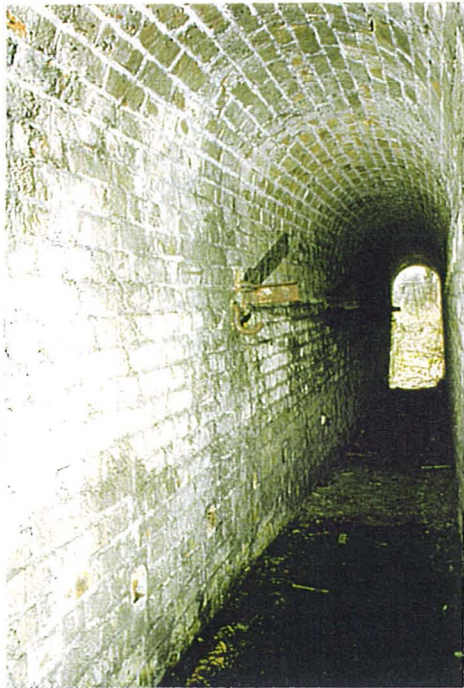
Plate 36
View along the southern conduit tunnel (looking S). The row of iron brackets set into the E wall formerly supported the nitroglycerine gutter
