**Quinan Stove
Royal Gunpowder Mills
Waltham Abbey**

Structural Engineering Report

| Date | 8 December 2017 |

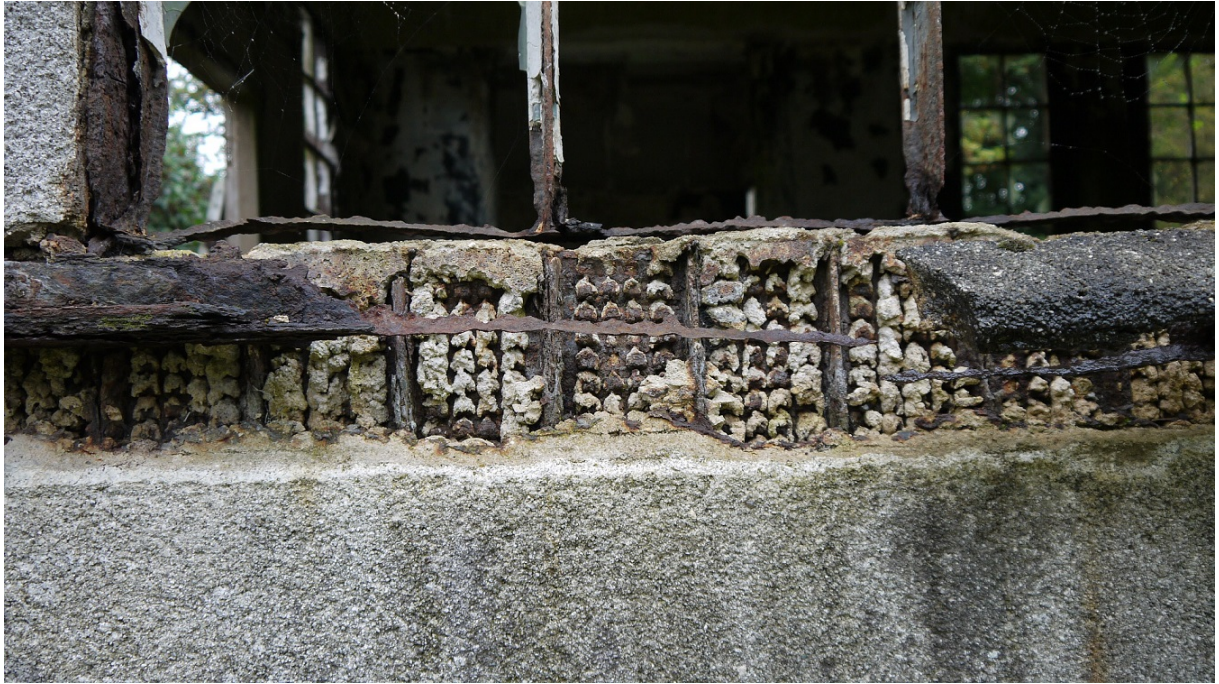
2. Detail of the ribbed lath wall at window cill level. The horizontal angle has completely corroded

Most of the areas with the greatest damage are secondary elements such as the angles below the windows. In some places the steel has completely corroded. There is also significant damage to the metal lathing that supports the concrete wall panels as shown in photo 2.

As noted above, the external reinforced concrete walls and roof are not part of the primary structure. Their repair is a specialist item and a trial would be needed to assess the process and how to retain the maximum amount of historic fabric. The repair is likely to involve temporary support, the careful removal damaged reinforcement and the addition of a galvanized steel mesh (to follow the principle of the existing construction) and a compatible cement-based render.

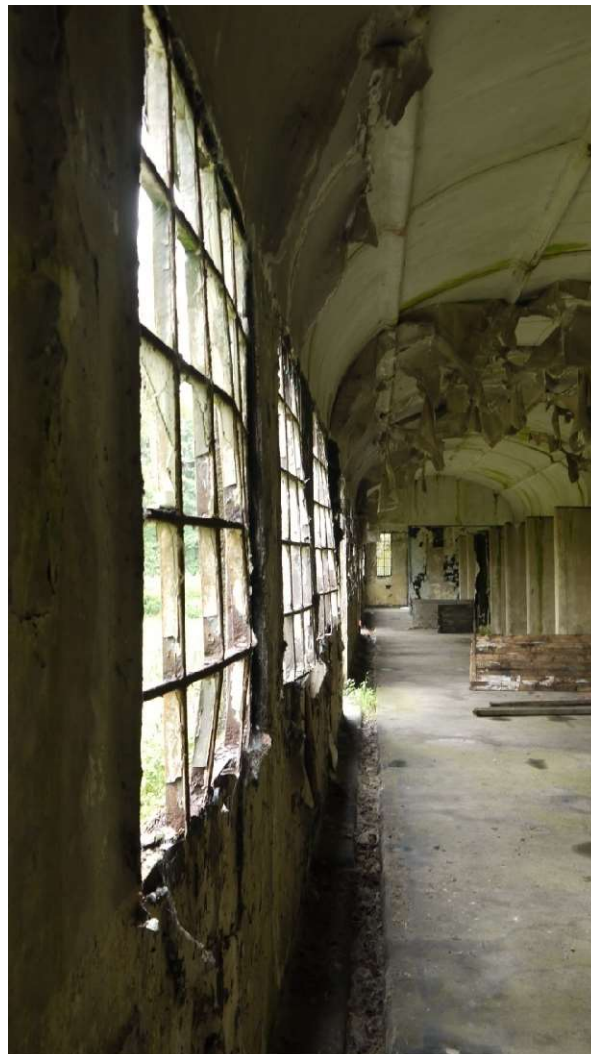
Corrosion has also caused a significant loss of cross-section to a number of the main stanchions. This has resulted in a distortion of the structure as the reduced cross-section can no longer support the weight of the roof structure or lateral loads from wind, see photo 4.

4. Inside of east elevation showing bow in wall

At present there is still sufficient capacity in the steel frames to allow the loads to be redistributed away from the severely damaged sections of steelwork. But if left the damage will continue and eventually lead to a failure and collapse. The structural form means that any failure is likely to be local but it will cause distortions to the surrounding structure and increase the extent of repair/replacement of historic fabric. It will also increase the risk of water ingress and, if not addressed, will accelerate the rate of decay.

Where the steel frame has been exposed by spalled concrete the steelwork should be cleaned and assessed, and then repaired in line with the degree of damage. Superficial damage can be dealt with by applying a corrosion protection and reinstating the concrete. More significant damage will require the addition of new steelwork alongside or welded to the existing metal. The repair of some key steelwork connections is needed where there are signs of structural movement.

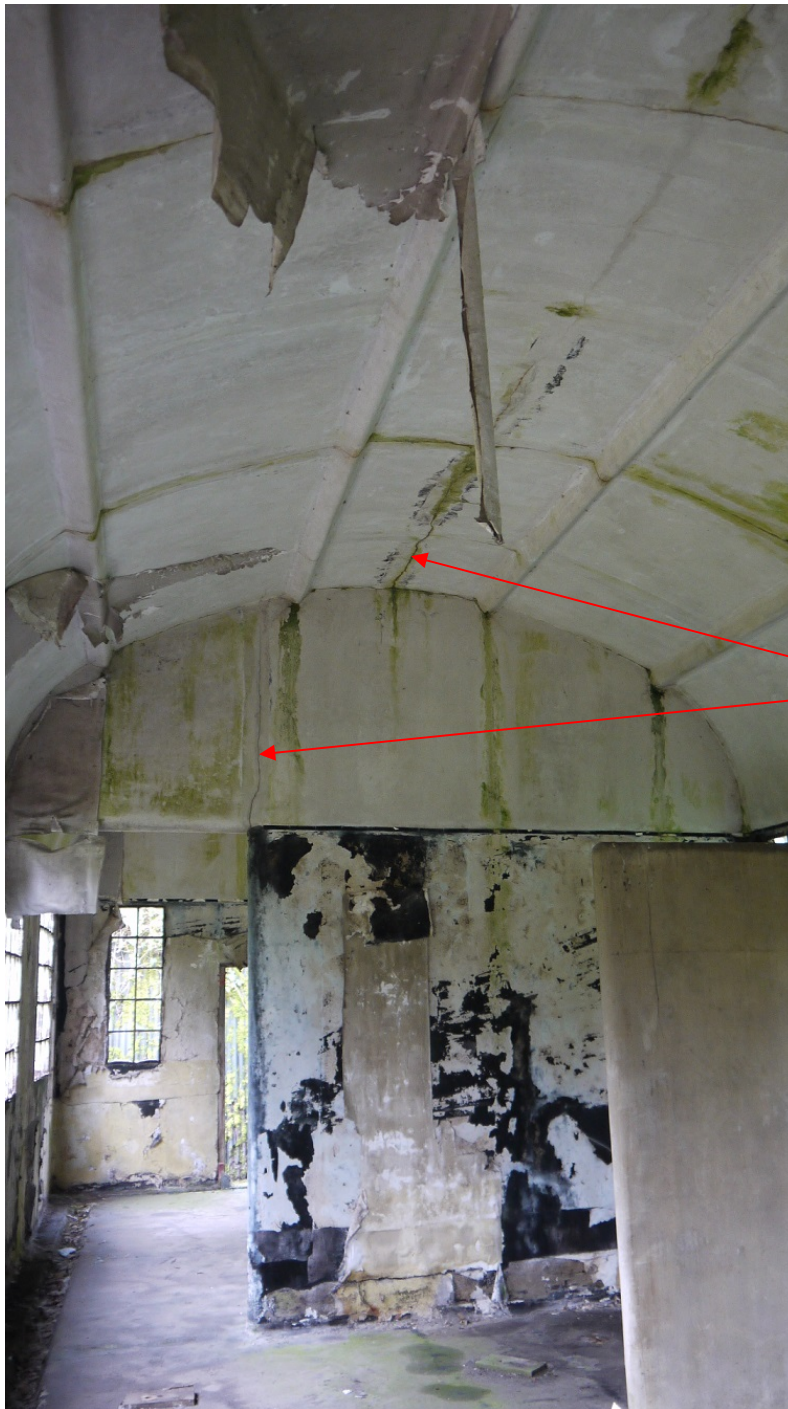
We also noted a longitudinal crack in the underside of the curved roof and a vertical crack in a concrete spandrel panel. This is not continuous and looks to be the result of an outward spread of the top of the walls rather than corrosion of steelwork in the concrete.

5. Cracks at high level

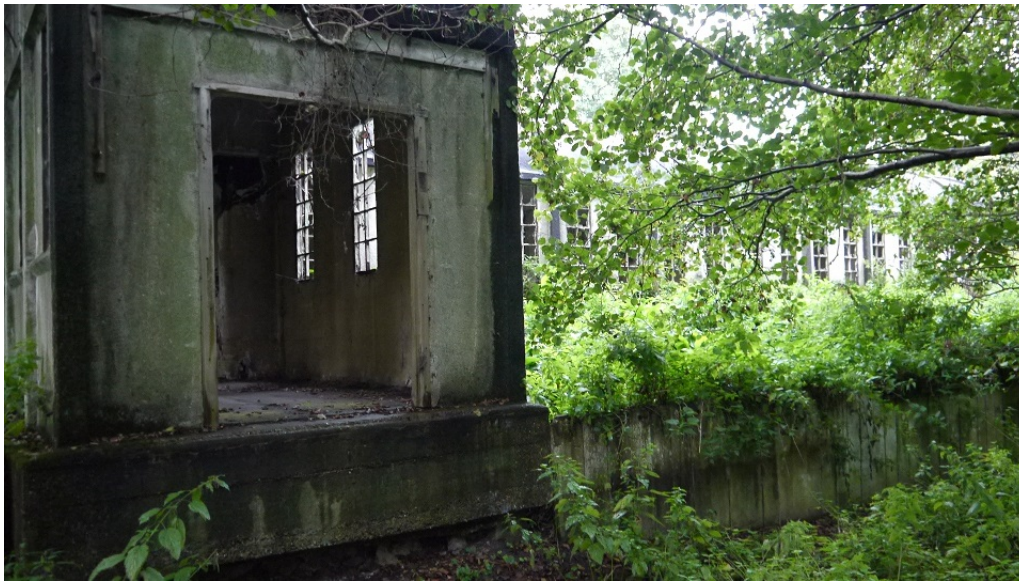
We saw that part of the edge of the slab on the west elevation has been exposed by erosion of the ground. The piled foundation means that this is not currently a significant concern.

6. Edge of slab undermined by ground erosion

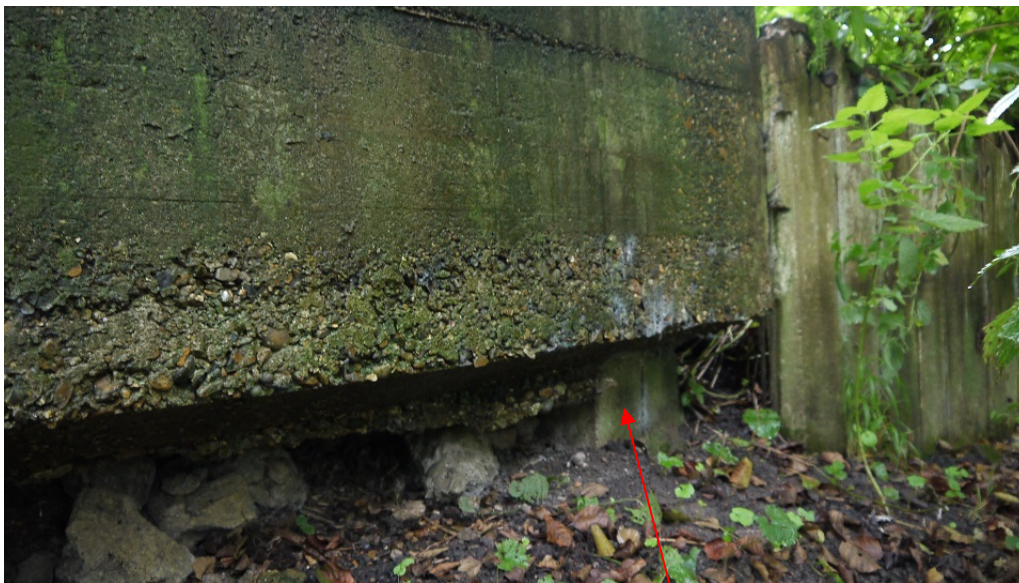
7. Top of concrete pile exposed by ground erosion

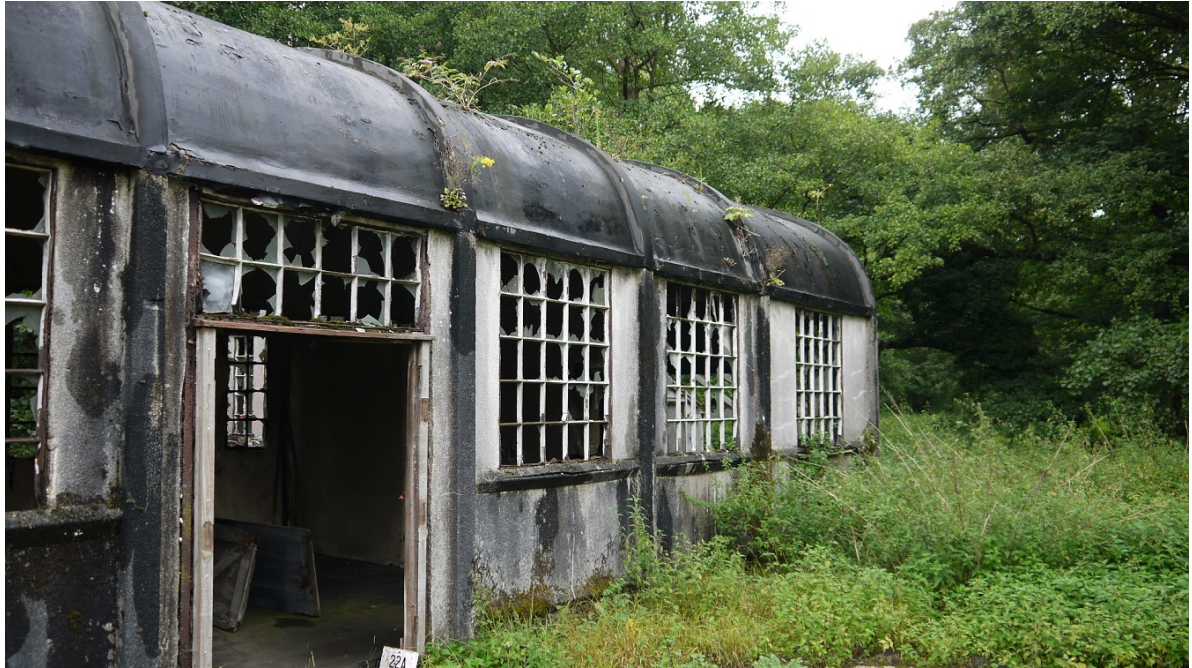
The other main cause of damage, apart from water ingress, is due to invasive vegetation. The growth of plant roots is expanding existing cracks in the finishes and concrete. This damage then allows water to enter the structure. The main area of concern is at roof level where plant growth is exacerbating the damage from cracks in the asphalt finishes, photos 7 and 8.

8. Plant growth at roof level

The key short-term actions to reduce the rate of deterioration are to prevent water ingress and remove plants at roof level. If this is not implemented the damage to the structure will continue until a local collapse occurs. It is not possible to give an exact timescale for when a failure will take place but it could be within the next one to two years.

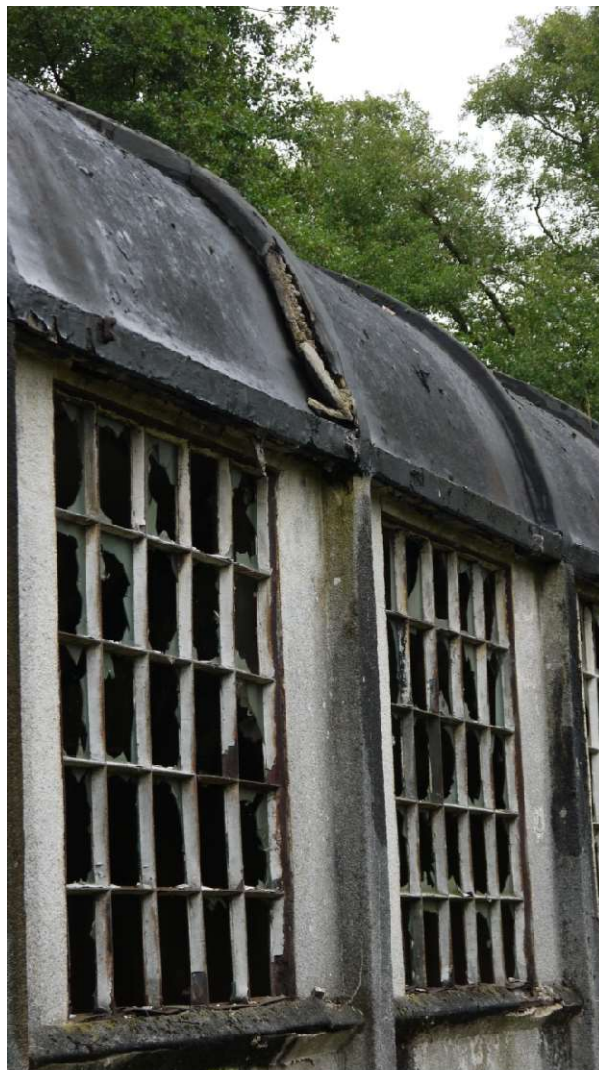
9. Corroded reinforcement and spalled concrete behind damaged asphalt
