RARDE NORTH SITE WALTHAM ABBEY

BRIDGE ASSESSMENTS

JUNE 1993 JOB NO. ICC 657 Rev.A

DEFENCE LANDS SERVICES 3 CENTRAL DISPOSALS UNIT MINISTRY OF DEFENCE LEATHERHEAD ROAD CHESSINGTON KT9 2LU

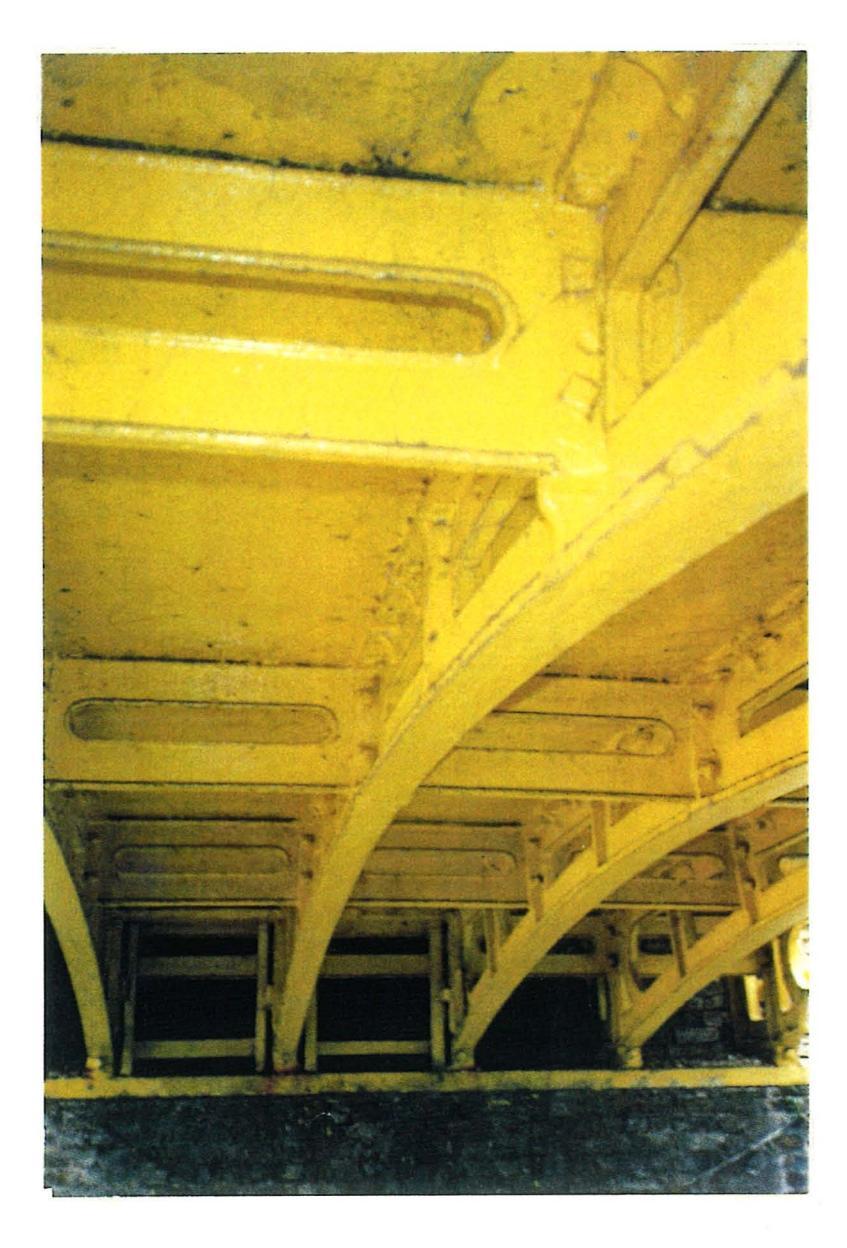
BRIDGE NO. 1

Some of the bolts fixing the arch ribs to the brickwork are severely corroded and there is a considerable quantity of loose material on the bearing shelf. A number of pieces of timber have been fixed into the bridge over each bearing and these should be removed and the paintwork behind made good. Generally the paintwork to the bridge is in good condition.

The abutment on the north west side is very damp due to the amount of water draining off the bearing shelf on the south west corner. Under the bridge the face of the brickwork has spalled away to a depth of 50mm to a height of 1.1m above the water level. On the south east abutment the brickwork has spalled away to a depth of 25mm within 1m of the water level. This has previously been patch repaired with mortar which is now coming away.

Underside of bridge showing cast iron arch ribs and west abutment.

Where the bolts fixing the arch ribs to the brickwork abutment are severely corroded they should be removed and replaced with new ones. The brickwork behind should be made good including the location where the steam main penetrated the abutment wall and the bearing shelf cleaned of all loose material.

The brickwork face on both abutment walls is spalling off including previous mortar patch repairs on the south east abutment. All loose material should be cleaned off, the surface sealed and subsequently a proprietary mortar render applied. Where the brickwork to the abutment and adjacent embankment walls has been damaged by root ingress the walls

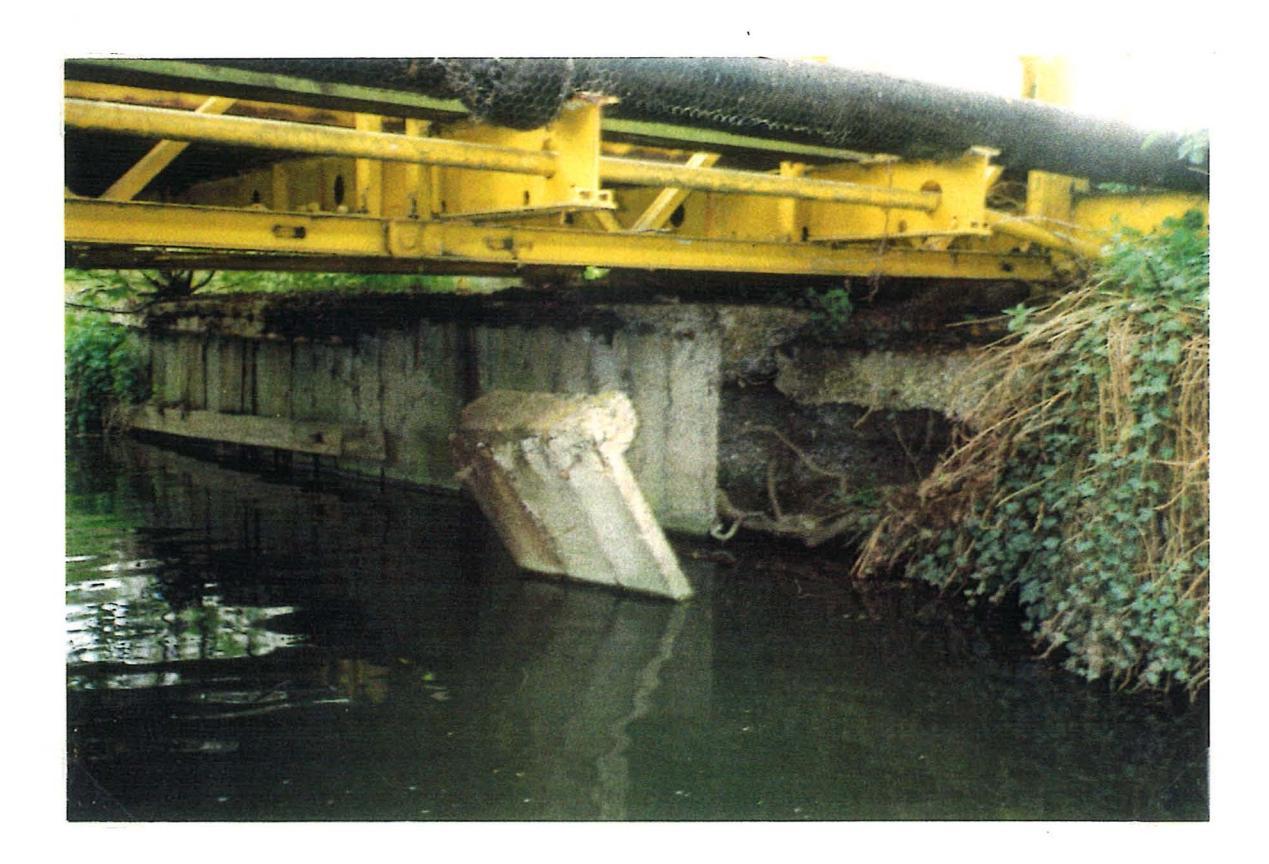
BRIDGE NO. 2

The reinforcement in the south abutment concrete piles is too close to the surface, is exposed in a number of locations and is hence corroding. This will shortly lead to spalling of the concrete and loss of the integrity of the piles. At the west side of the bridge a 1.3m length of pile wall is missing and a further 3 piles are residing at an angle of 45 Deg into the river. The ground behind this area has been washed away and a section of concrete slab has dropped. This in turn is affecting the

South abutment showing damaged piles and missing embankment wall.

The abutment at the south west corner of the bridge requries remedial works. The concrete piles leaning at an angle into the river need to be removed and approximately 2m of abutment and embankment wall replaced with either concrete or sheet steel piles. The area behind should be backfilled with either concrete or well compacted material. If the existing bridge is to be retained the level of the bearing should be raised such that the deck of the bridge is in the same plane rather than being twisted as it is at present.

i/ To remove damaged concrete piles and replace 2m length of river wall, backfilling with concrete and raising the level of the bridge bearing at the south west corner.

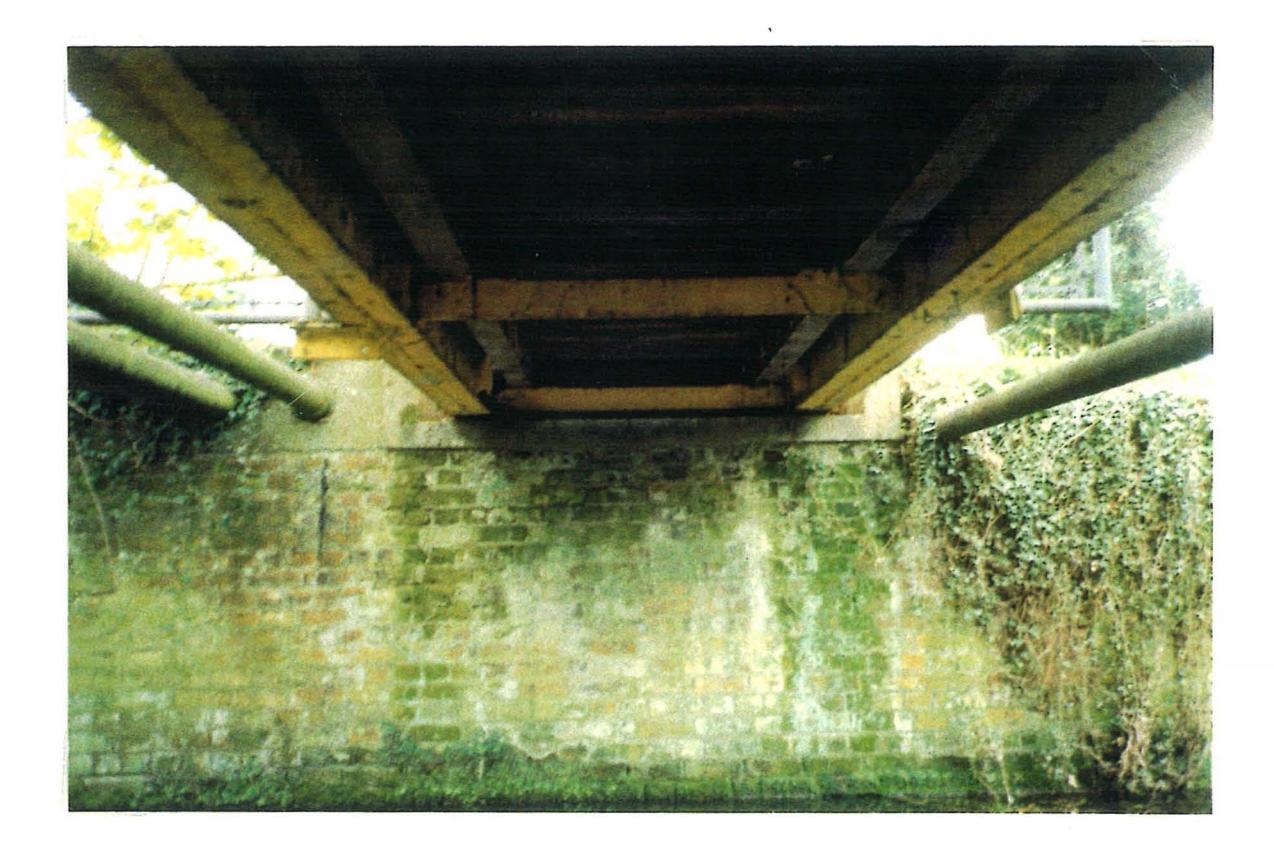
BRIDGE NO. 3

Both abutments are brickwork. The south west abutment was very damp where water runs down from the bearing shelf. The brickwork above water level was in fair condition although at and below water level the pointing was missing to a depth of at least 100mm and bricks have fallen out of the wall.

Underside of bridge showing west abutment.

The abutments are adequate to support the footbridge provided remedial works are carried out. The brickwork needs repointing and any missing bricks should be replaced. The cause of the horizontal crack below the north east bearing shelf is unknown. The joint should be infilled and checked on an annual basis to ensure that the damage is not progressive.

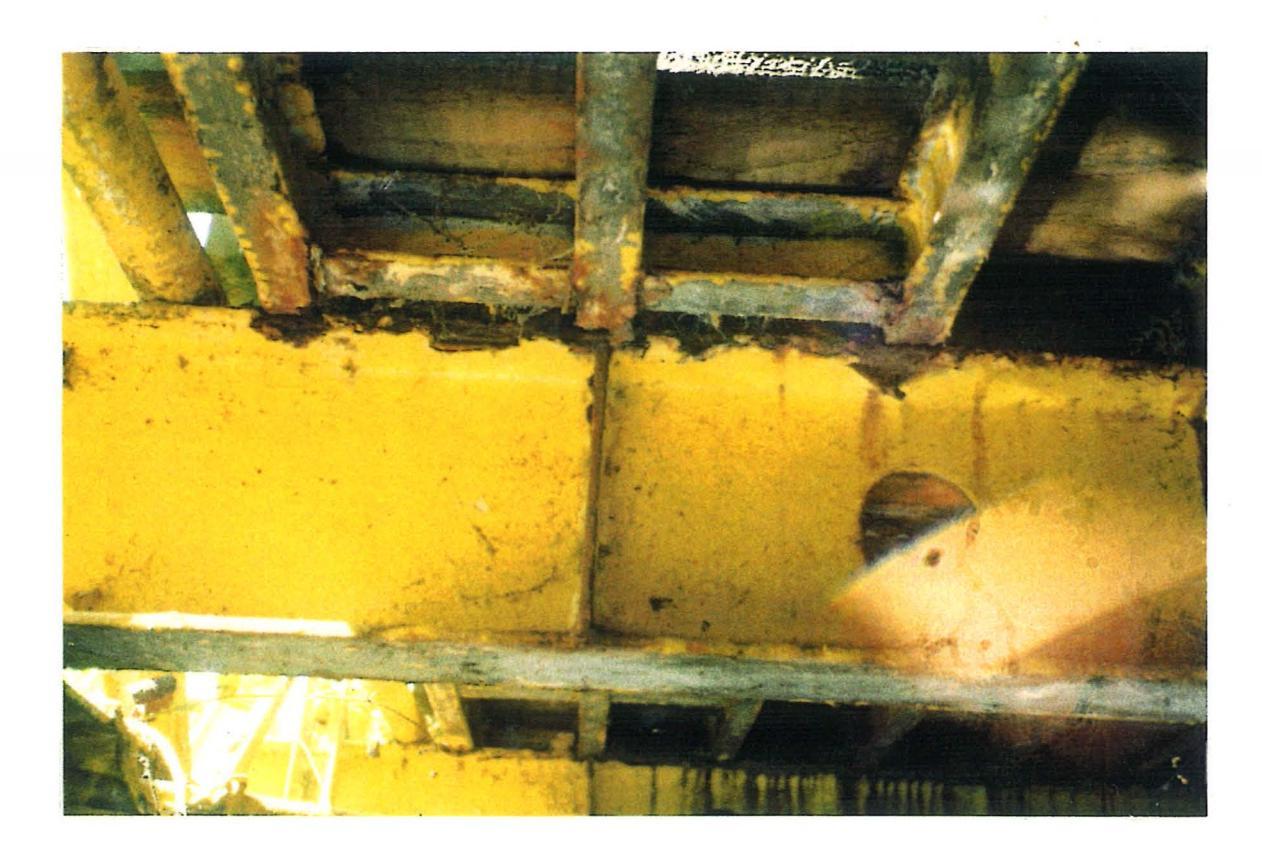
BRIDGE NO. 4

Underside of deck showing corrosion at joist, transom connection.

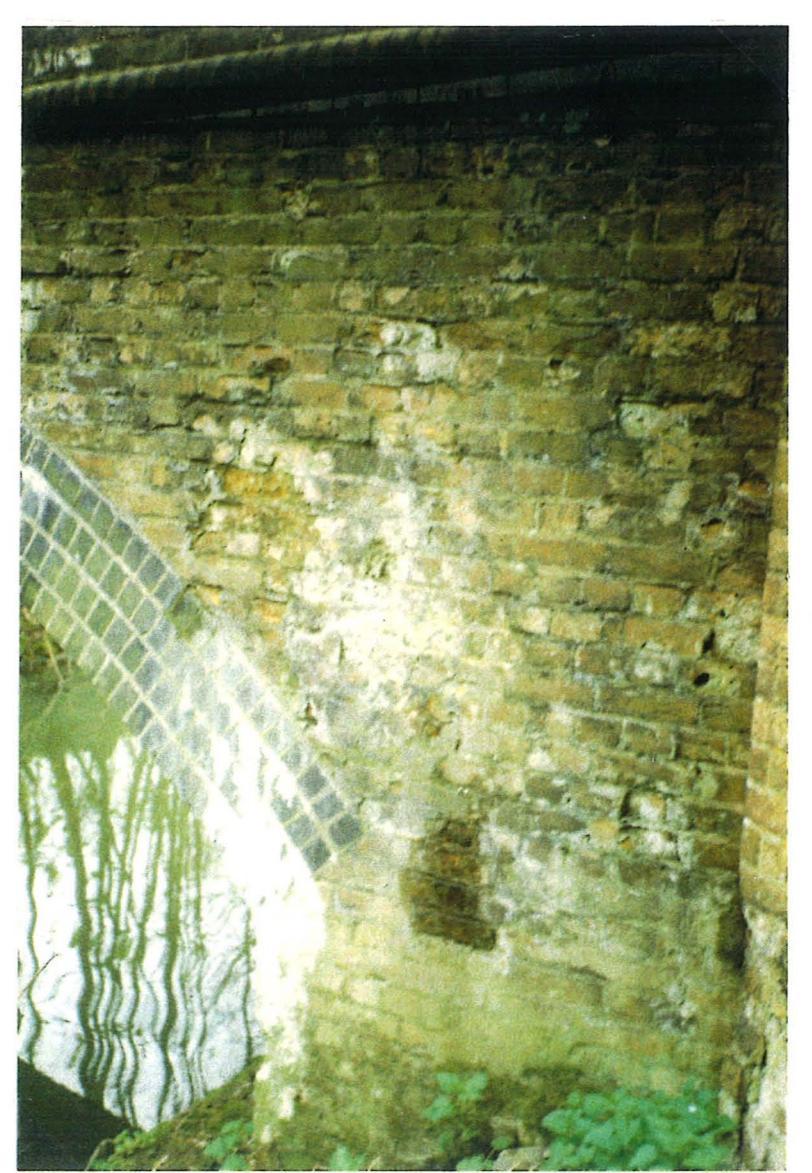
BRIDGE NO. 10

North-east spandrel wall showing weathered brickwork and water leakage.

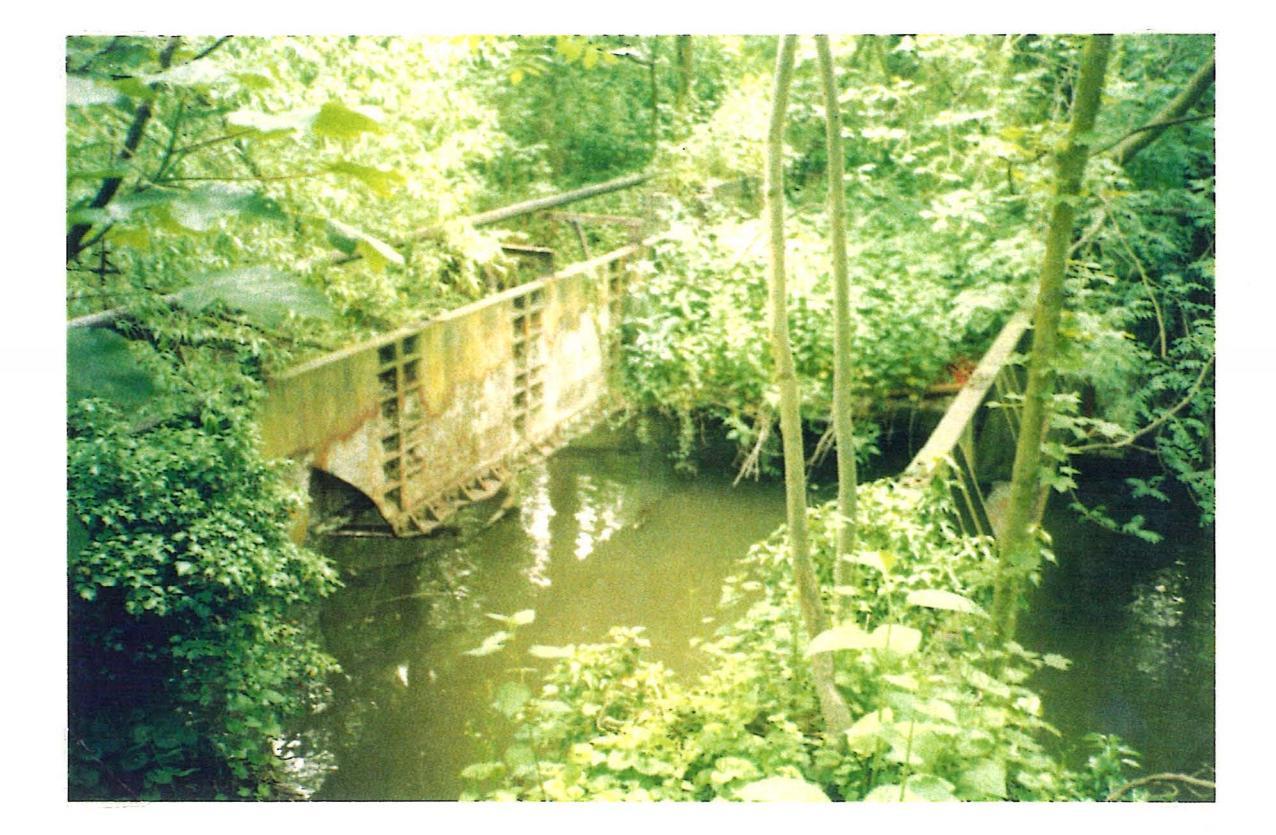
BRIDGE NO. 20

Looking east showing base missing from cast iron trough.

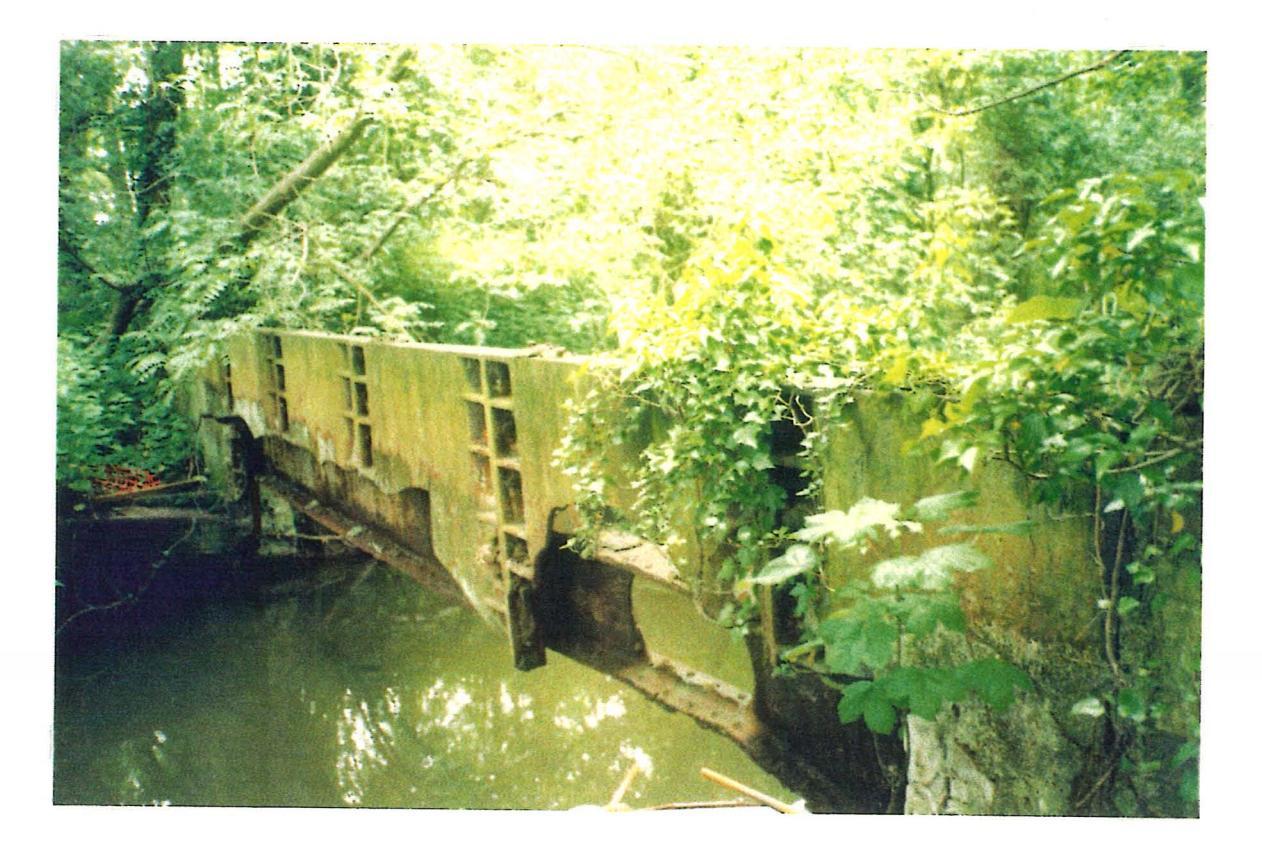
South internal side showing damage to cast iron sections and hole in web of plate girder.
