RARDE NORTH SITE WALTHAM ABBEY

BRIDGE ASSESSMENTS

JUNE 1993 JOB NO. ICC 657 Rev.A

DEFENCE LANDS SERVICES 3 CENTRAL DISPOSALS UNIT MINISTRY OF DEFENCE LEATHERHEAD ROAD CHESSINGTON KT9 2LU

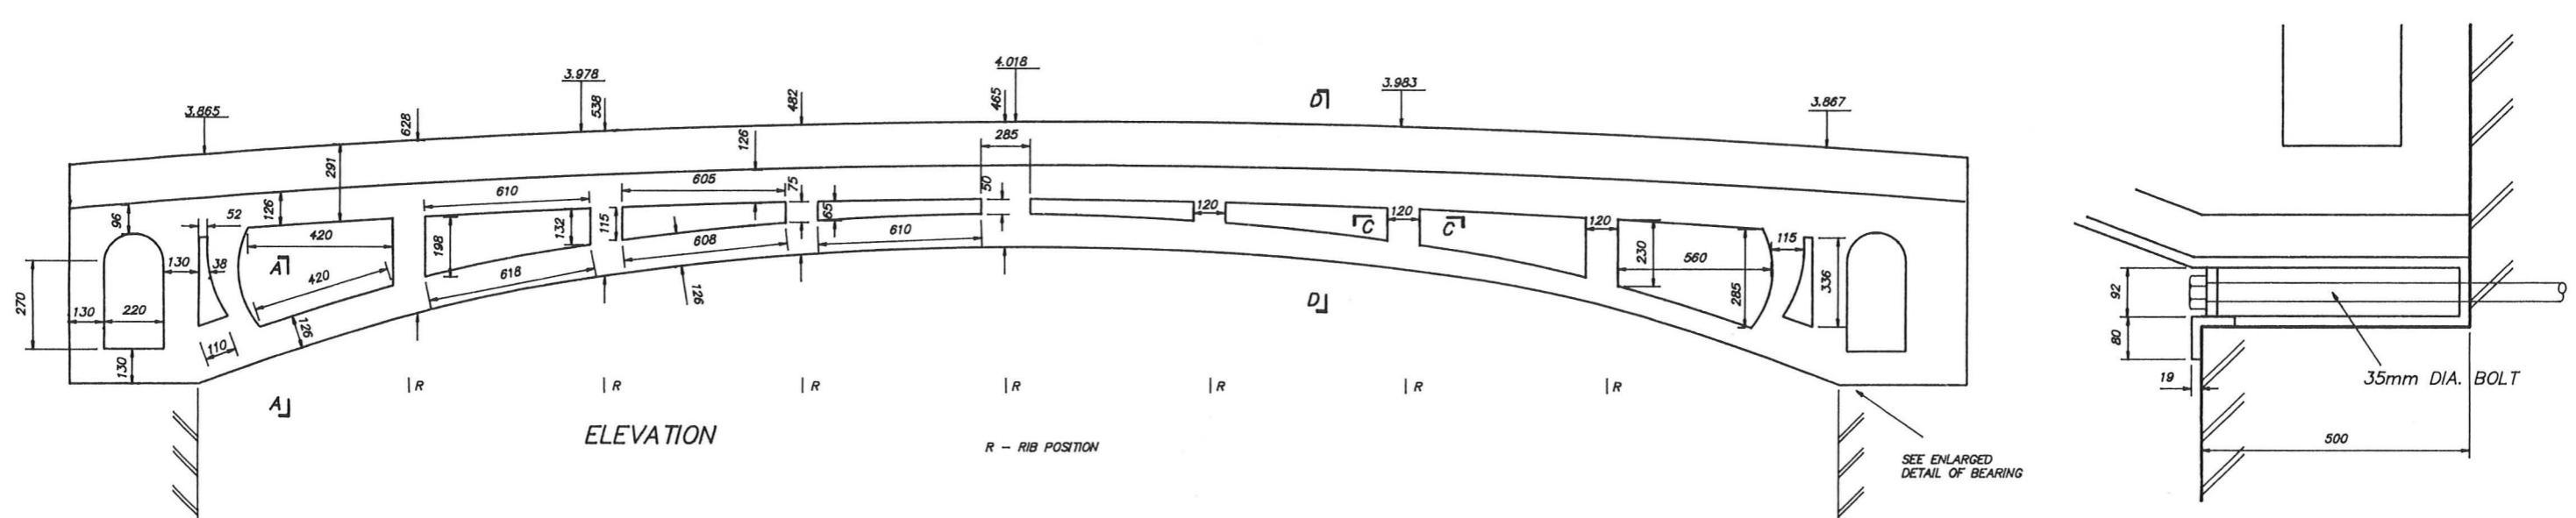
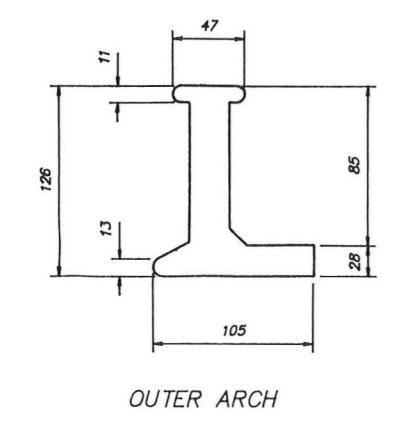
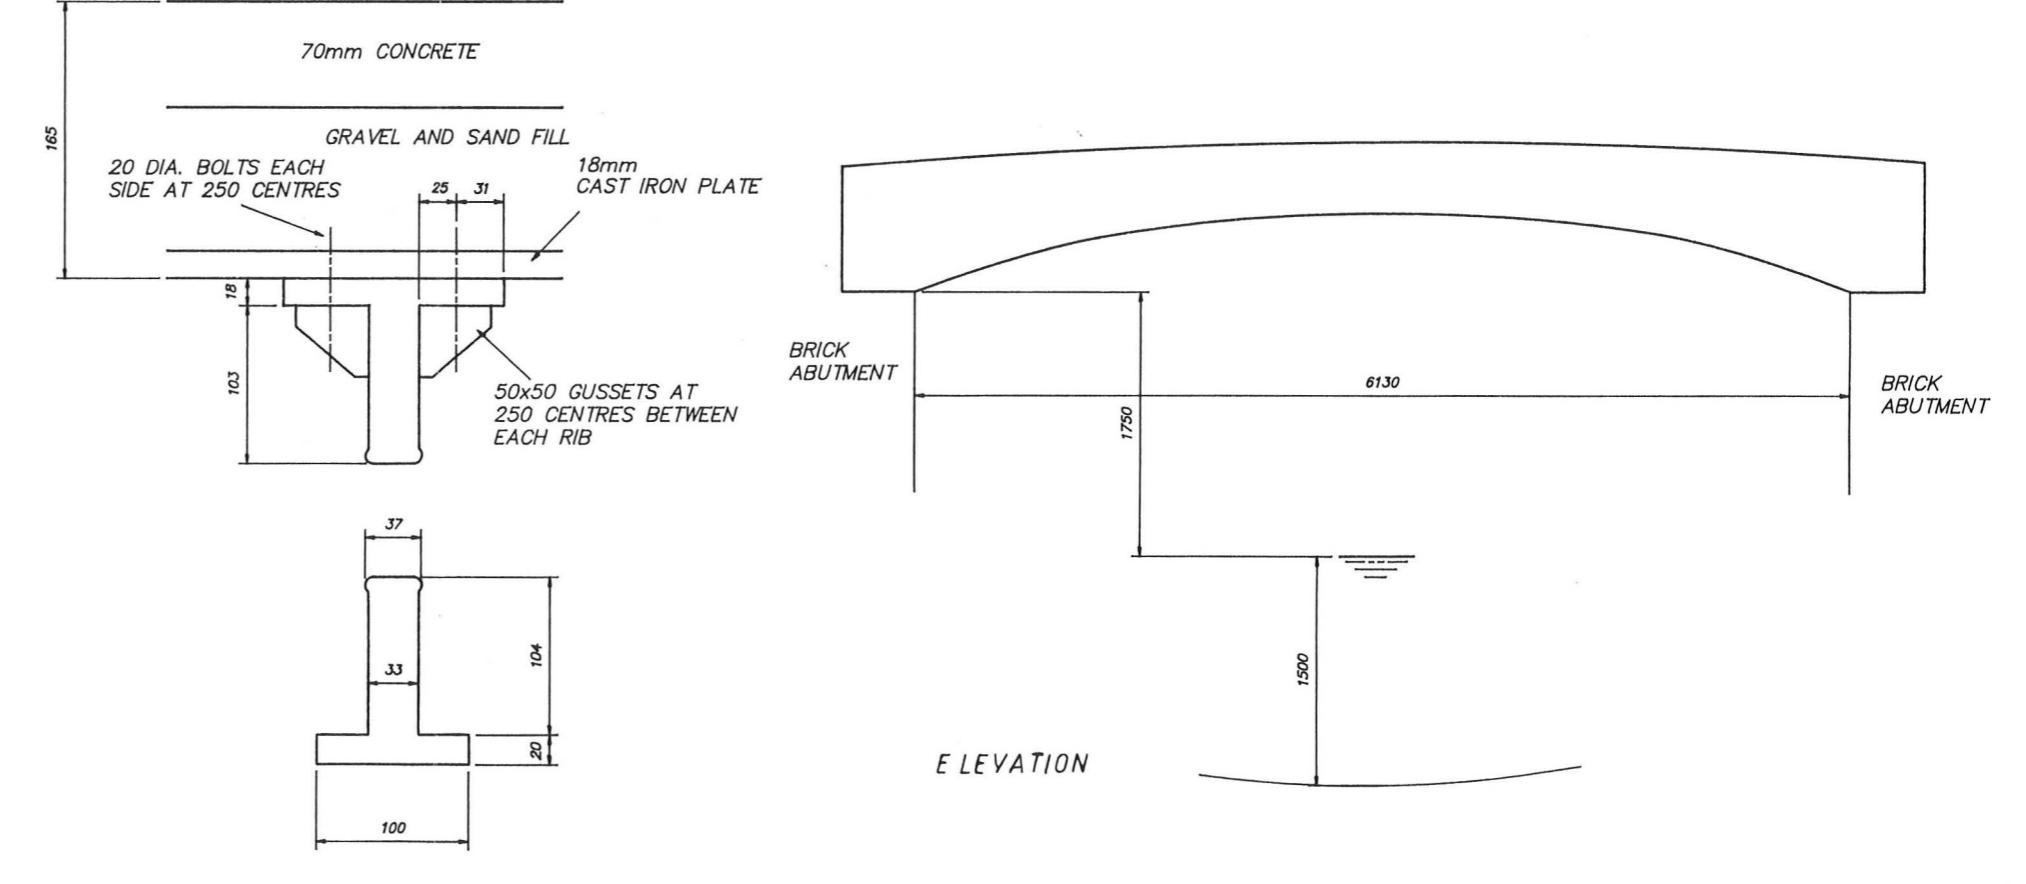
Sheet 1

Between the two most south western cast iron arch ribs the restraint sections have been removed in order to install a steam main; it is believed this steam main is now redundant and can be removed. The external arch on the north east side has two sections of the bottom flange missing adjacent to the north west abutment. It is not possible to swap this arch with any of the internal ones as they are different.

Some of the bolts fixing the arch ribs to the brickwork are severely corroded and there is a considerable quantity of loose material on the bearing shelf. A number of pieces of timber have been fixed into the bridge over each bearing and these should be removed and the paintwork behind made good. Generally the paintwork to the bridge is in good condition.

The north east external arch rib should have the bottom flange repaired where the two sections are missing adjacent the north west abutment. This can be done by bonding in a new section of cast or ductile iron using epoxy adhesives. Welding of cast iron is not possible.

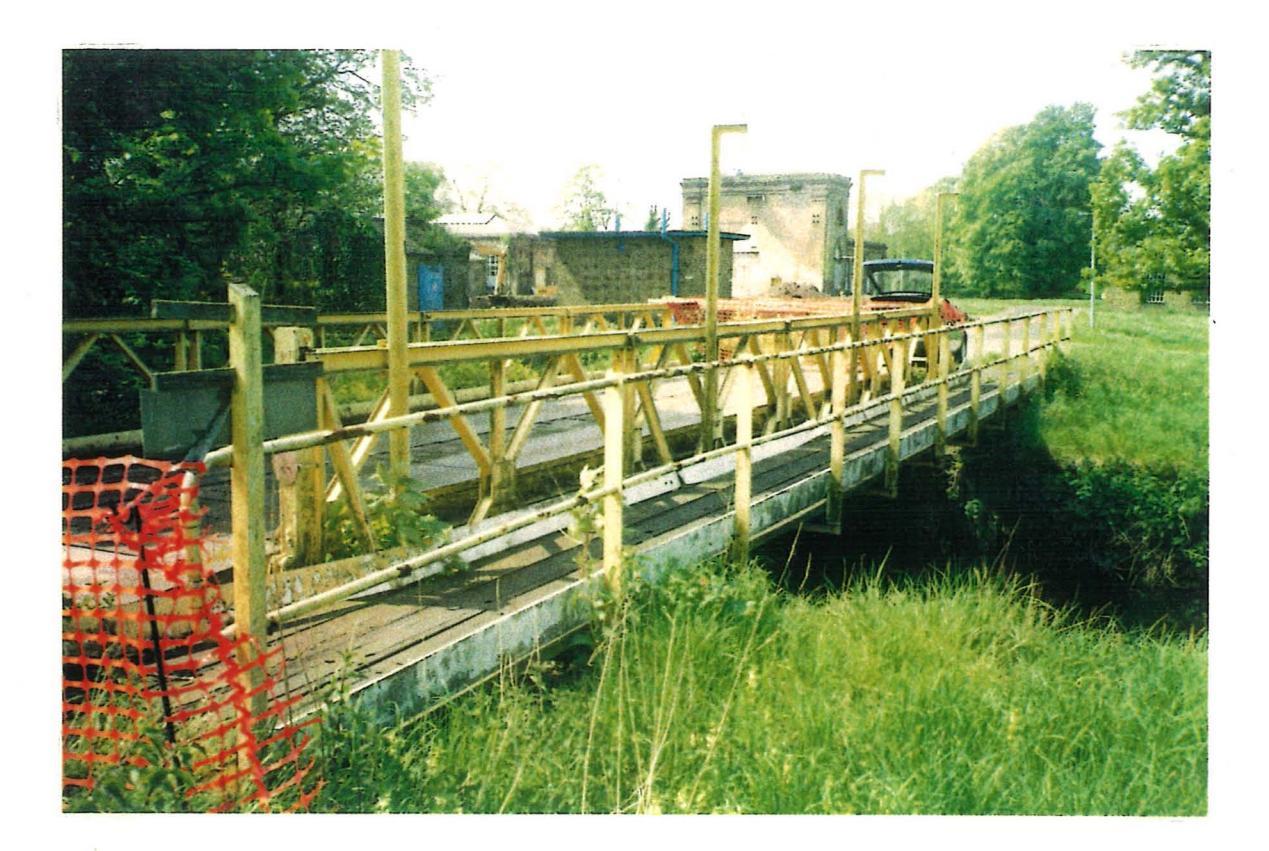
North elevation looking west showing footway.

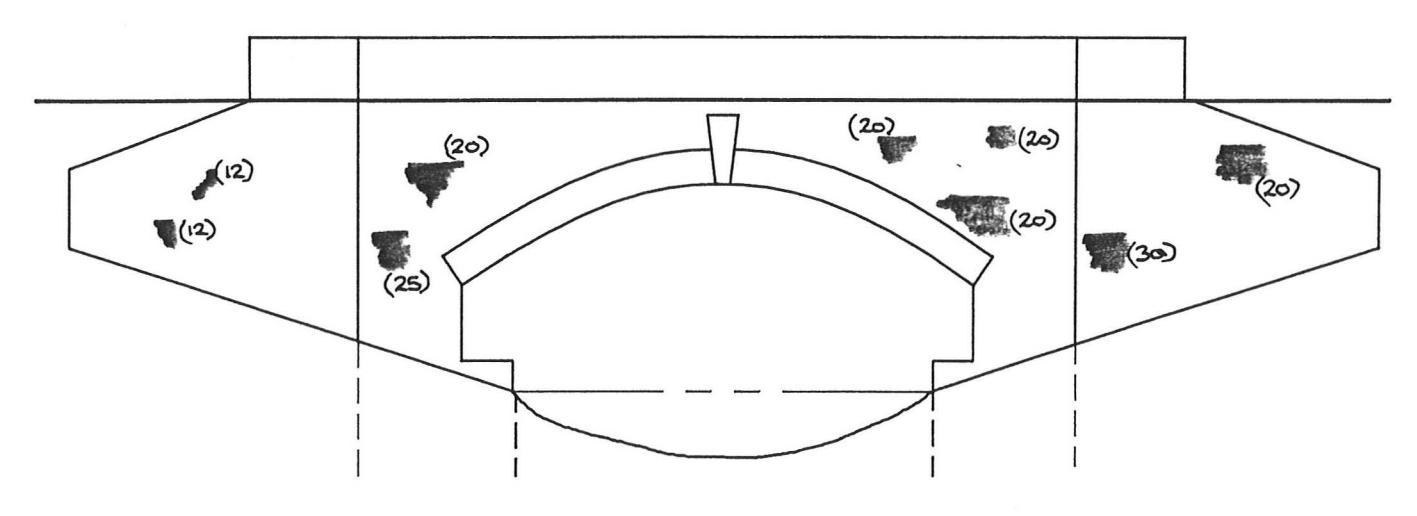
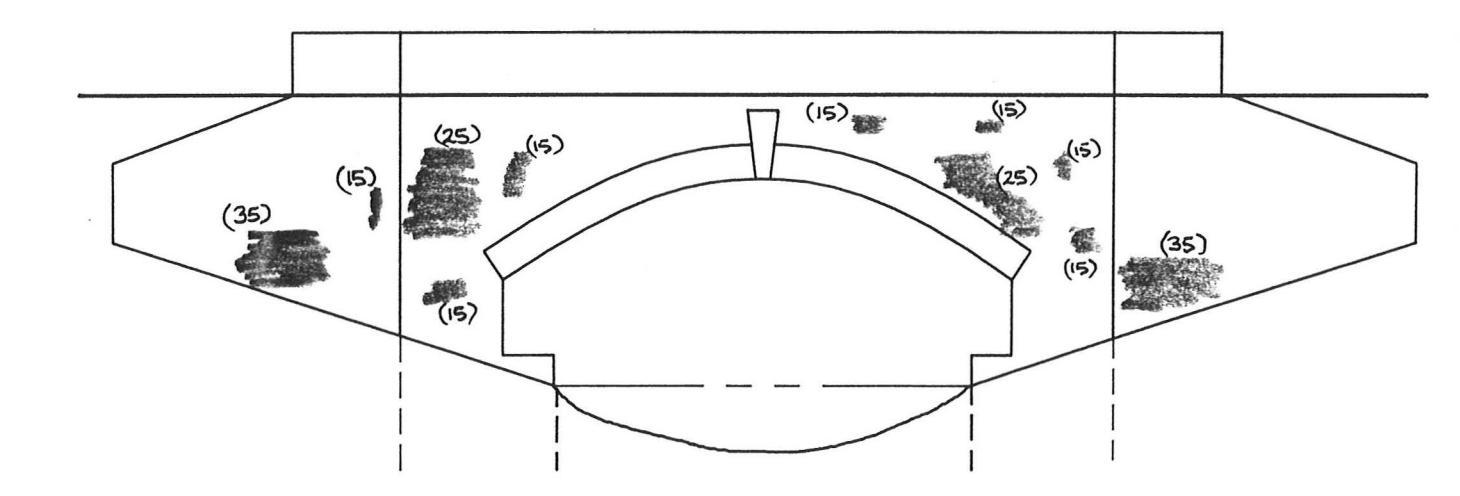
FIGURES IN BRACKETS INDICATE DEPTH OF WEATHERING OF BRICKWORK

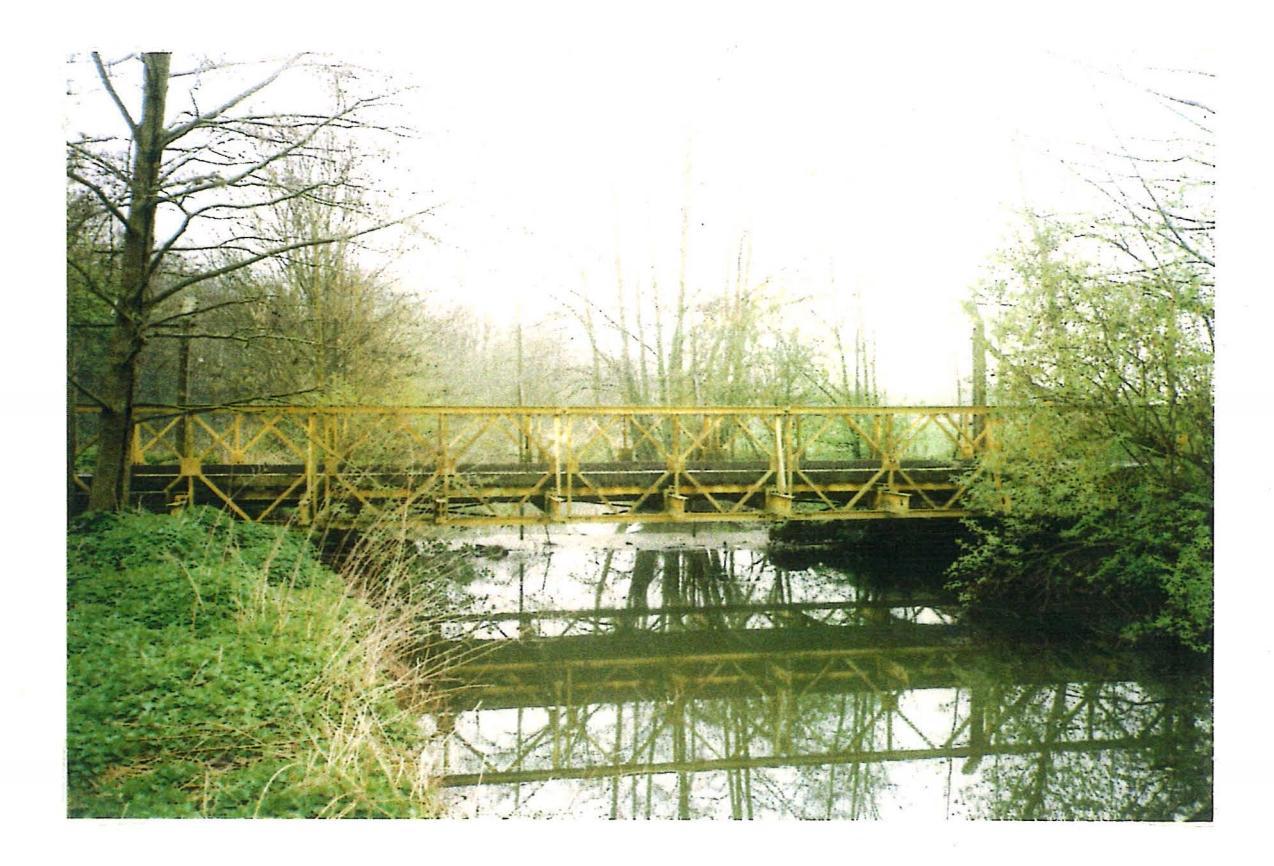
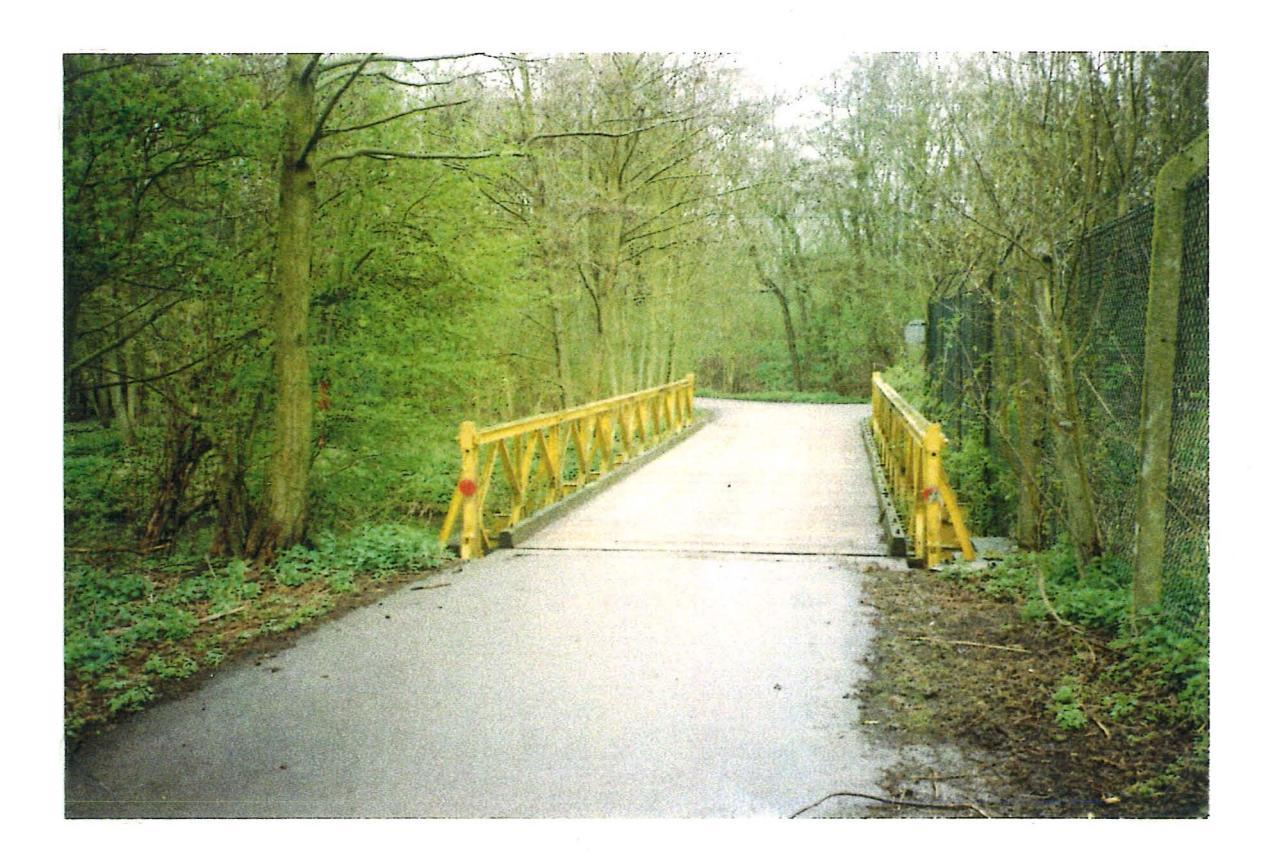
BRIDGE NO. 11

The asphalt surfacing is in fair condition. The underside of the steel troughing has heavy surface rusting with laminates coming away on the north trough adjacent to both abutments. It is possible that the underside of the troughing has been cleaned down in the past and a thickness of metal removed. However given the age of the bridge and the lack of maintenance on the remainder of the bridges around the site we would anticipate that this has not occurred and the remaining thickness of metal is only slightly less than the 12mm originally detailed.

The east abutment appears to have been rebuilt fairly recently, 215mm brickwork replacing the original stone abutment. The brick wall is in good condition with sound pointing. The west abutment is rough hewn stone blocks cemented together. An average of 50mm - 75mm of pointing is missing and 2 stone blocks have fallen out completely. There is ivy growing up the wall. There is evidence of water having leaked down the face of both abutments from the outer troughs.

The deck is capable of carrying the 40 Tonne assessment live load. In determining the allowable load, no account has been taken of the composite action between the concrete and the steel trough decking as corrosion may have affected the bond due to water permeating through the concrete to this interface. There is no way of draining the steel trough section and no waterproof membrane preventing water entering the concrete.

The parapet hand railing does not comply with the requirements of Technical Memorandum BE5. The moment of resistance of the post is inadequate, the frame has not been infilled and no plinth or kicker has been provided. The parapet should therefore be replaced.

The west abutment requires all vegetation to be removed. It must then be repointed and where stone blocks are loose or have fallen out these need to be rebedded or replaced respectively.

In order to ensure the long term durability of the bridge, the surfacing should be removed down to the top surface of the concrete, a waterproof membrane installed and the surfacing replaced. Holes should be drilled in the bottom of each end of each trough to allow any water which penetrates the deck to escape. The underside of the steel troughs should be grit blasted to remove the corrosion and then the steel troughs coated with chlorinated rubber paint.

a/ To remove the road surface down to the concrete, apply waterproof membrane and replace the surfacing.

- b/ To grit blast the steel trough deck and apply 2 coats of paint. £1650
- c/ To replace the handrail with a parapet that complies with the requirements of BE5.

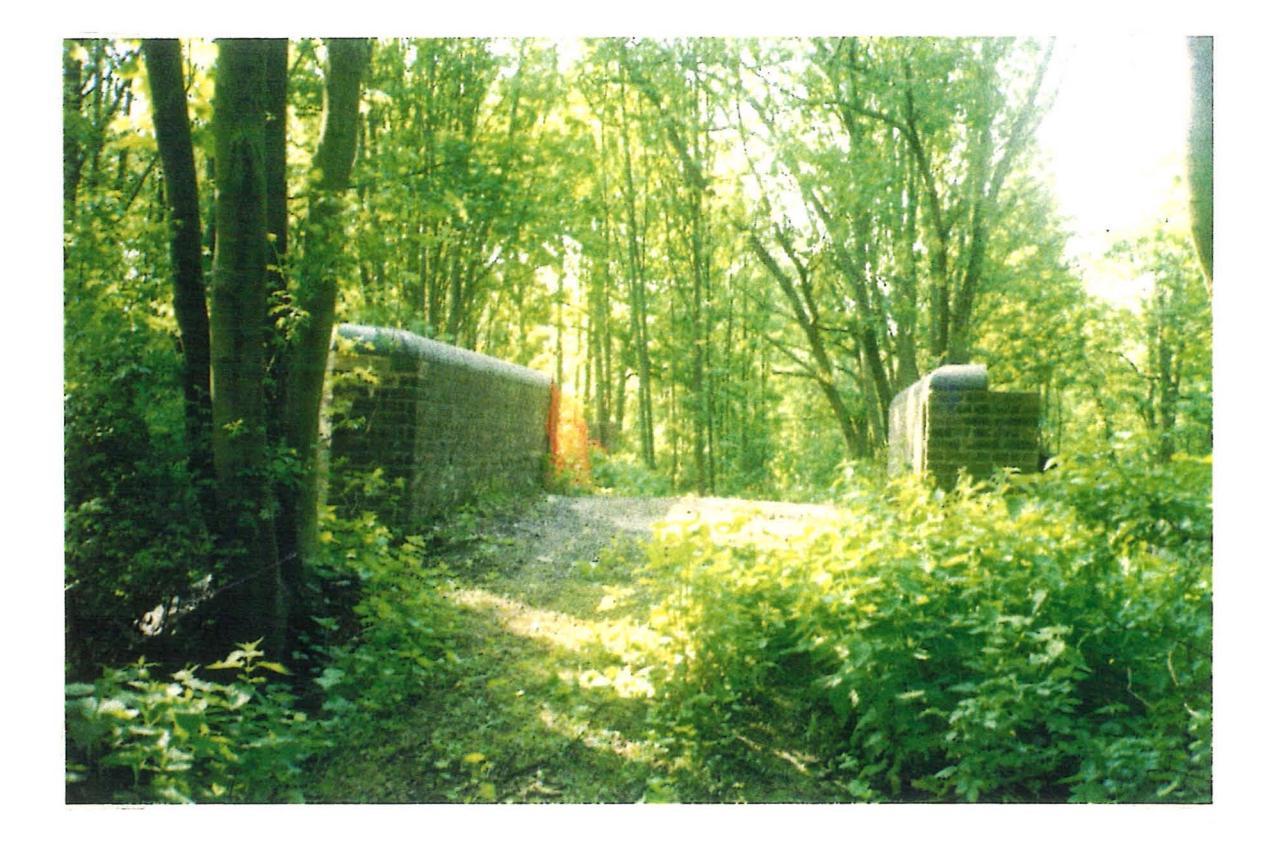
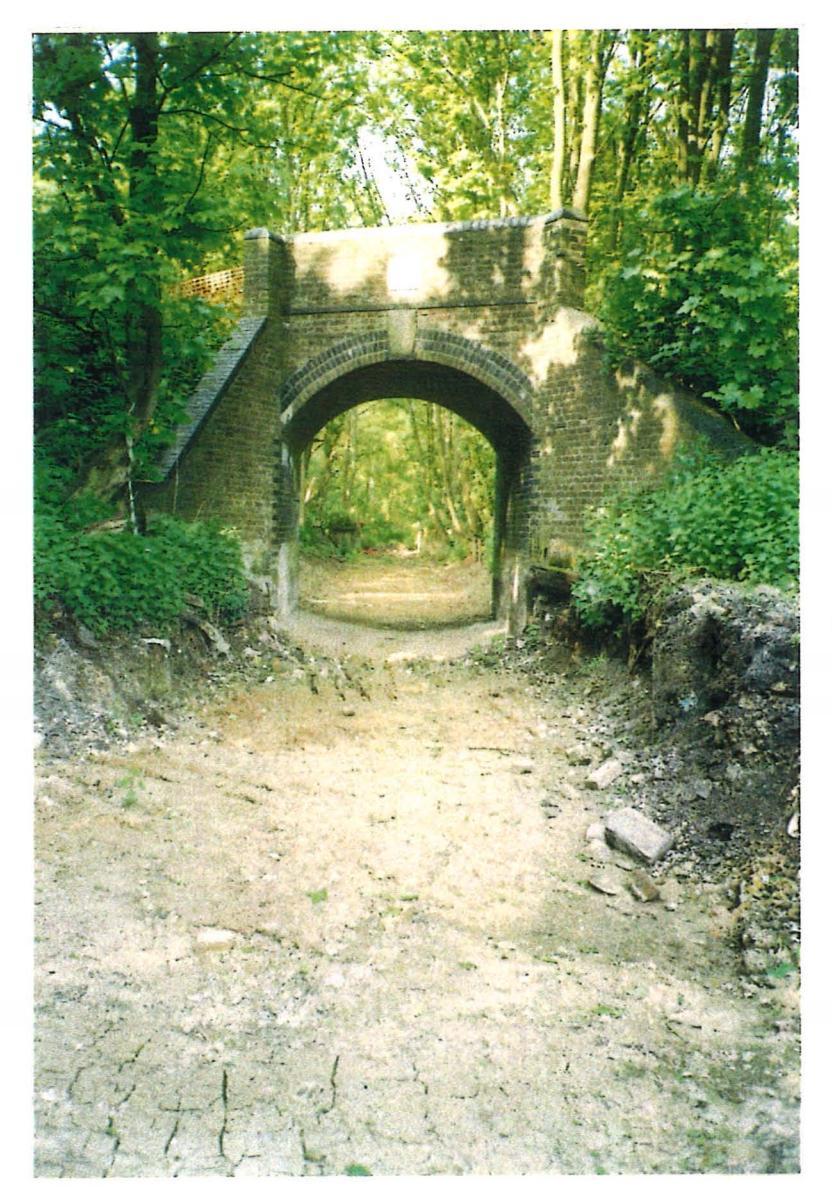
BRIDGE NO. 16

Item No.	Item Description	Condition G - Good	Defects		Remarks
		F - Fair P - Poor	Extent	Severity	
1	Foundations				Not visible.
2	Invert				River bed.
8	Abutments	Ρ	с	4	West: concrete with exposed reinforcement. East: rendered brickwork poor pointing below water level. Very overgrown. Top of abutment tilted backwards.
10	Enbanknents	F	D	2	East: brickwork overgrown. West: precast concrete piles.
13	Main Beams	VP	С	4	Steel truss each side. Top and bottom members fair. Detail C connection on Drg 17 condition varies from good to totally failed.
15	Bearings				Nil.
16	Transverse Beams	P	D	3	Tops of angles and flats corroded.
20	Bracing and/or Cross Ties				To be installed.
21	Deck Timbers	F	D	3	Need cleaning and preservative.
34	Paintwork	P	В	4	At joints with lower boom paintwork flaked away.
35	Parapets				Steel truss.

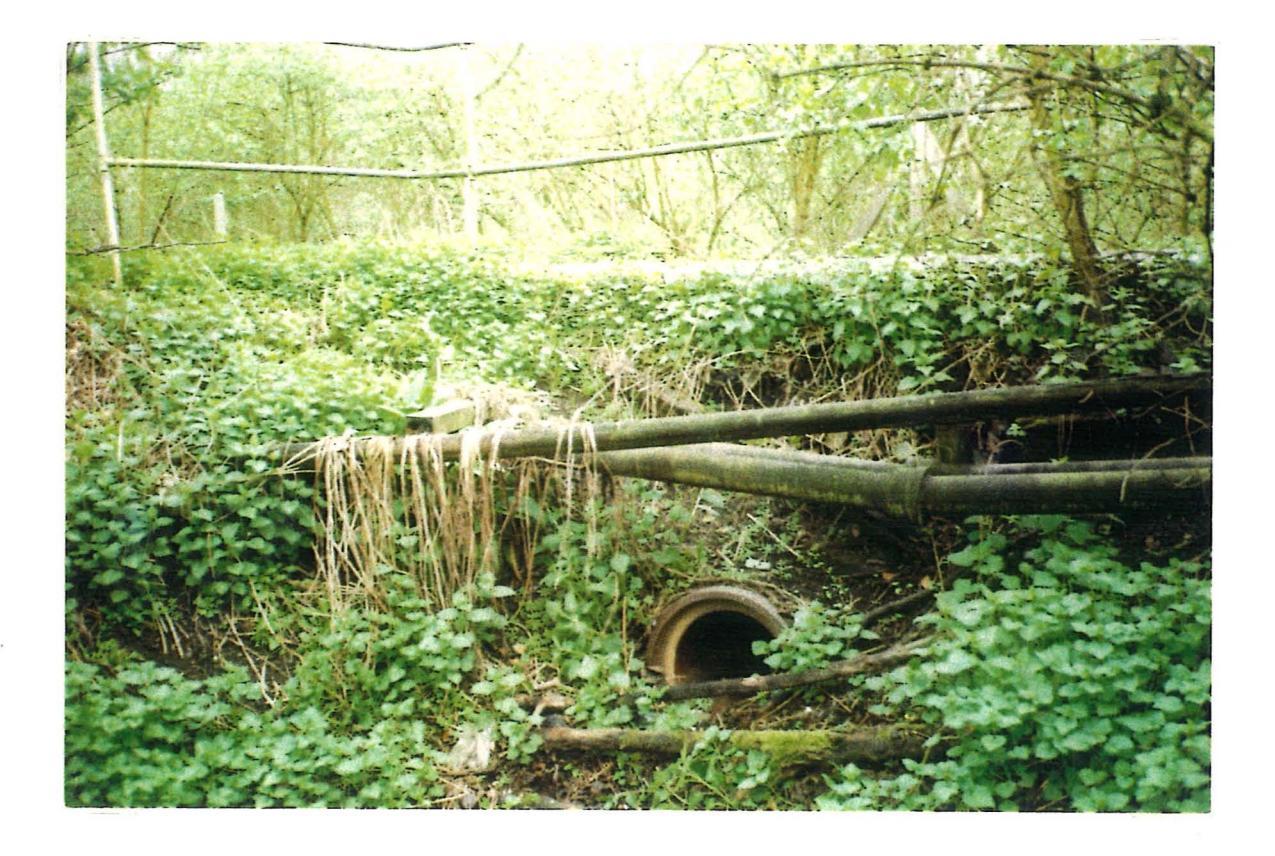
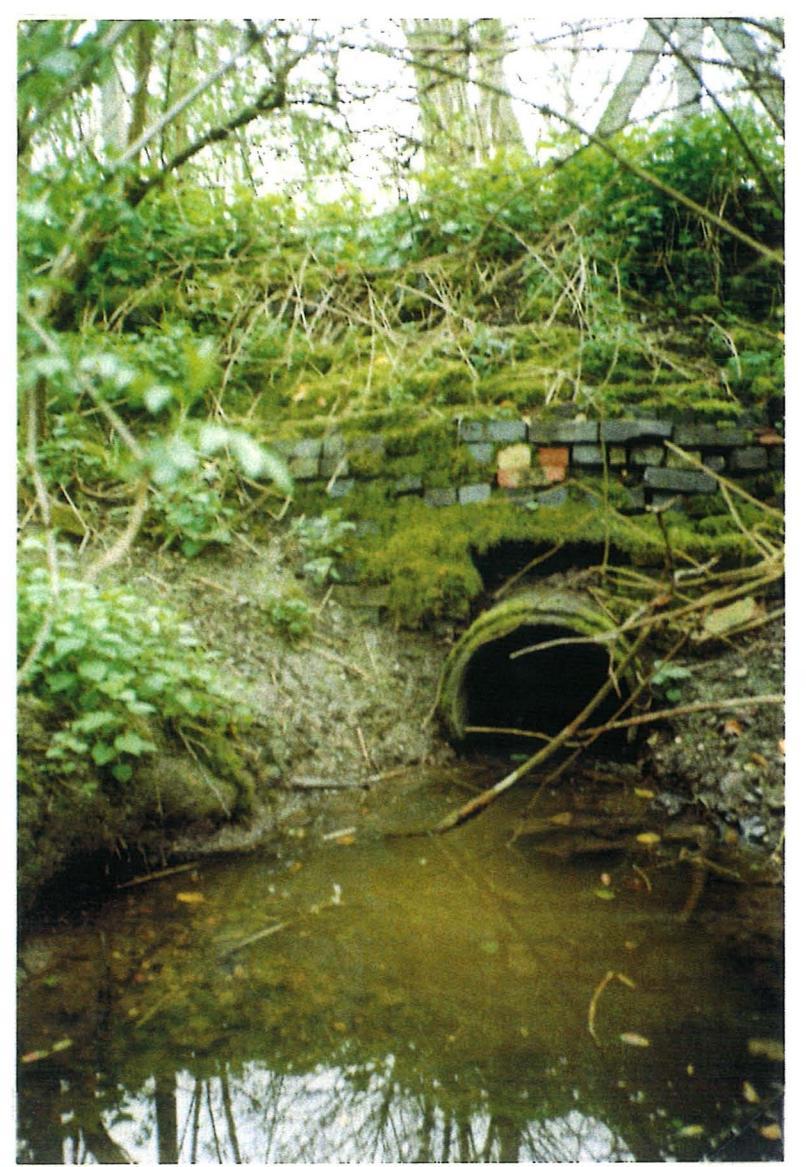
BRIDGE NO. 18 (CULVERT)

The existing culvert is adequate to carry vehicle loads. However the headwalls at either end are very dilapidated and there is danger of the road collapsing particularly on the west side. We therefore recommend that the culvert is removed and replaced by a new pipe. To excavate, lay a new culvert 9.5m long with headwalls at either end, backfill and reinstate road would cost

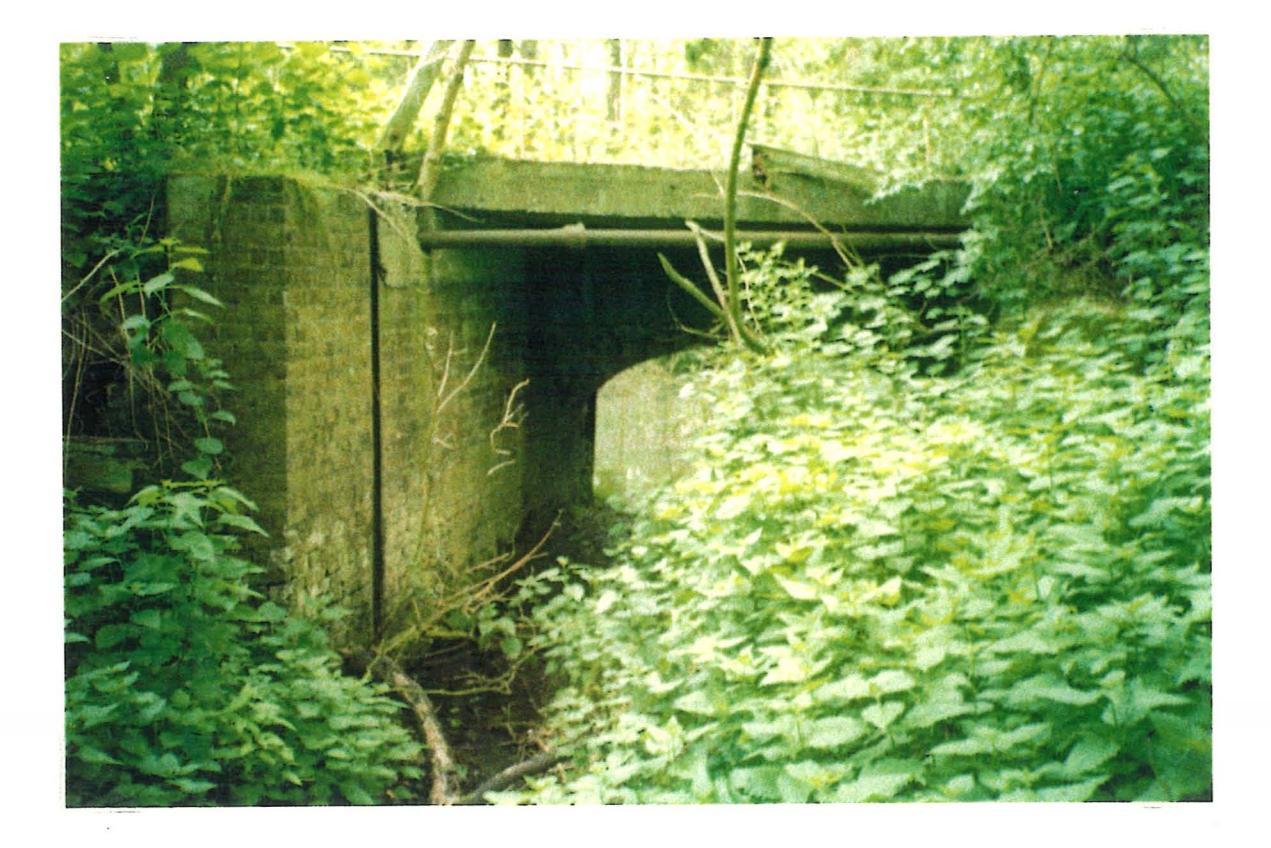
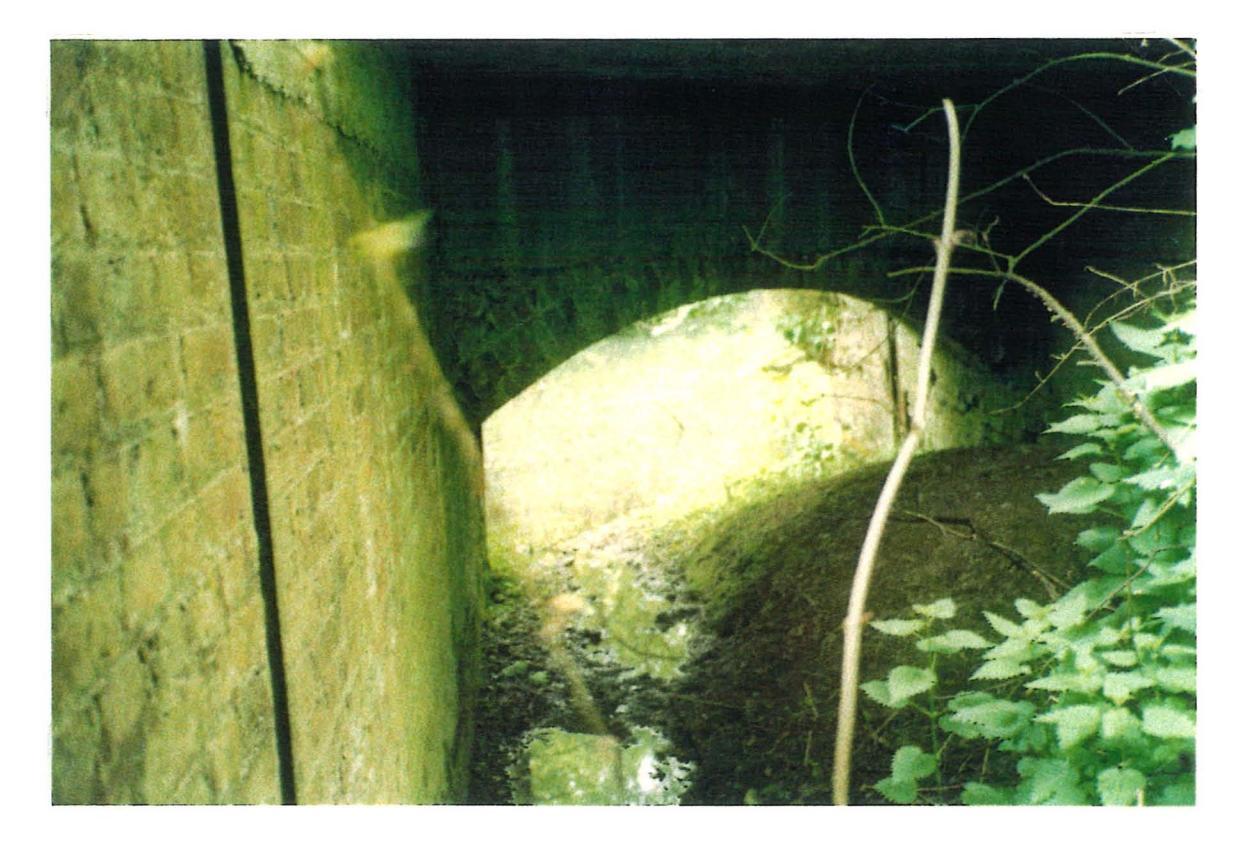
BRIDGE NO. 19

This bridge is in such poor condition that it should not carry anything greater than pedestrian loads and even then the parapet is not acceptable. It will therefore be necessary is to demolish the concrete deck and what is left of the masonry arch leaving only the abutment walls. If English Heritage are interested in the structure the abutment walls would need to be repaired and a new masonry arch constructed. However the most cost effective solution would be to place a culvert in the bed of the water course between the remaining abutment walls and the whole section backfilled up to the existing track level.

Item	Item Description	Condition G - Good	Defects		Remarks	
NO.		F - Fair P - Poor	Extent	Severity		
1	Foundations				Not visible.	
2	Invert				River bed.	
8	Abutments	West VP East P	D C	4 3	West: bricks missing North corner, South corner severely damaged. East: South corner bricks missing tree root ingress to top of wall.	
10	Enbankments	VP	D	4	Overgrown river bank.	
11	Training Walls	VP	D	4	Top damaged by tree roots.	
13	Main Beams		D	4	Replacement required.	
15	Bearings				Nil.	
28	Deck Plates		D	4	Cast iron trough non- existent.

Further along this ditch there is a 450mm diameter pipe under a road. Unless flooding is known to have occurred in this area due to inadequate pipe size we suggest this culvert also comprises a 450mm diameter pipe. The cost of demolishing the bridge deck and laying a 450mm diameter culvert 9m long in the bed of the existing water course, constructing a small head wall at either end and backfilling with granular material would be

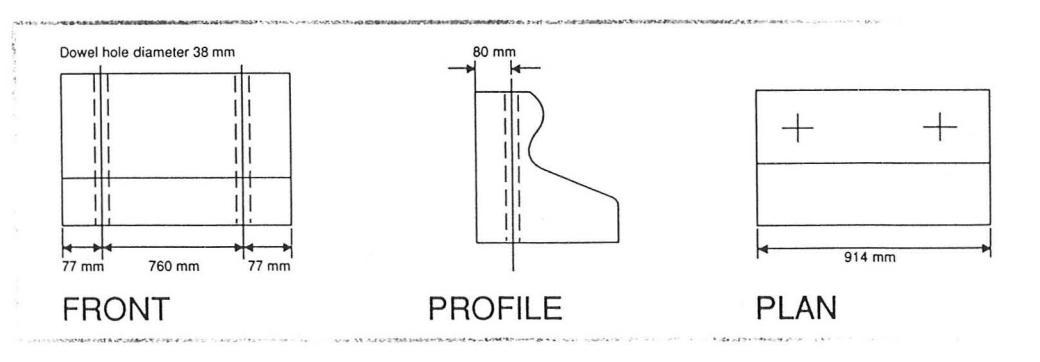
DOWEL HOLES

Where insufficient haunching is available Redland Trief Kerb can be supplied with vertical dowel holes moulded into the unit. Dowel bars can then be put through the unit and anchored securely.

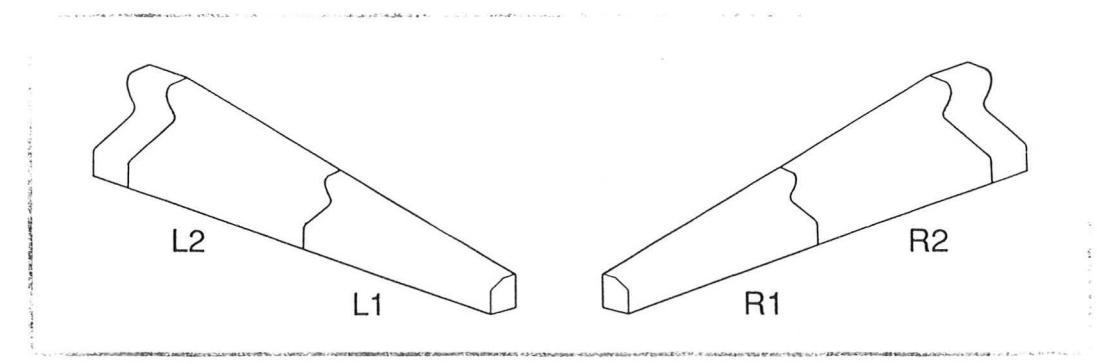
TAPERS

To allow Redland Trief Kerb to return to the normal lower profile of the roadside kerb a taper unit has been developed. The tapering Trief profile to normal roadside kerb is completed in two units. The Trief Kerbs match to half batter and splayed roadside kerbs.
