WALTHAM ABBEY SOUTH SITE ROYAL GUNPOWDER FACTORY

BUILDING No. SS113

HISTORICAL SURVEY OF BUILDING NO. SS113

Air Raid Shelter SS113, South Site, Waltham Abbey Royal Gunpowder Factory, Essex

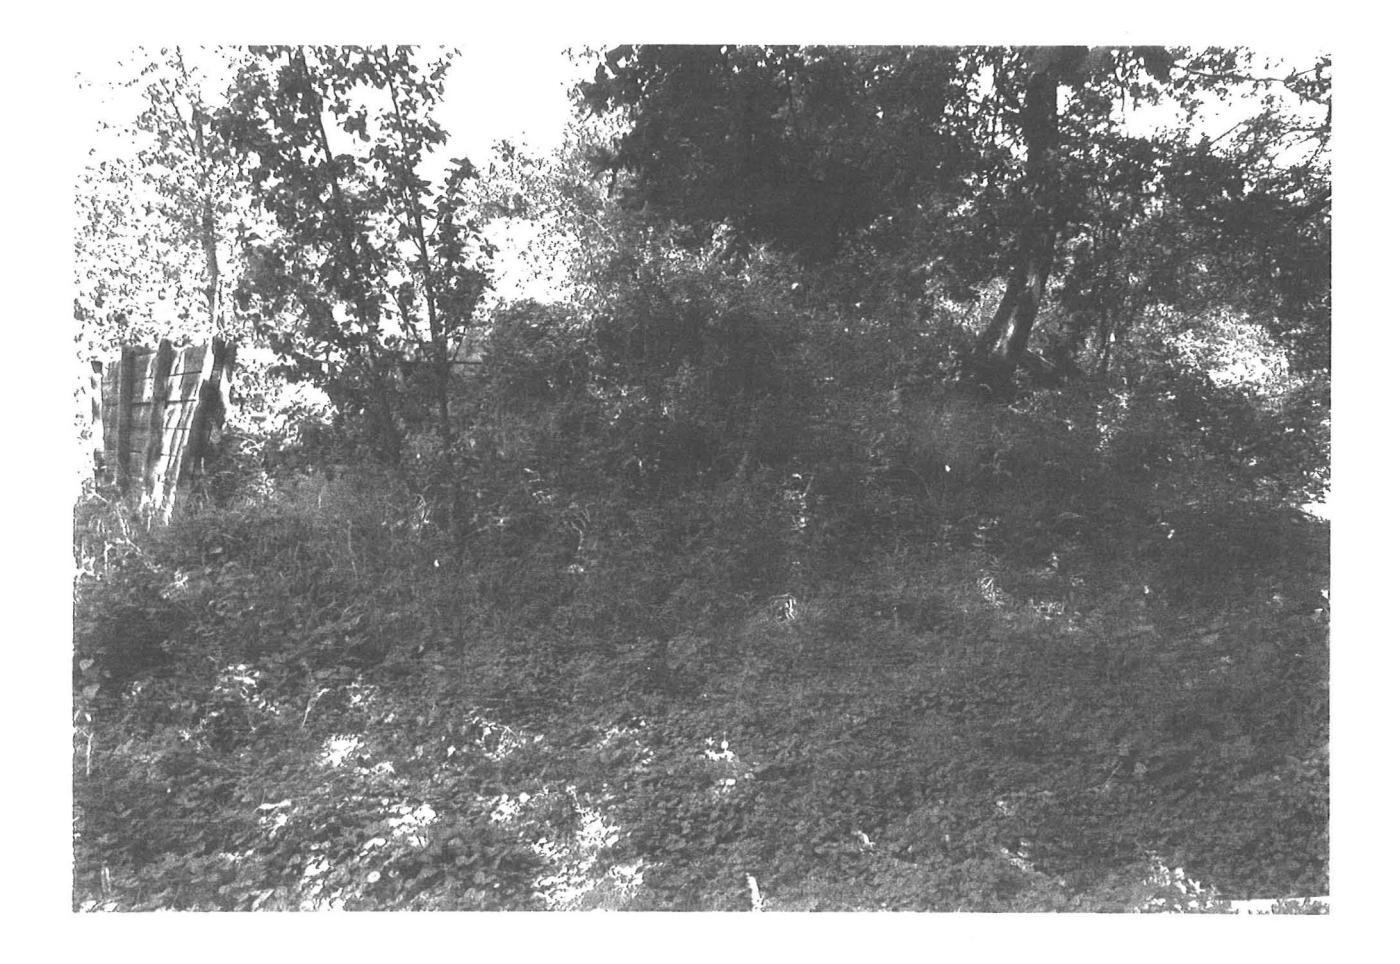
SS113 PLATE 1 - EXTERNAL VIEW, FROM SOUTH WEST

Rectangular plan 'Nissen Hut'-type structure sheathed in concrete beneath an earth mound, 11.5×9.8 m overall, aligned east-west (Plate 1). Entrances and revetments of timber at east and west ends, with earth-filled timber blast walls (Plate 2). The shelter interior is one large room, subdivided at its west end into two small compartments, one a two-seater toilet.

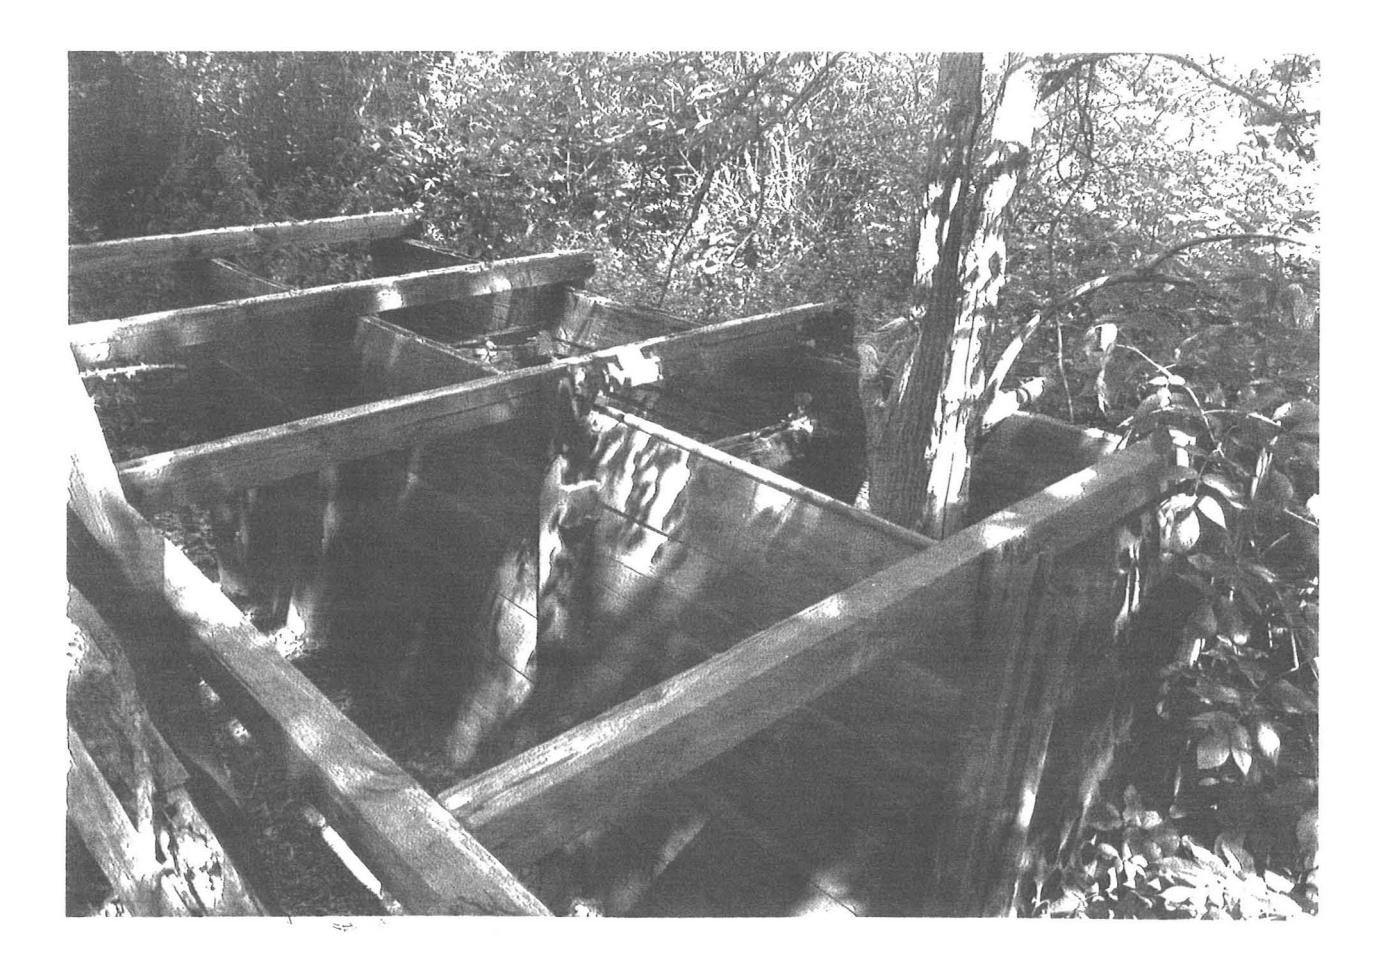
SS113 PLATE 2 - EASTERN BLAST WALL, FROM SOUTH-WEST

Timber Revetments: At each end of the structure, *c*.1m out from the end wall, is a revetment constructed with planks 230×50 mm section, nailed and bolted horizontally in a framework of 80×100 mm timbers (Plate 2). The profile of the revetment rises upwards in a triangle ending in a flat top, the whole extending beyond the profile of the mound (this may be due in part to settlement of its earth cover). The space between the revetment and end wall is filled with earth. Access to the interior is gained through each revetment by means of a short corridor or porch, about 800mm wide, lined with vertical boards (Plate 8). The revetment is joined to the blast wall beyond (Section 3) by a series of horizontal timbers at a level above the roof of the porch.

Blast walls: At each end of the building, 1.45m from the timber revetments, are blast walls 4 x 1m and c.1.8m high, constructed with planks 230 x 50mm section, nailed and bolted horizontally in a framework of 80 x 100mm timbers, the interior being filled with earth. The western blast wall has collapsed against the end of the building, and much of the soil fill has leached out of the eastern blast wall. The top of each blast wall is joined by horizontal timbers to the timber revetment (Plate 2).

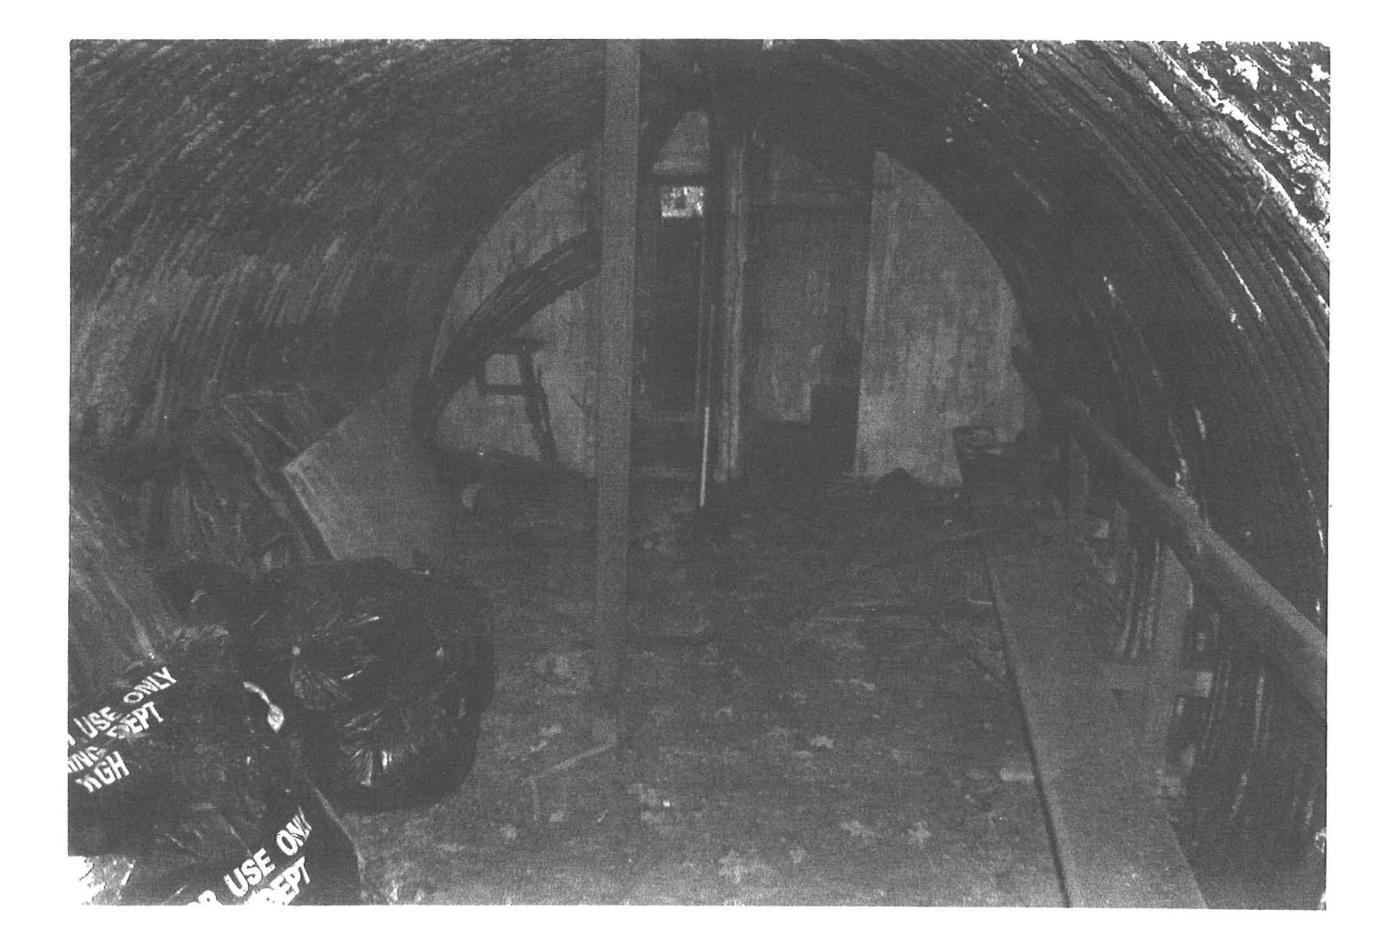
SS113 PLATE 3 - INTERIOR OF SHELTER, FROM EAST

Central Structure: Barrel-vaulted, length 8.75m, diameter. 3.65m, constructed of preformed sheets of corrugated iron, backed with bitumenised canvas (Plate 3). This is covered with a layer of ?reinforced concrete, 230mm thick over the top of the structure. Covering this is a layer of earth, on which are growing some substantial trees, giving an indication of the structure's age (Plates 1 and 4). The roof is supported throughout by a 'ridge pole' consisting of two lengths of 'I' beam 120 x 80mm, butt-jointed with bolted plates (Plate 5). This beam is carried on four uprights of 100 x 80mm 'I' beam, held in uprights set in the concrete floor at c.2.5m centres. The ends of the beam are fastened to the end walls with 'L' shaped iron brackets (Plate 6). There are traces of red paint on the beams.

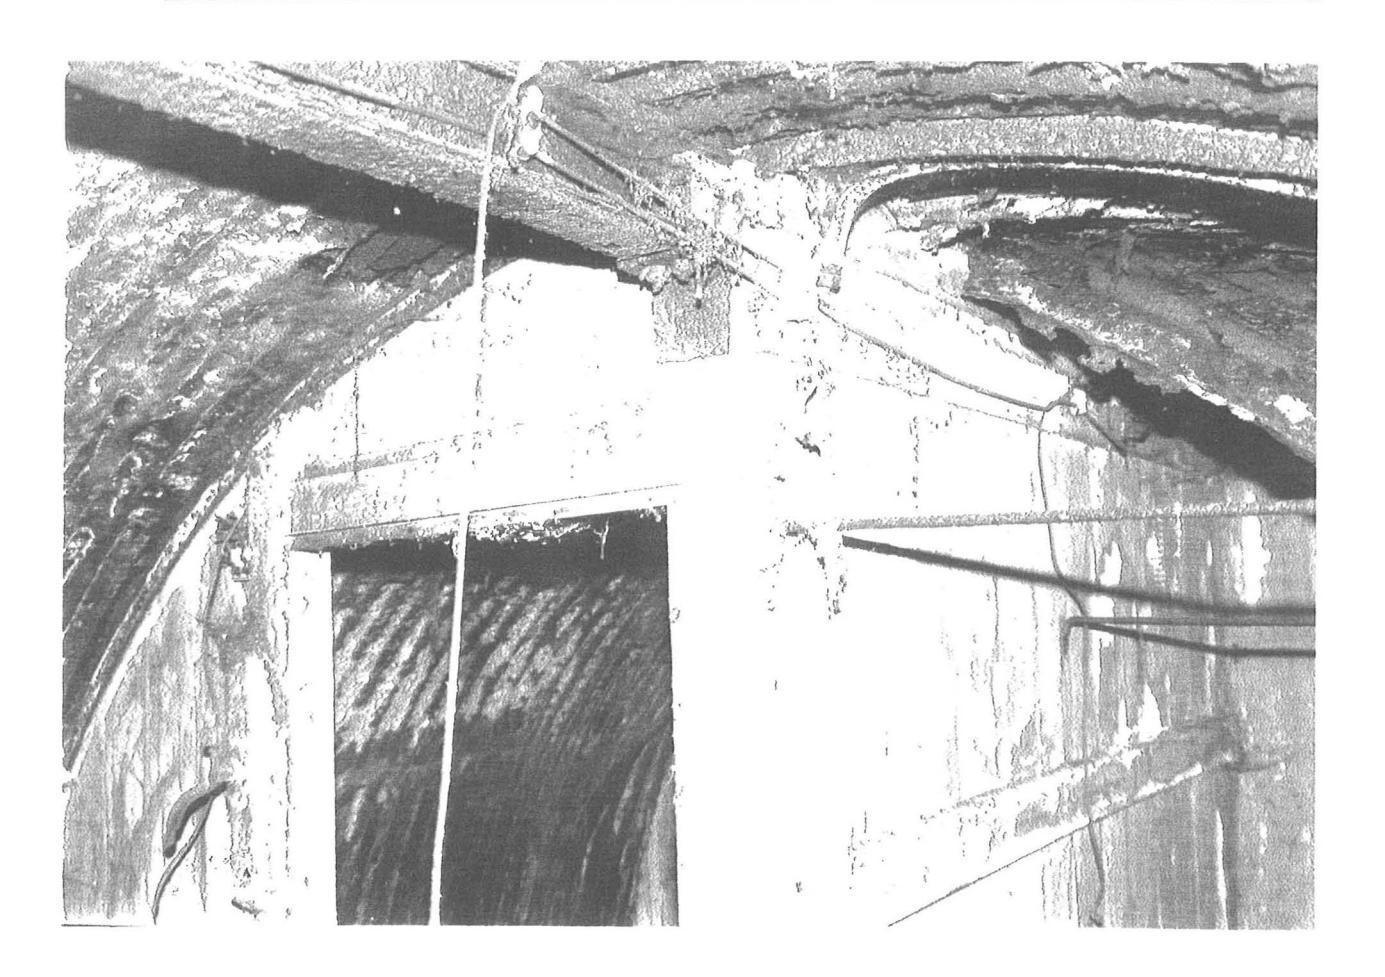
SS113 PLATE 6 - DETAIL: SURVIVING WIRING AT ENTRANCE TO TOILET COMPARTMENT

Electricity: Fabric-covered cables run along the north side of the roof support beam for about $^{2}/_{3}$ of its length, eastwards from the internal partition. The cables are held in white porcelain clamp-type insulators, bolted to the beam (Plate 6). High up on the wall at the entrance to the toilet compartment is the remains of a switch. Beyond this is the remains of an unshaded light fitting, also fastened to the toilet wall. From this general area a single wire runs in a conduit pipe over the toilet door, and follows the curve of the roof down the toilet wall to end about 400mm above the floor in the north-east corner of the compartment.

Although the cable runs are damaged and most of the fittings are missing, it appears that the elements described above form part of a lighting system consisting of perhaps two lights in the main room of the shelter and one in the toilet compartment, fed by a batteries in the corner of the toilet compartment, using the metal inner shell of the building as an earth return. The structure's function lends some weight to this interpretation.

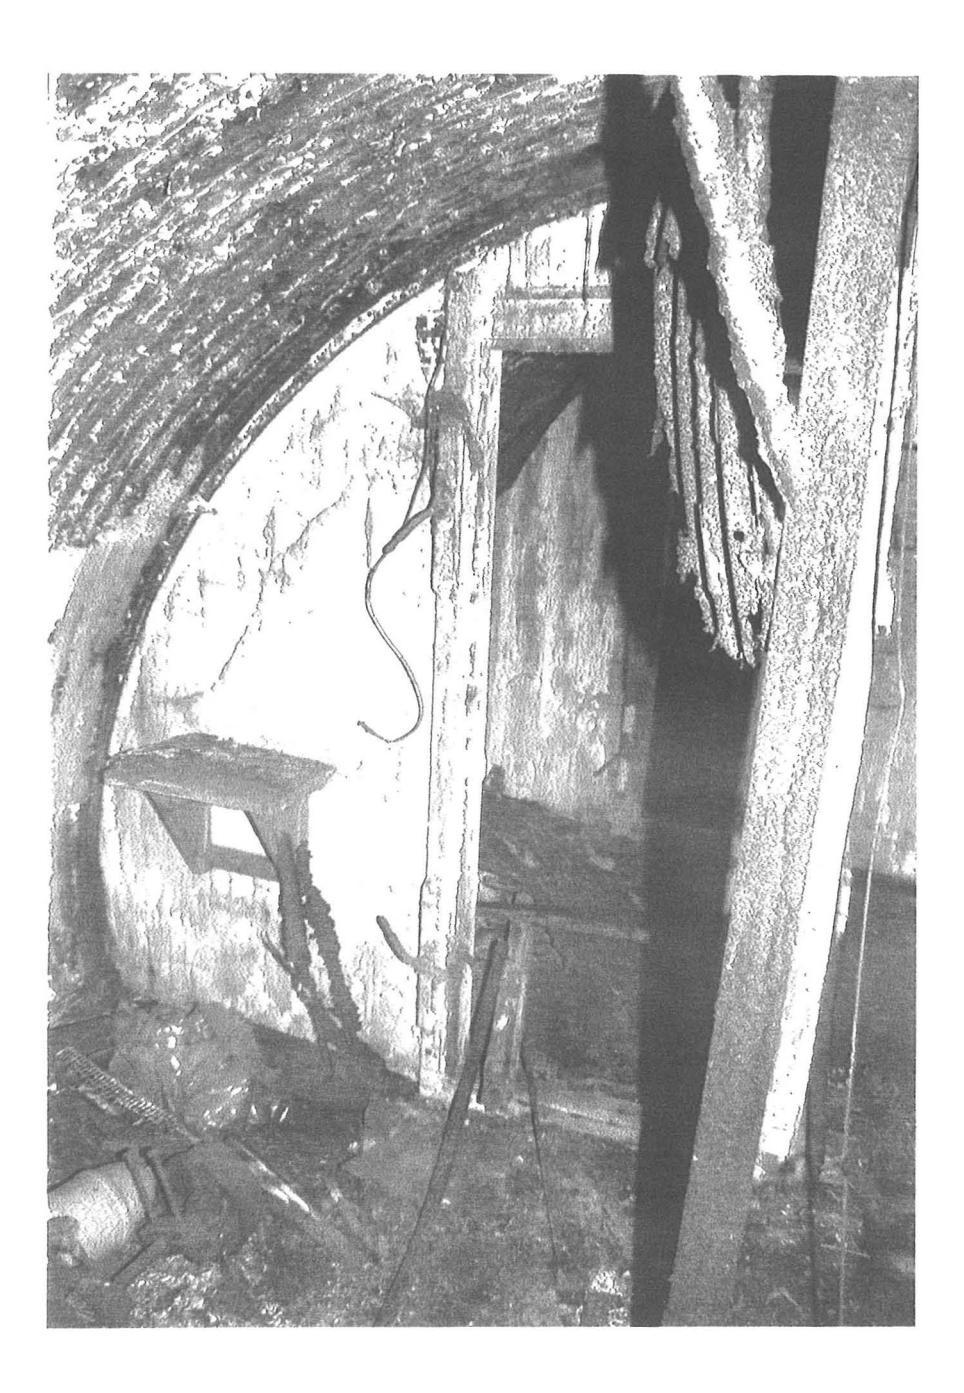
SS113 PLATE 7 - INTERNAL PARTITION, SOUTH HALF, FROM EAST

The end walls are of flush vertical 140mm wide planks, painted white, backed with corrugated iron sheeting covered with bitumenised canvas on its outside face. The end walls are fastened to the roof by 45×45 mm angle, preformed to follow the outline of the roof (Plate 7).

Shelf: On the east (inner) side of the inner partition is a wooden shelf. 280 x 460mm, 830mm above the floor. Supported from beneath by two triangular wooden brackets, screwed to the partition (Plate 7).

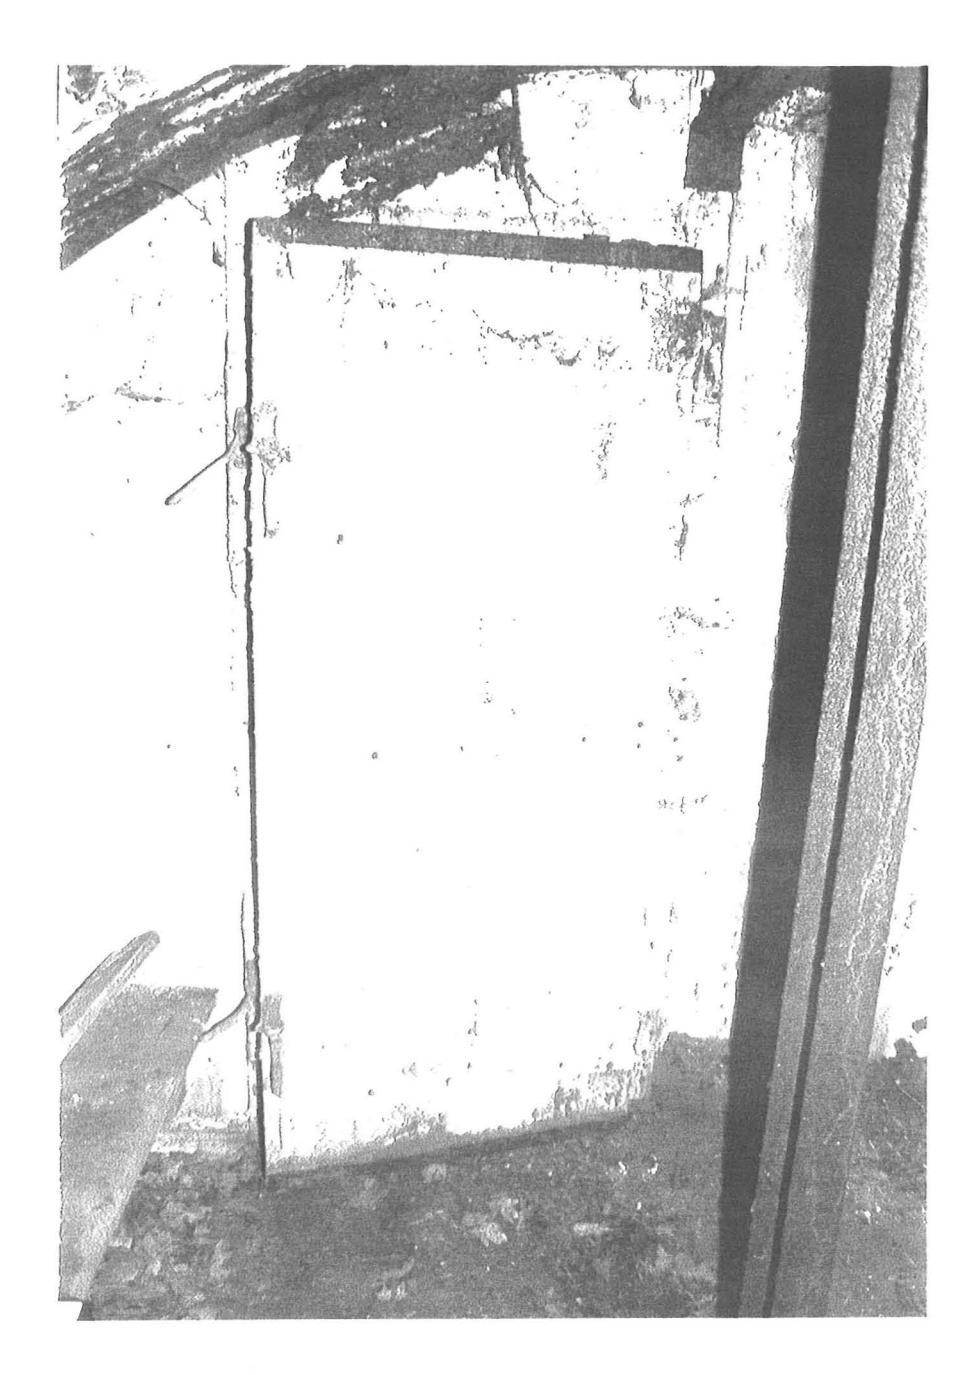
SS113 PLATE 9 - EASTERN ENTRANCE DOOR, FROM WEST

All doors are of identical construction. Door frames are made of 75 x 80mm section timber, assembled using dowelled mortise & tenon joints. The outer doorframes are nailed to the end walls. On the left-hand inner face of each door frame are screwed two $400 \times 40 \times 40$ mm battens. Doors are 1760 x 760mm, matchboarded, with a sheet of heavy galvanised metal sheet screwed to the inner face. The doors are hung on galvanised strap hinges 580mm long, screwed to the interior of the door. Locking is provided by two clamp-type lever catches with provision for locking pins, mounted on the battens on the door frame, locating in corresponding handles on the door. These catches are reminiscent of those fitted to the doors of large commercial refrigeration units, are made of a cast white metal, and are

labelled 'THE CASSEY' (Plates 7 and 9). On one doorframe is nailed a fragment of a reinforced rubber 'P'-section seal. This appears to have originally been present on all three doors, forming a continuous seal. In conjunction with the door clamps, this would have made all doors quite airtight.

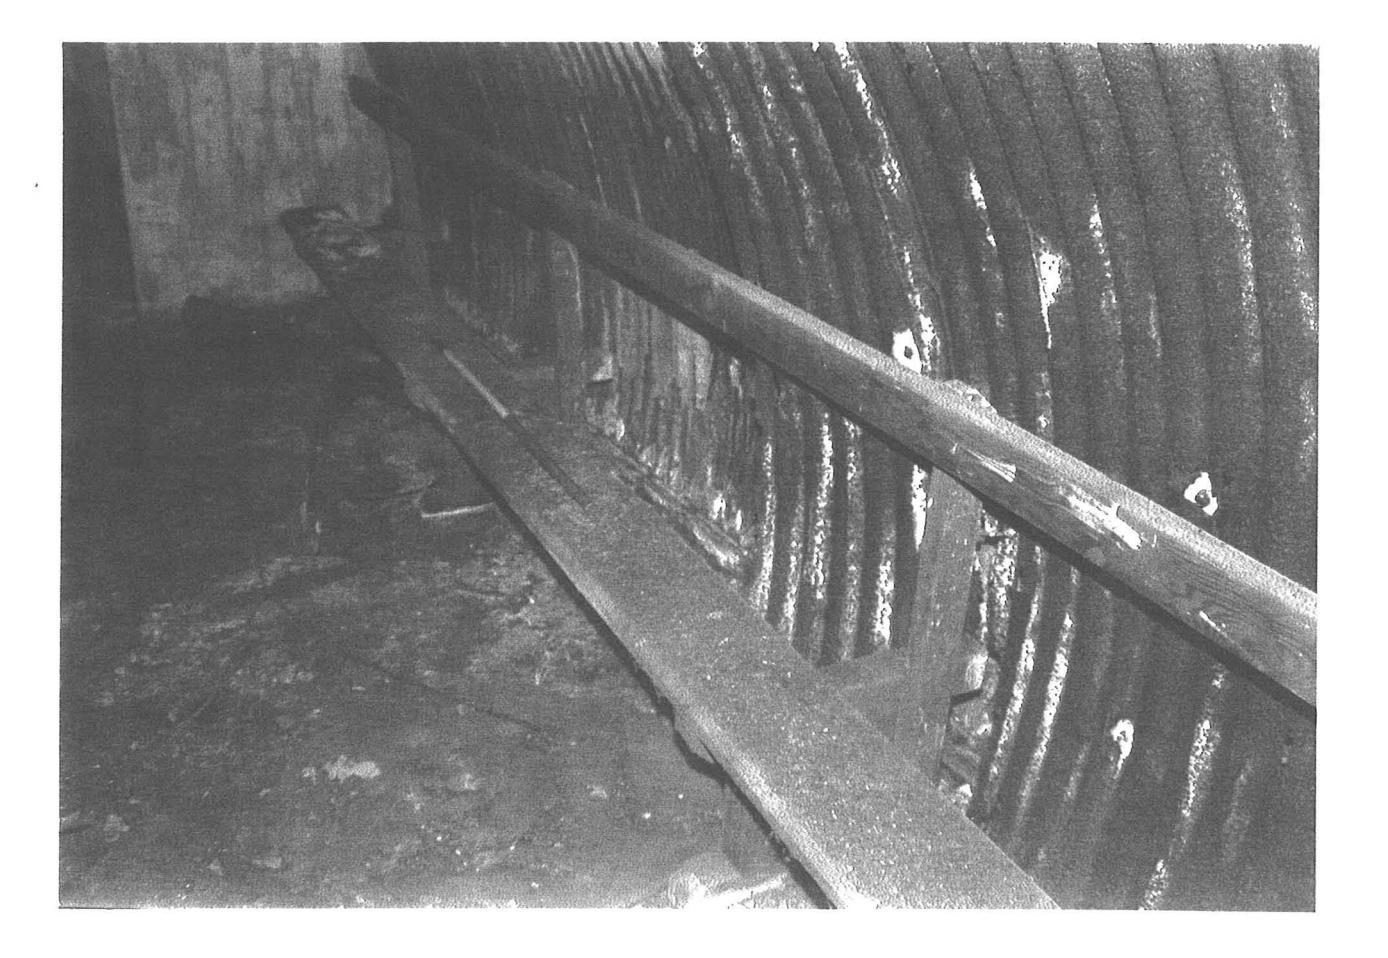
SS113 PLATE 10 - FIXTURES AND FITTINGS: WOODEN BENCH, NORTH SIDE

Benches: Along each side of the inner compartment run wooden benches. Both are freestanding, and of screwed and jointed construction. Each has a seat and single back rail, and could seat about 13 people (allowing 0.5m per person) (Plate 10).

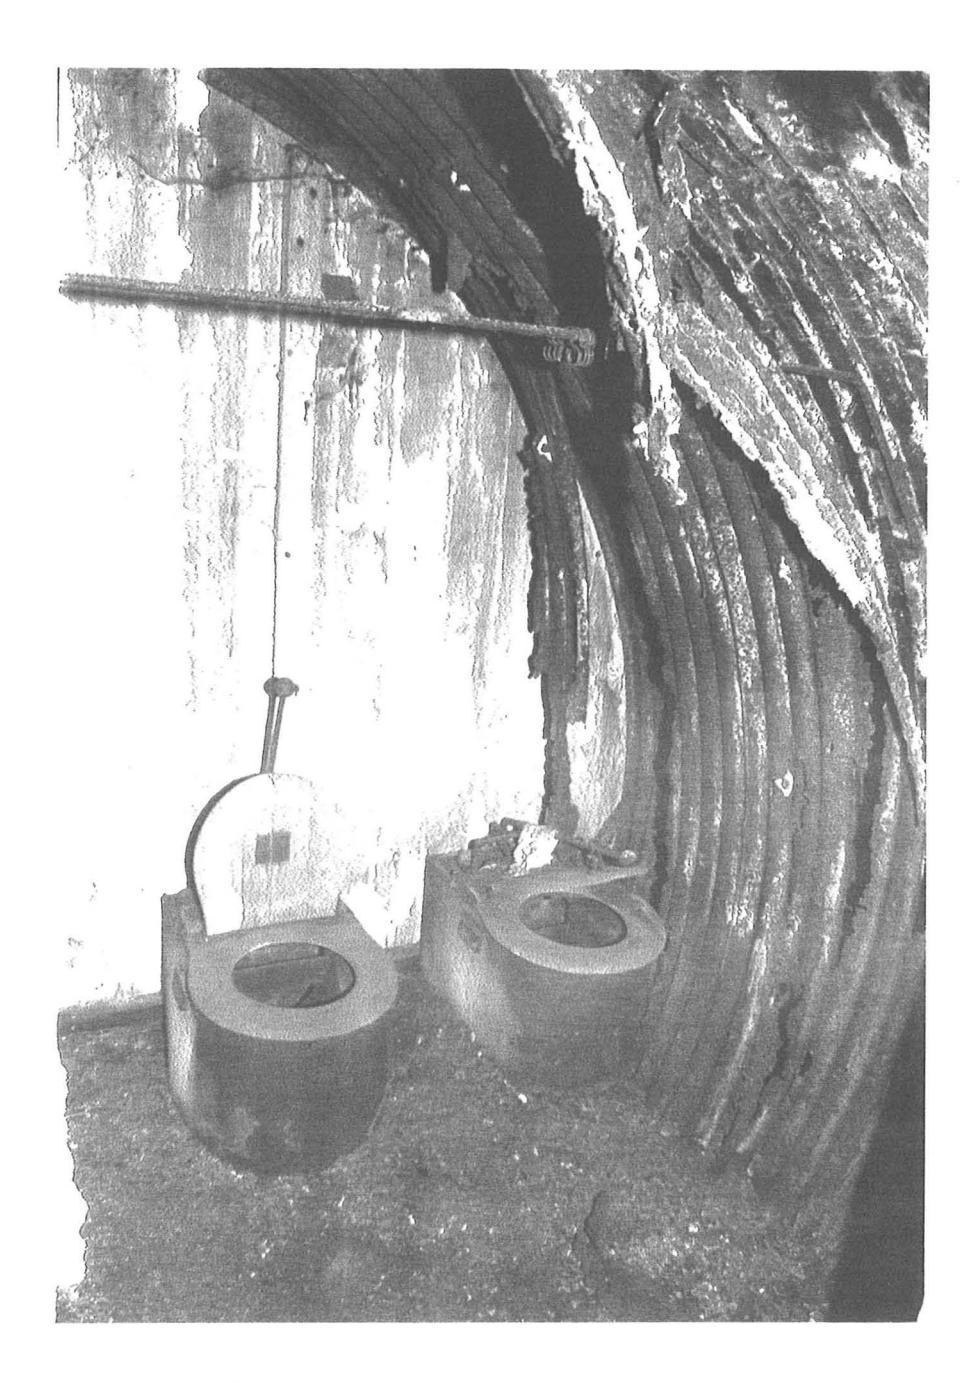
SS113 PLATE 11 - TOILET COMPARTMENT, FROM EAST

Toilet Compartment: This measures $c.1.84 \times 1.69m$. Access to it is through a doorway 800mm wide in the inner partition, adjacent to the east-west partition, closed off by a curtain hung on an iron rail (Plate 11). Within the compartment are two metal toilet units with wooden seats, bolted to the floor. The toilets are AUSTRAL AUTO-FLUSH CABINETS, made by the AUSTRAL CABINET Co LTD, St JAMES', LONDON. Both have a long operating handle projecting vertically from the rear, and appear to be a version of the 'bucket & chuck it' type of chemical toilet. An arrangement of curtain rails above the two toilets would have permitted a degree of individual privacy for each toilet (plate 12).

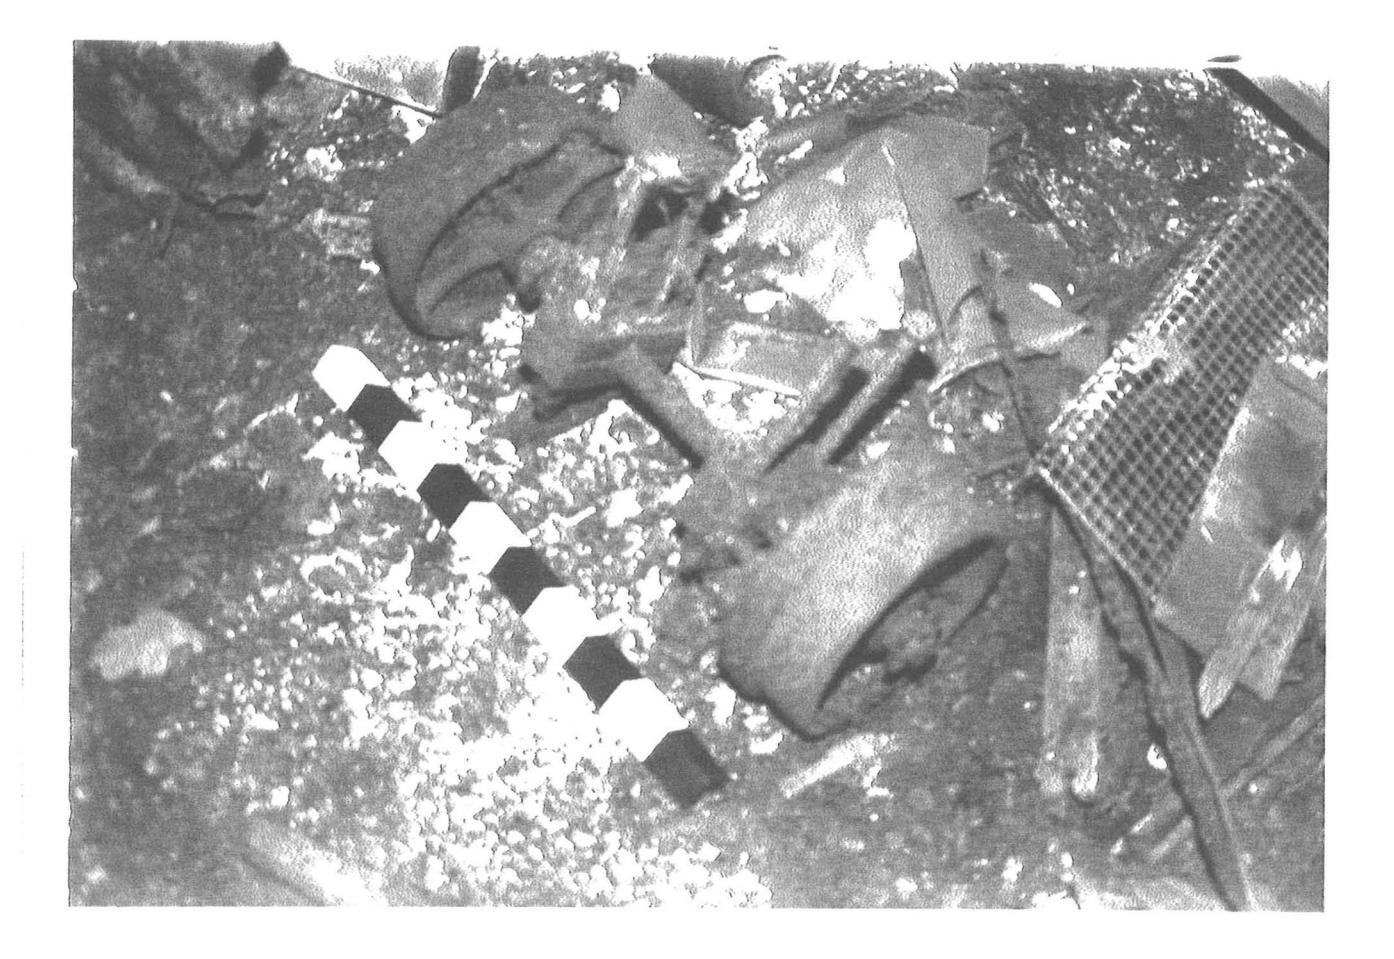
SS113 PLATE 13 - FIXTURES AND FITTINGS: TRAMWAY WHEELS, AXLE & BEARINGS

Artefacts: About one-third of the inner chamber is filled with bags of unidentified rubbish. Apart from the toilets, the only artefacts of possible note are two pairs of flanged wheels, complete with axles and mountings for some wooden superstructure (plate 13). It is possible that these wheel-and-axle sets are from vehicles used on the site's internal tramways.
