# WALTHAM ABBEY SOUTH SITE ROYAL GUNPOWDER FACTORY

# **BUILDING No. 486**

HISTORICAL SURVEY OF BUILDING NO. 486

# Mixing House 486, South Site, Waltham Abbey Royal Gunpowder Factory, Essex

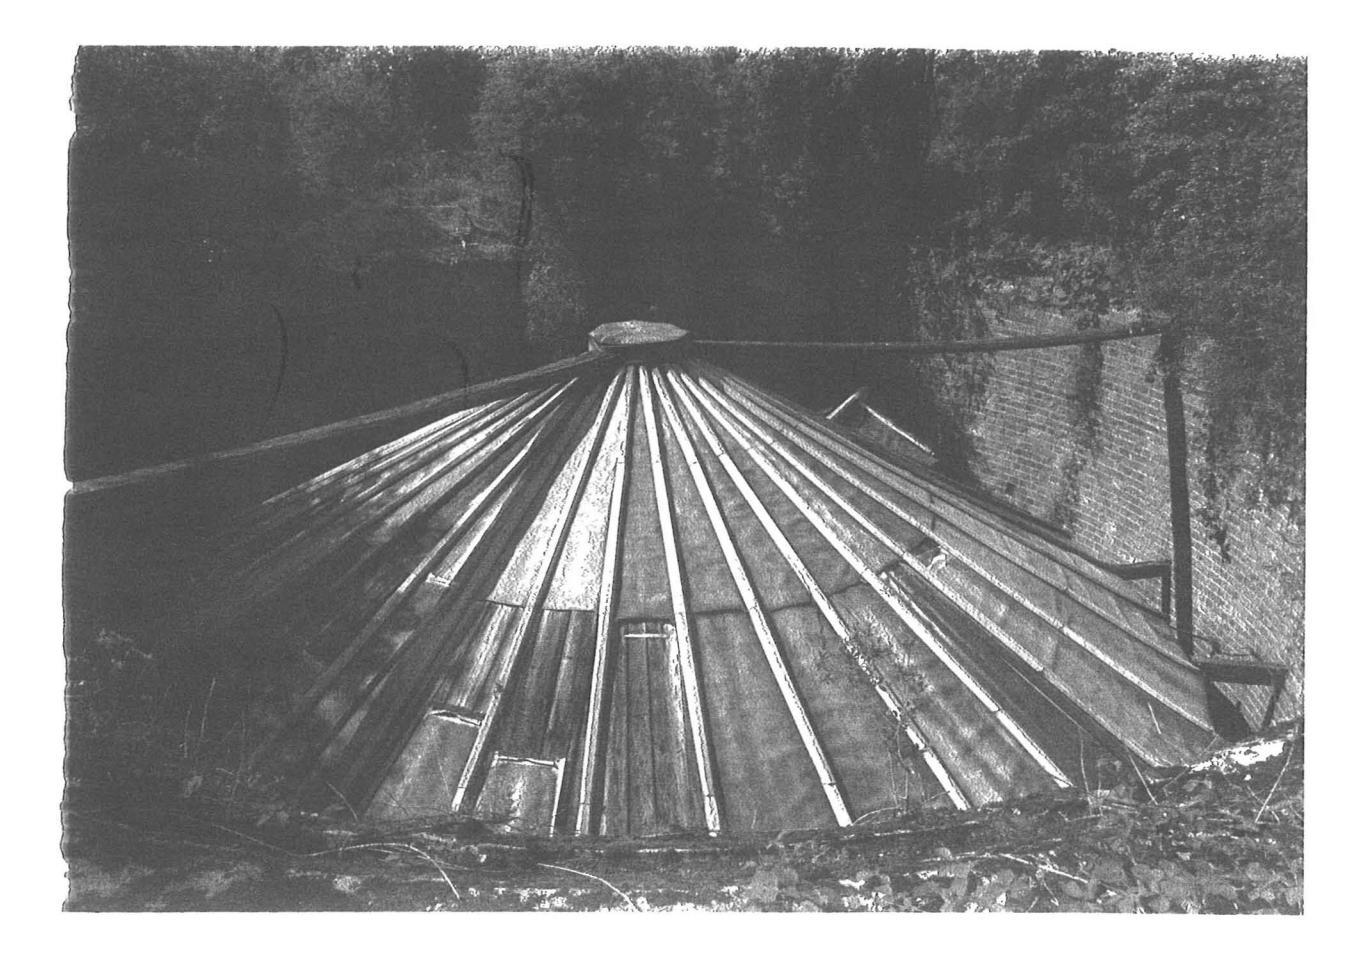
486 PLATE 3 - EXTERIOR OF ROOF OF INNER ROOM, FROM SOUTH EAST

A circular timber-framed inner room (external diameter 7.9m) with a conical roof, constructed within a brick revetment wall and earth traverse (Plate 3). Access via a curving entrance tunnel to the south (Plate 4) : a second smaller NG delivery tunnel, now blocked, enters the building from the north (Plate 5). The inner room has a double door in line with the access tunnel, and 24 windows, in pairs, set high in its walls. Between the inner room and the revetment wall is an encircling inner passage. Where the access tunnel meets the inner passage there is a roofed 'shoe room'. A roofed timber bridge links the NG delivery tunnel and inner room (Plate 6).

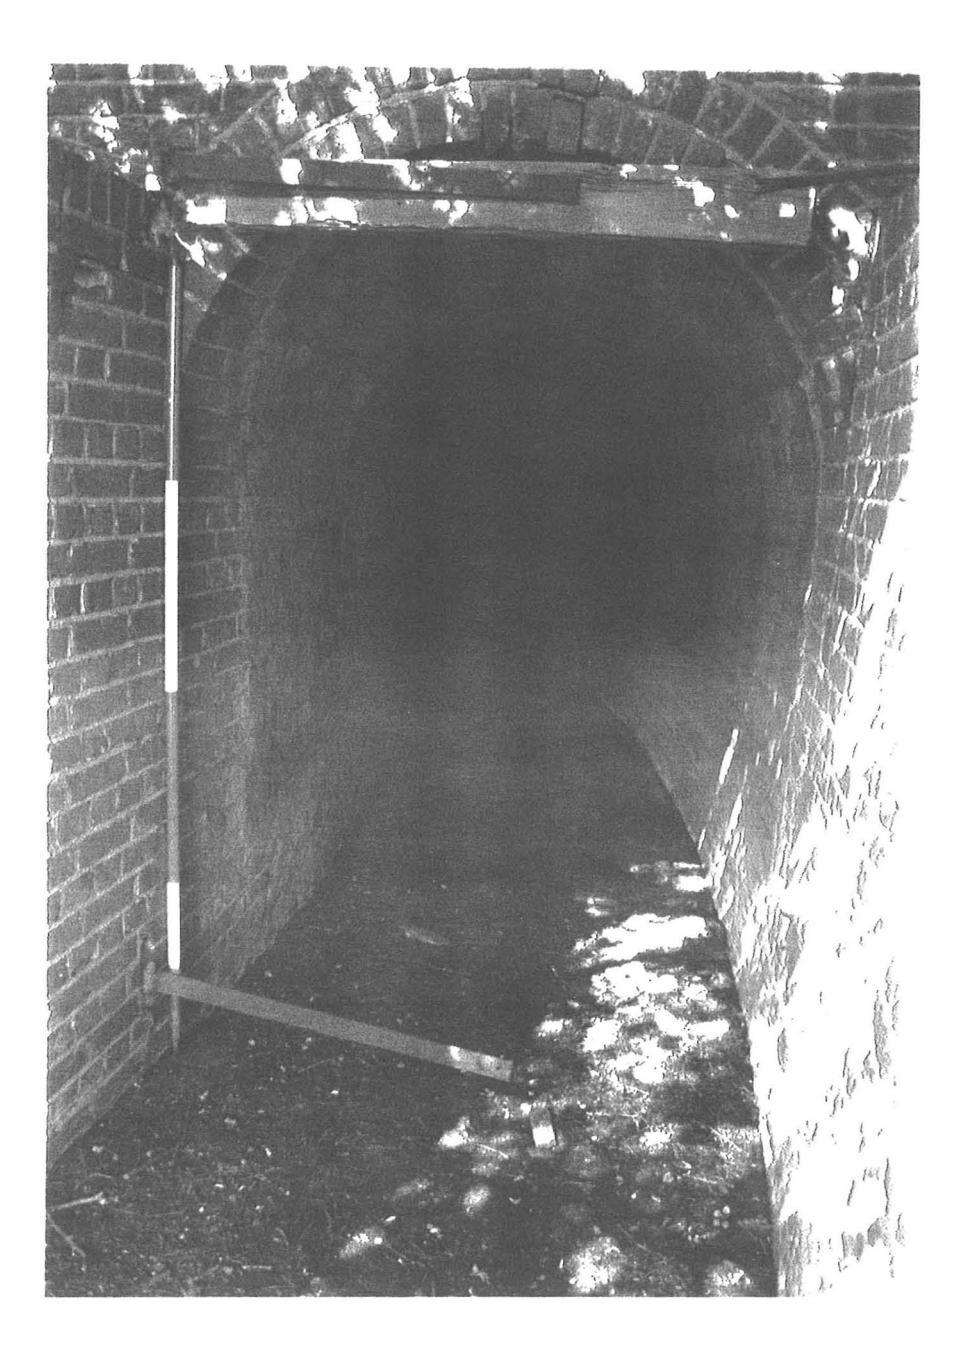
486 PLATE 4 - DOORWAY OF ACCESS TUNNEL, SHOWING SURVIVING DOOR FITTINGS

*Entrance Door:* Single door, outward opening, 2220 x 1500 x 50mm, vertical boarded, flush exterior. Screwed to large pintle hinges (hinge bar length 920mm), hung on pintles set into the brickwork of the tunnel mouth (Plate 4). Lower hinge further forward than upper, making door swing closed against iron stop set in right-hand wall (Plate 14). Socket for large bolt also in right-hand wall. Hook for fastening door open of west wall. Only top rail of door survives.

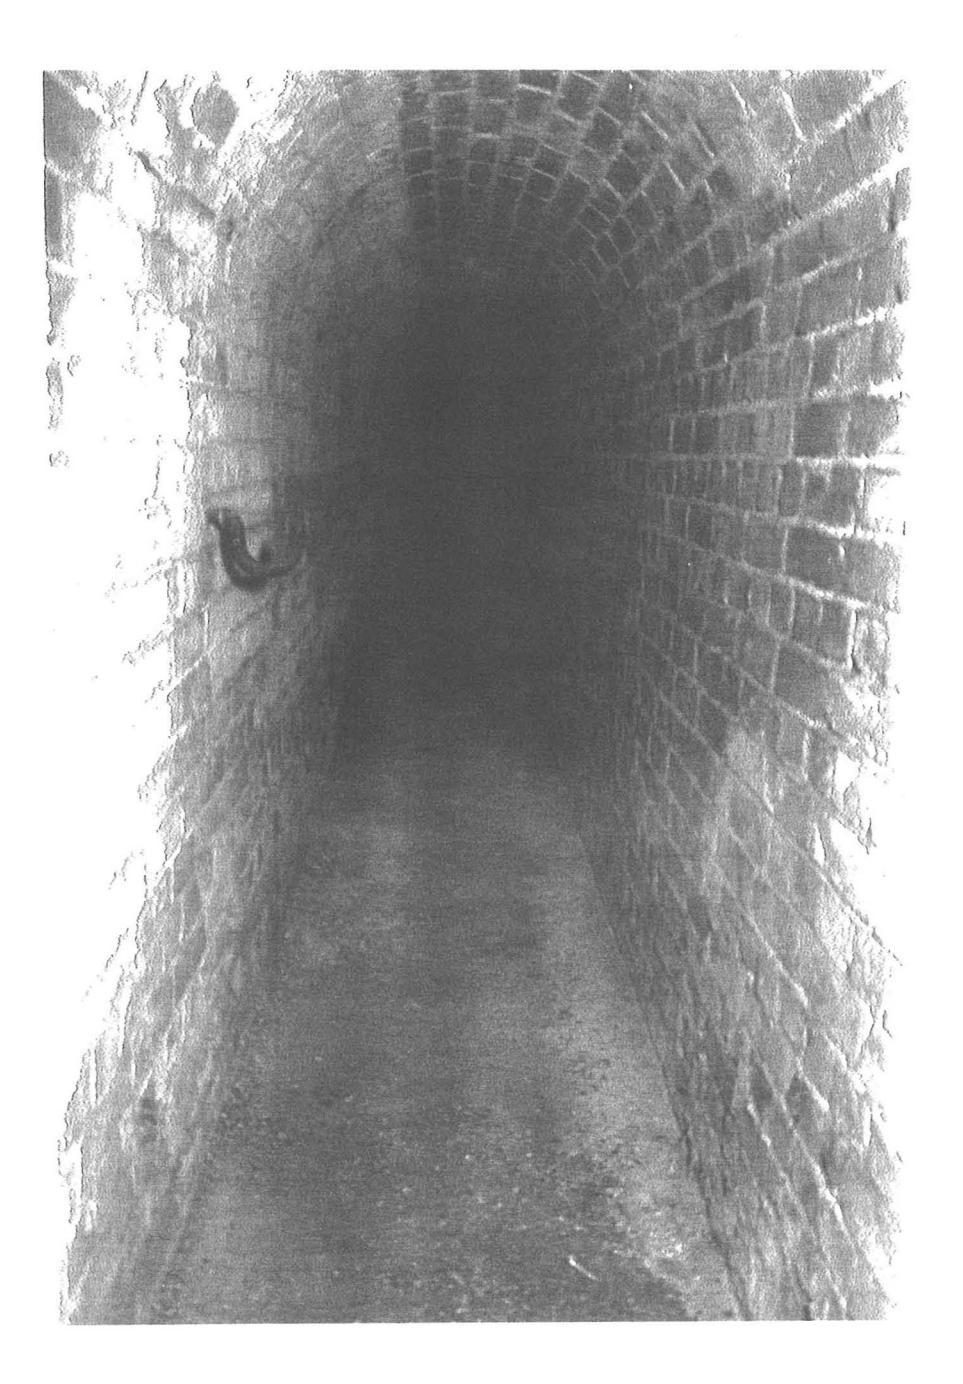
486 PLATE 5 - INTERIOR OF NITROGLYCERENE DELIVERY TUNNEL

*Delivery Tunnel:* At least 9m long, 1.7m high and 750mm wide. Straight, but approaches access point in revetment wall skewed westwards at an angle of  $c.18^{\circ}$ . Its outer end is filled with building debris, mostly concrete blocks, so details of the entrance are not available. Constructed of buff bricks, butted to revetment wall.

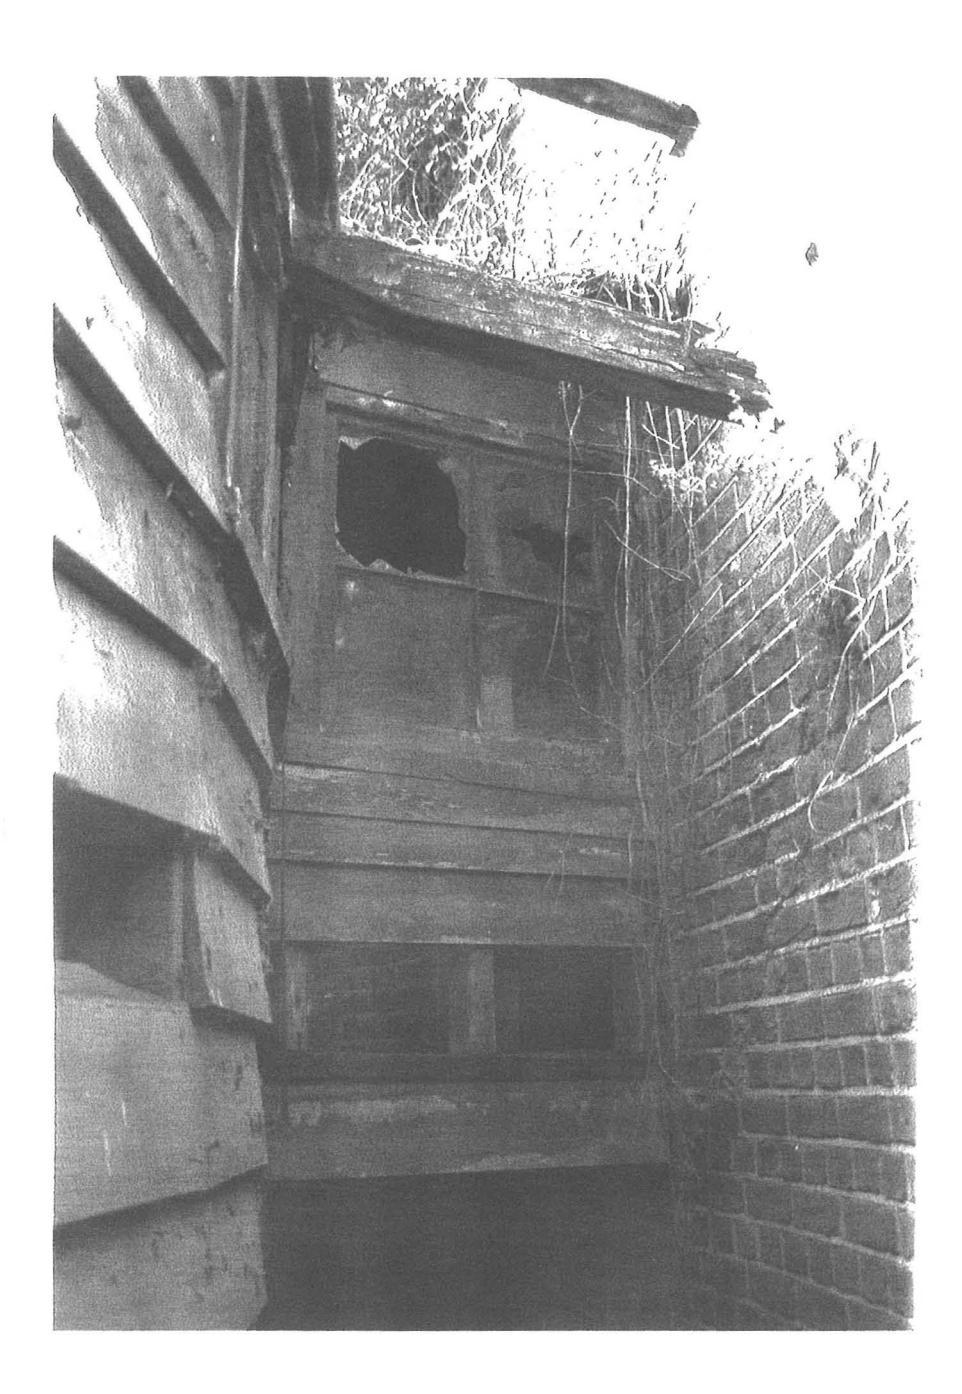
486 PLATE 6 - INNER PASSAGE: EAST SIDE OF NG TUNNEL BRIDGE STRUCTURE

The delivery tunnel is joined to the inner room by a roofed timber bridge (Plate 6). The west side of the structure is weatherboarded, with a hole part way up its north end for a pipe, c.75mm diameter. The east side is partly weatherboarded, below a 4-light window. The roof is ridged, with a timber framework covered with boarding, clad externally in zinc sheet.

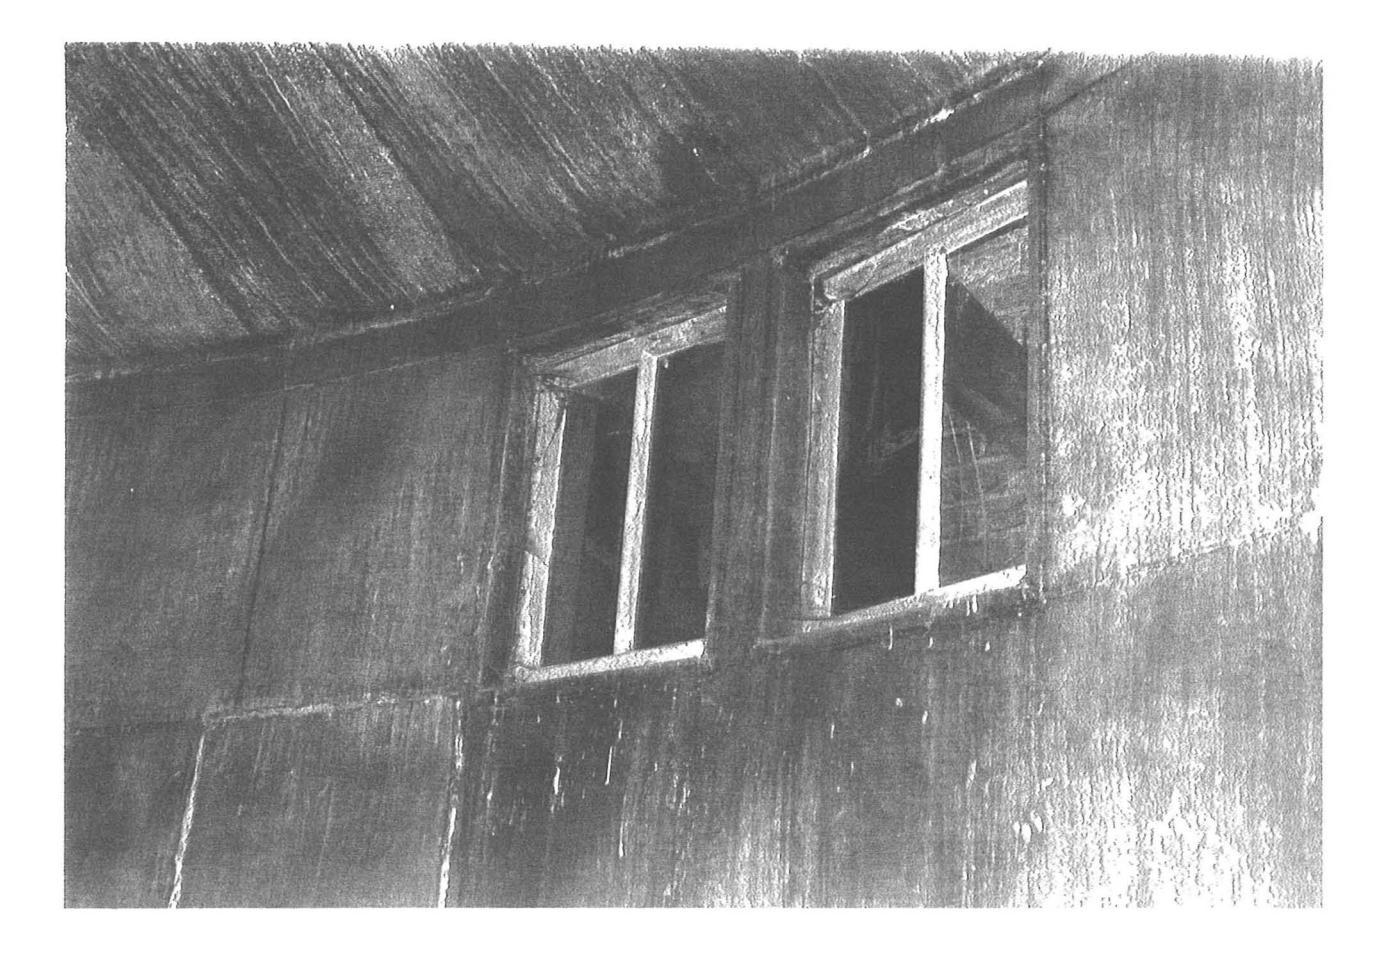
486 PLATE 7 - INNER ROOM, PAIR OF WINDOWS (NOTE BLACKOUT PAINT)

The inner wall surface is lined with vertical tongue and groove planking, planks 120 x 16mm, fastened with soft non-ferrous nails. This is covered with zinc sheeting, fastened with non-ferrous tacks (Plate 7).

*Inner Room Windows:* 24 2-light windows, set in pairs evenly around the room at a height of 2.58m (Plate 16). Overall dimension of a single window is 580 x 460mm. Many of those not connected with the lighting system for the room (see Section 8) have traces of blackout paint on the glass (Plate 7). Frames are painted white. All the windows appear to be non-opening.

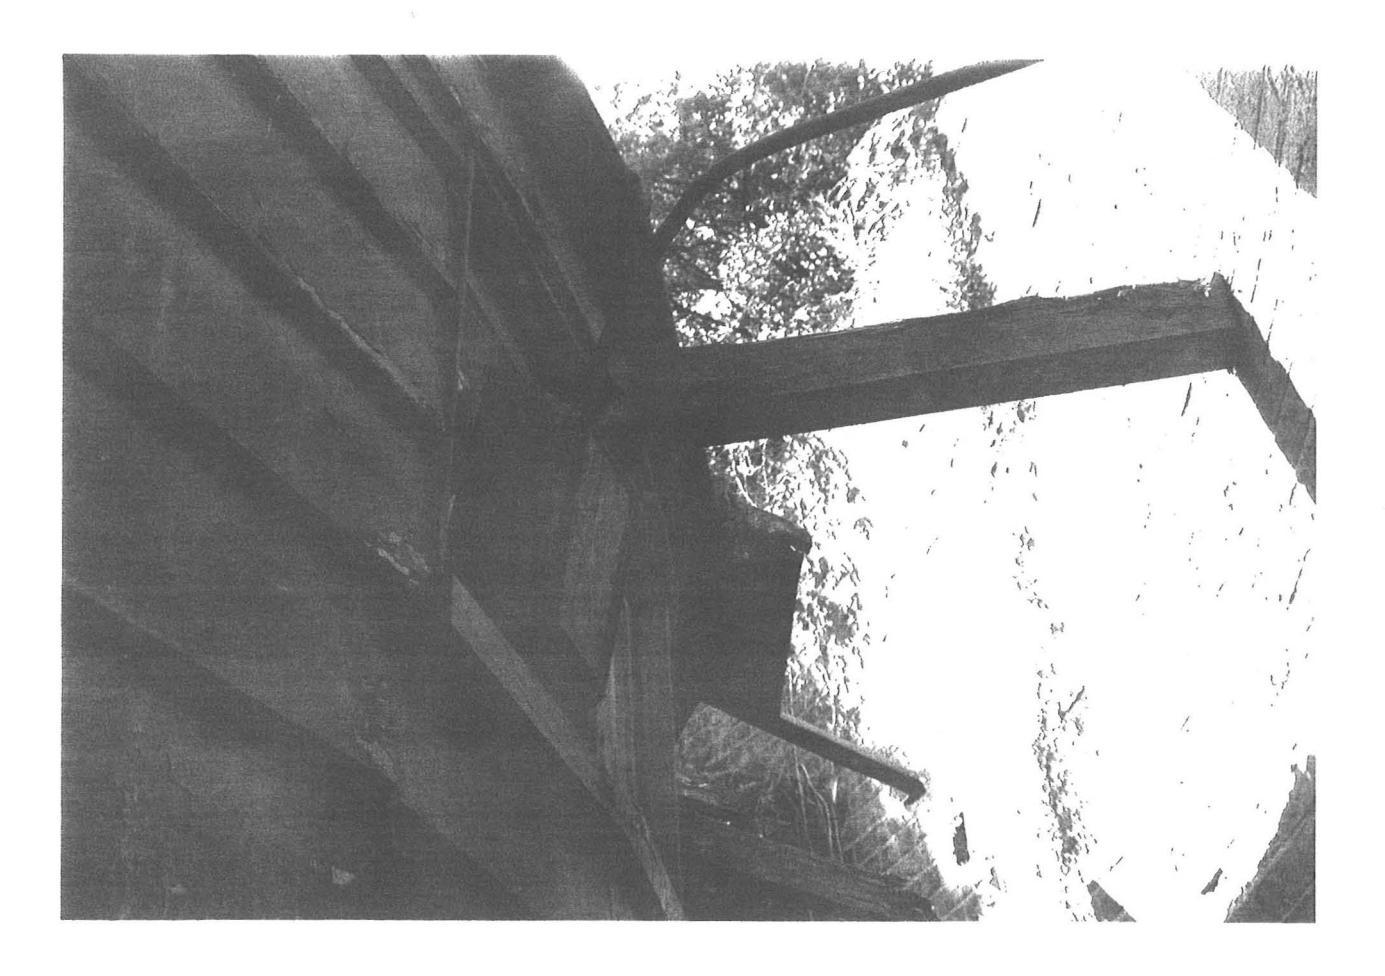
486 PLATE 8 - INNER PASSAGE: WINDOW WITH MAXLUME FITTING IN-SITU, AND BRACING BEAM OVER

The top of the inner room wall is braced to the revetment wall by horizontal beams,  $120 \times 100$  mm section, their outer ends set into the brickwork, the inner ends probably jointed to the wall frame uprights (no details of this visible) (Plate 8).

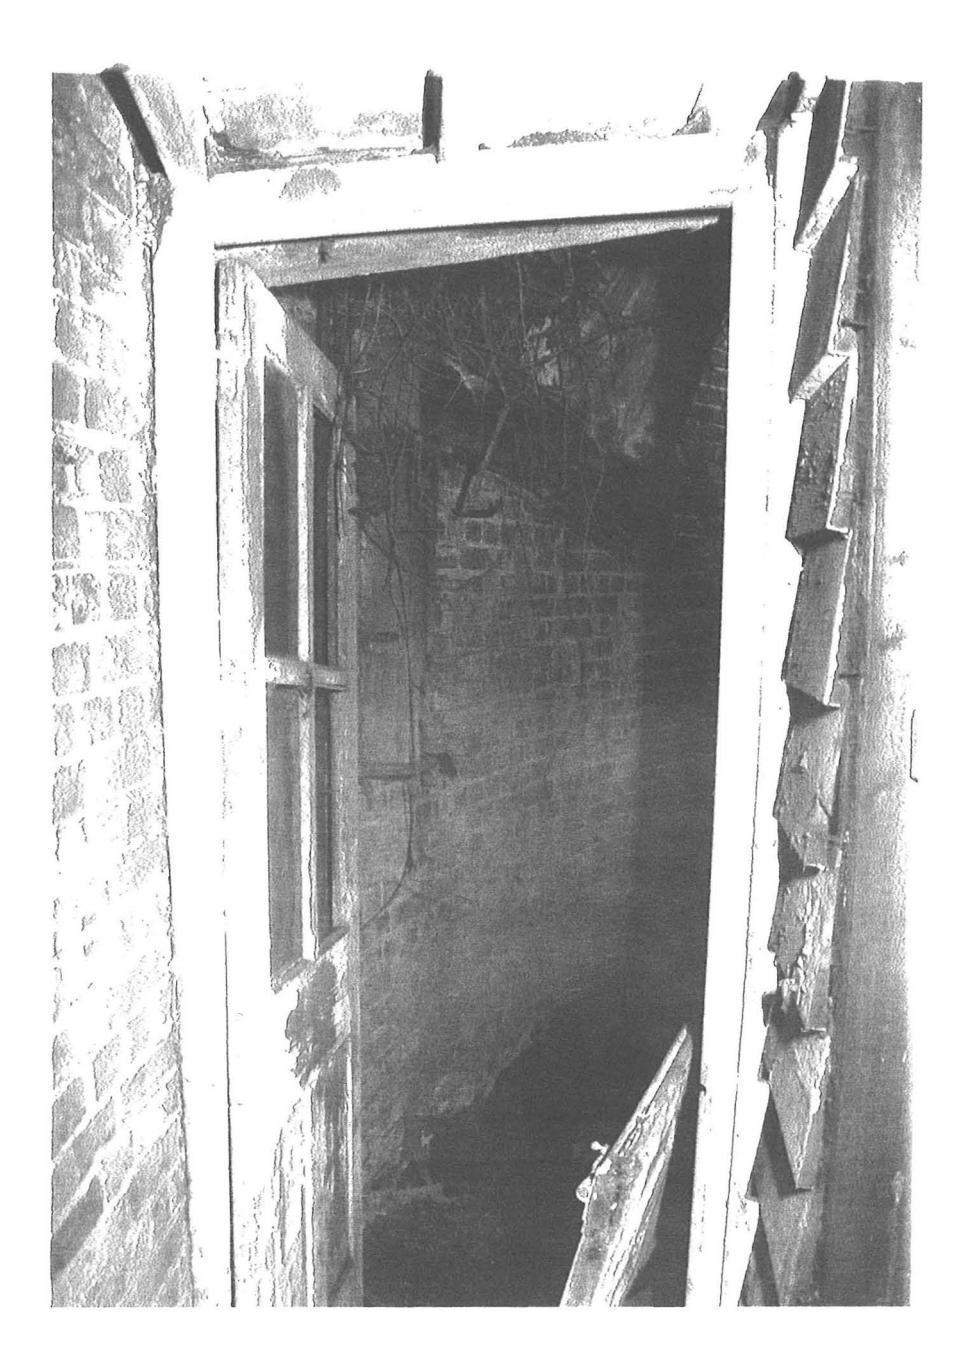
# 486 PLATE 9 - DOORWAY FROM WEST SIDE OF SHOE ROOM TO INNER PASSAGE

Shoe Room Doors: Outward opening doors to inner passage on east and west sides of shoe room (Plate 9). Doors each 2020 x 750mm, solid panel in lower 1/3 rd, 4 glassed lights in upper part. Each door fitted with 2 x 100mm brass hinges, and a 150mm brass bolt.

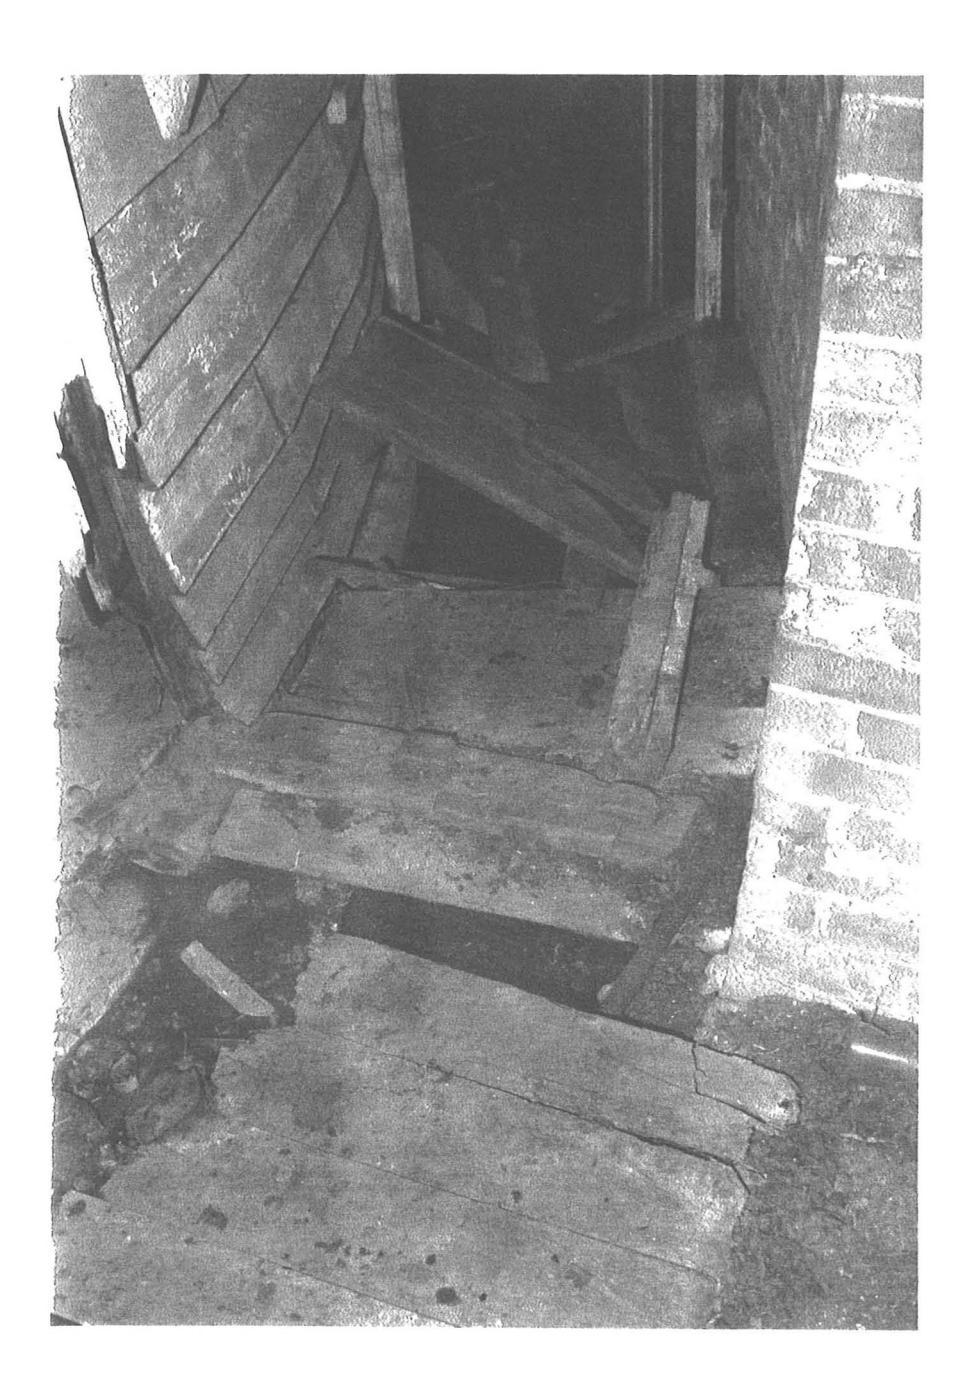
486 PLATE 10 - BOARDED FLOOR OF SHOE ROOM, AND DRAIN GULLY BENEATH

*Drainage:* Rainwater runoff from the inner room roof appears to have fallen directly into the inner passage: there is no evidence for gutter or downpipes. The inner passage floor level continues as a gully beneath the shoe room floor: presumably there is a drain at some point around the inner passage, but the debris present obscures this (Plate 10).

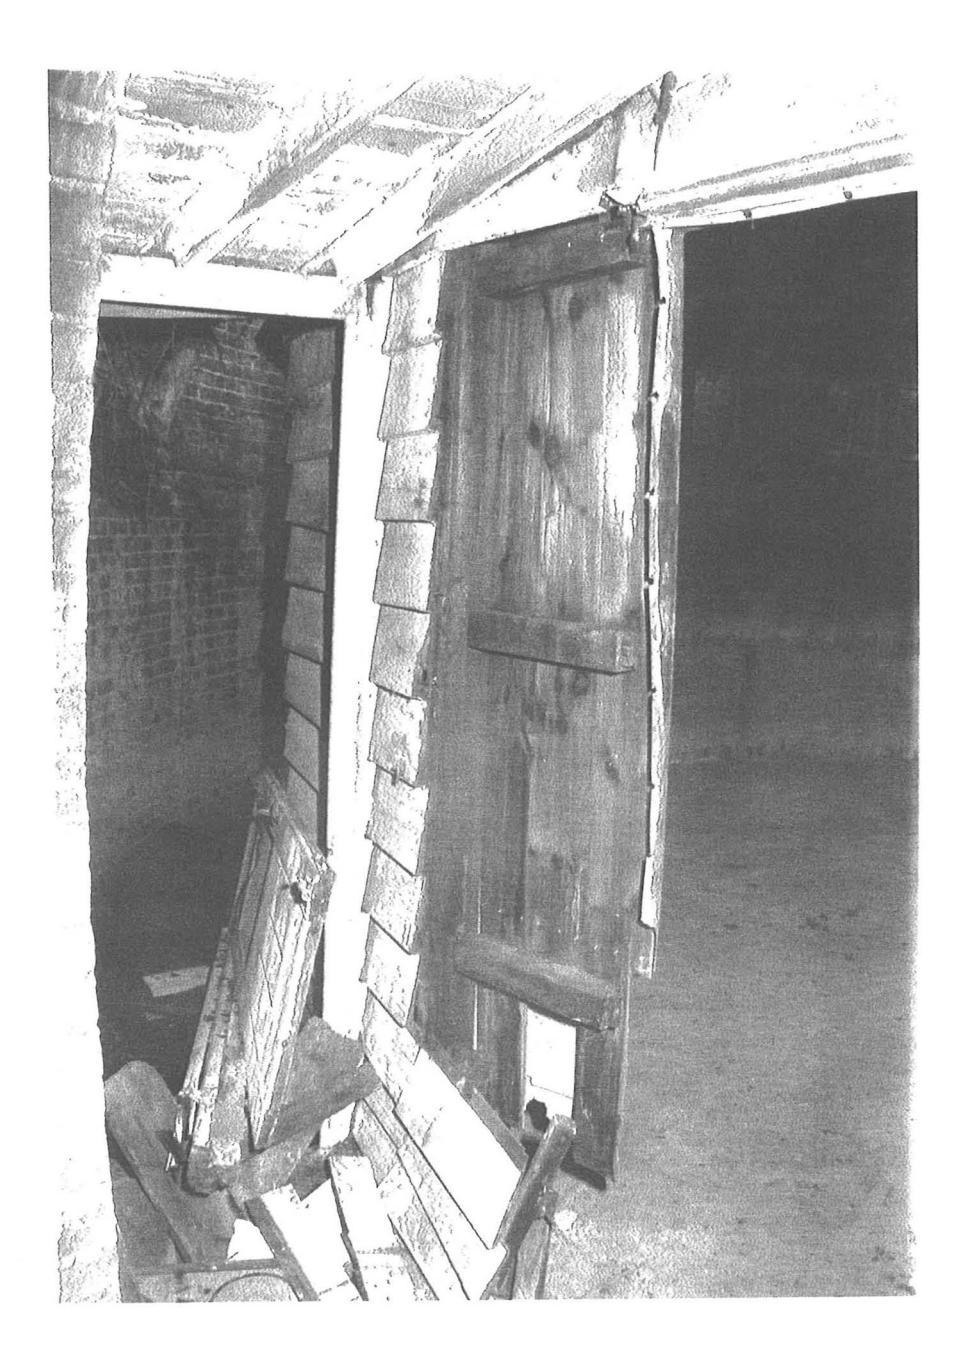
# 486 PLATE 11 - SHOE ROOM, WEST SIDE

*Inner Room Doors:* Double doors, outward opening,  $2010 \times 650 \times 50$ mm each.  $2 \times 100$ mm brass butterfly hinges on each door (Plate 15). Other fittings include: bolts at top and bottom (inner or north side only), a padlock hasp and ring, a wooden turnbuckle and thin leather loops fastened by non-ferrous brackets on the outer (south) side, and a brass pull handle on both sides. The door frame has been largely removed, so details of its construction, etc., could not be ascertained (Plate 11).

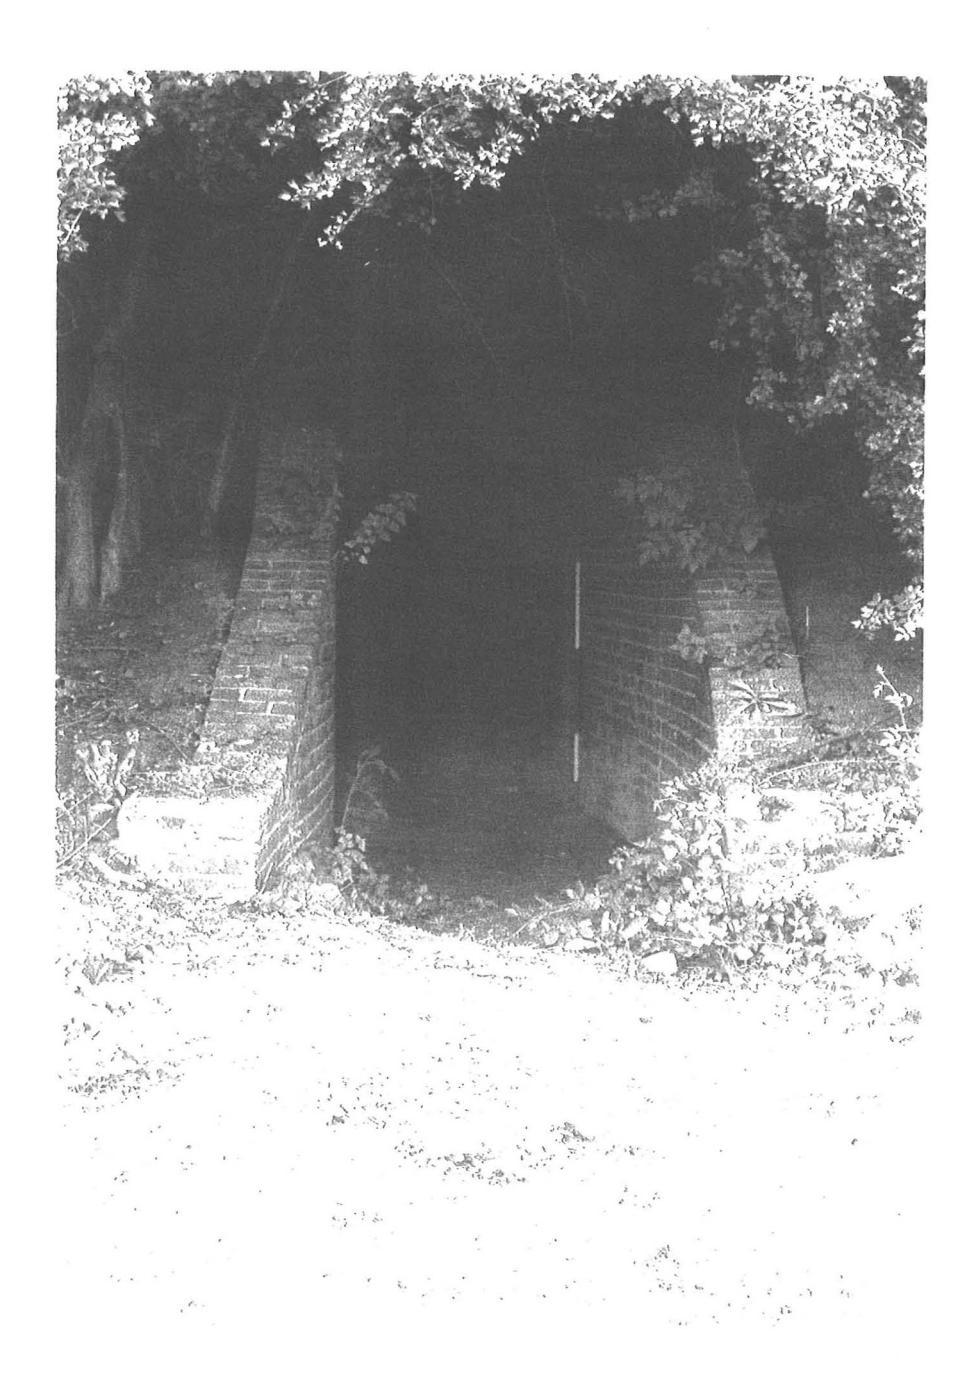
### 486 PLATE 12 - ENTRANCE TO ACCESS PASSAGE FROM SOUTH

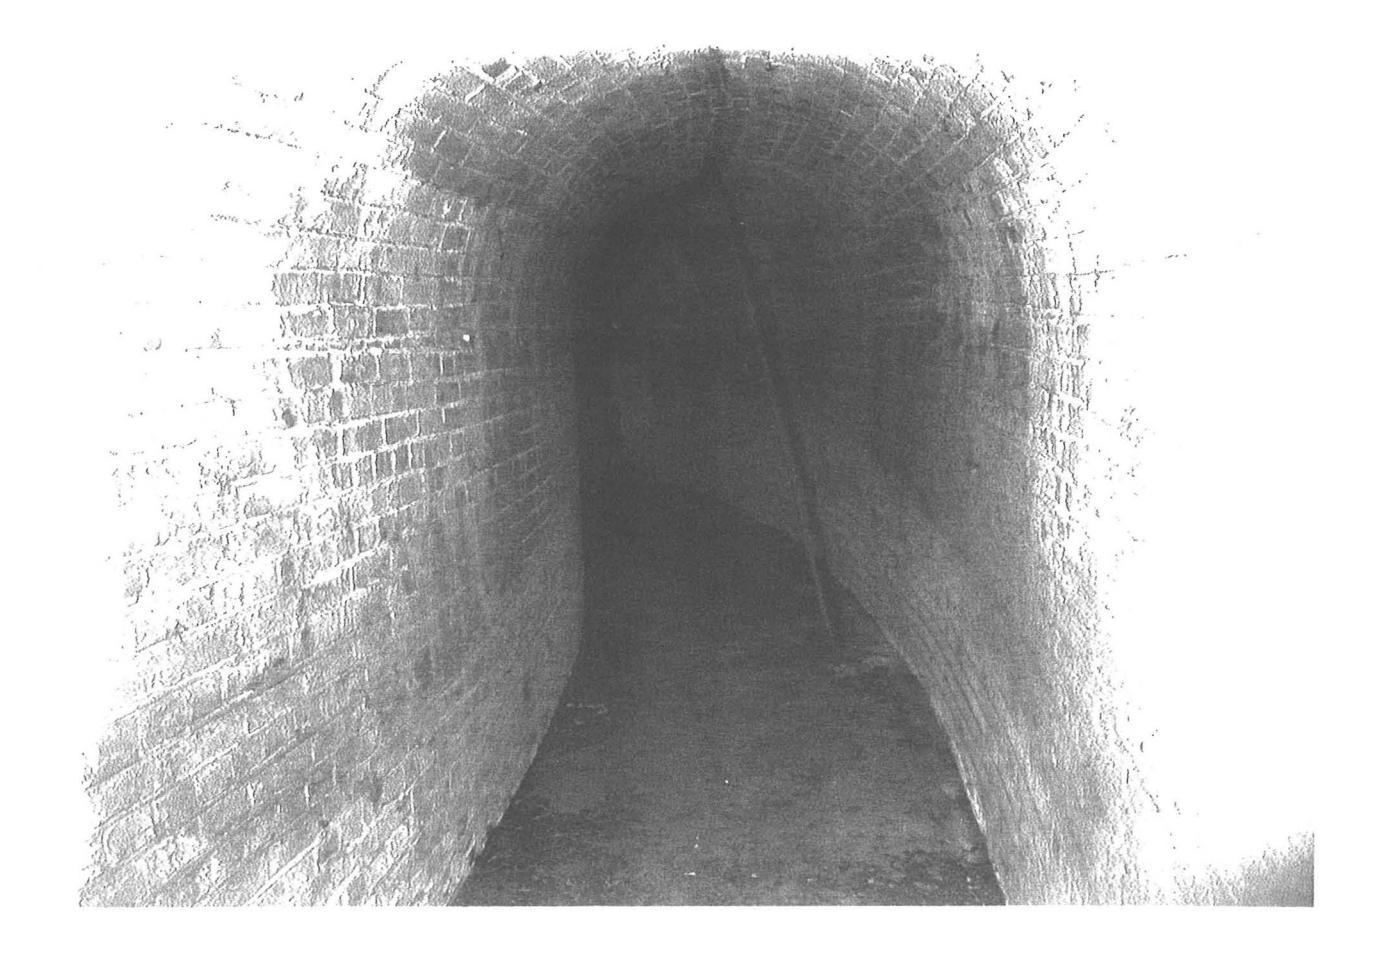
486 PLATE 13 - INTERIOR OF ACCESS PASSAGE, FROM SOUTH

*Electricity Supply:* Enters via a conduit fastened to the roof of the access tunnel (Plate 13). Beyond the tunnel mouth, no trace of its route remains. As with other buildings, the switch box and fuses for this building were almost certainly externally located, but have not survived.

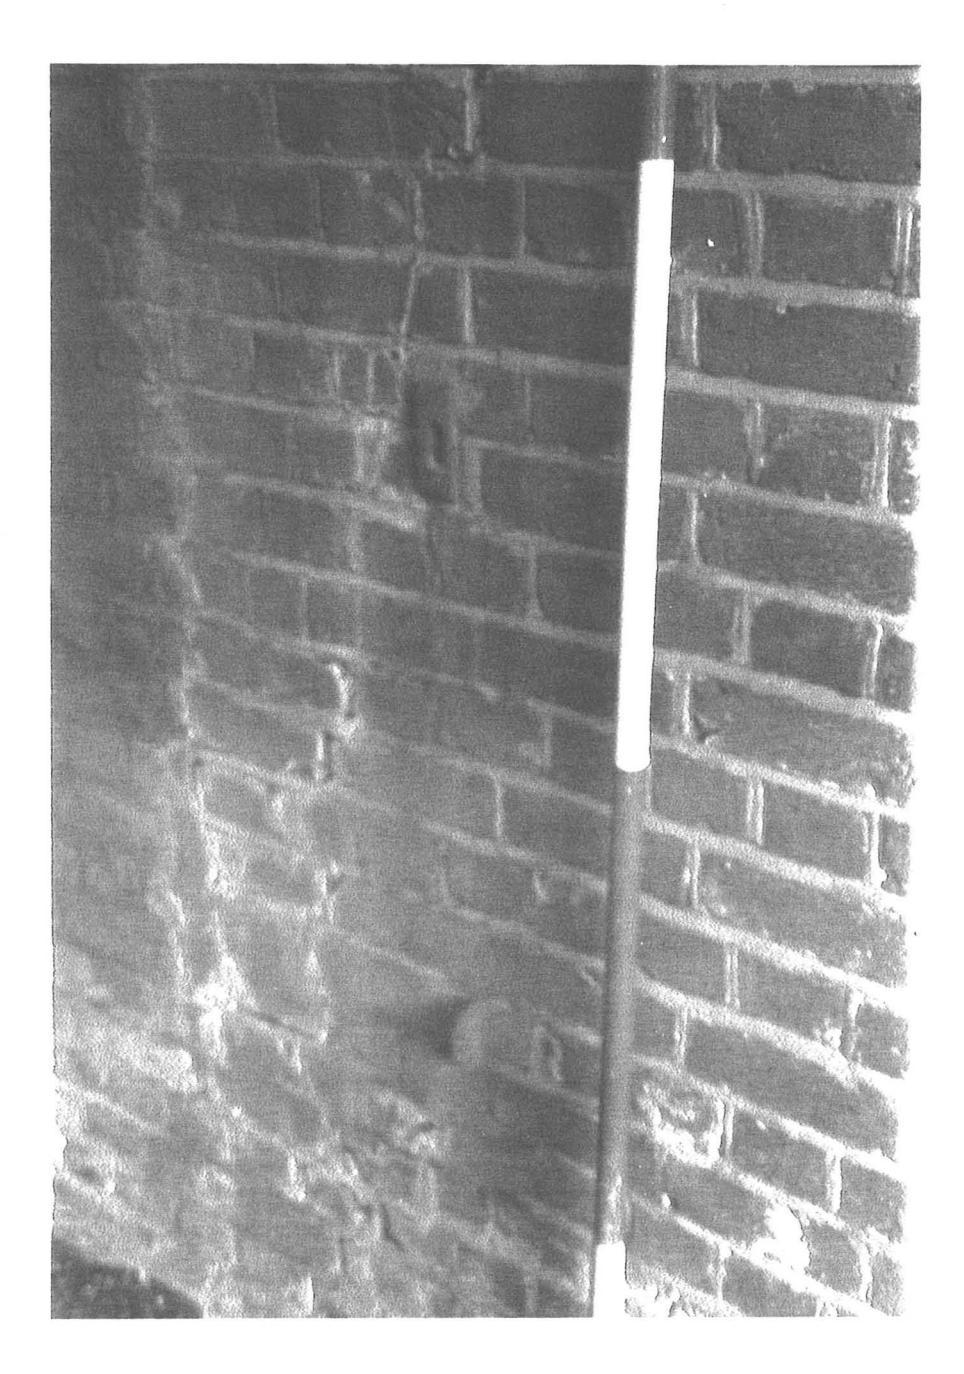
## 486 PLATE 14 - DOOR STOP AND LATCH SOCKET, EAST WALL OF ACCESS TUNNEL ENTRANCE

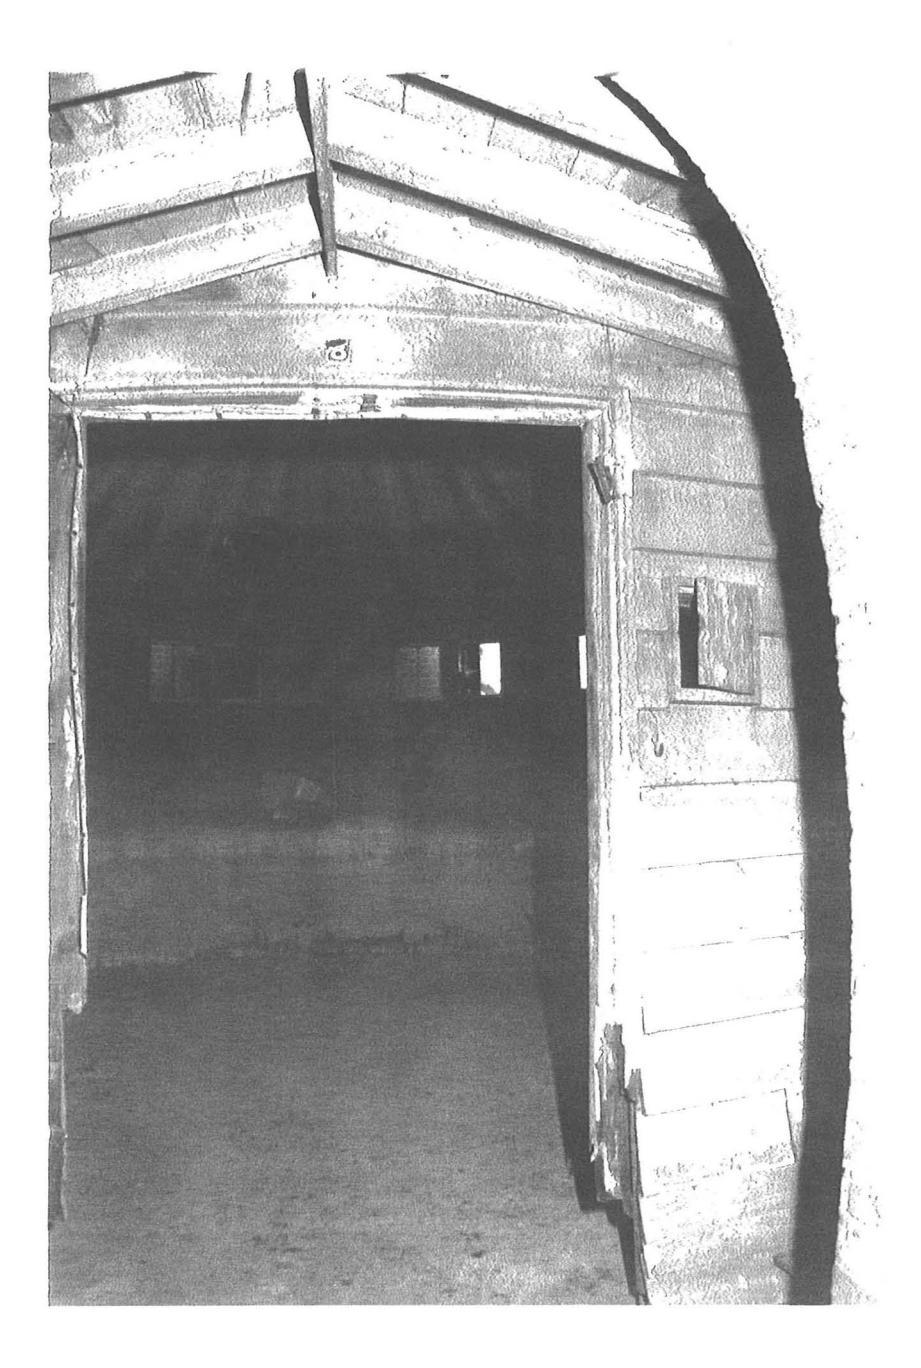
486 PLATE 15 - SHOE ROOM, DETAIL OF DOOR, ROOF, NUMBER OVER DOOR AND INSPECTION WINDOW

*Viewing Window:* To the east of the inner room doors is a small inspection window, 235 x 190mm (Plate 15). Glazed with a single pane, set almost flush with the inner face of the room. Hinged wooden door on  $2 \times 50$ mm brass hinges fitted with a small cabinet lock covers the window on the shoe room side (Plate 17).

Over the entrance to the inner room is screwed a small blue enamel plate bearing the number '8' in white (Plate 15).

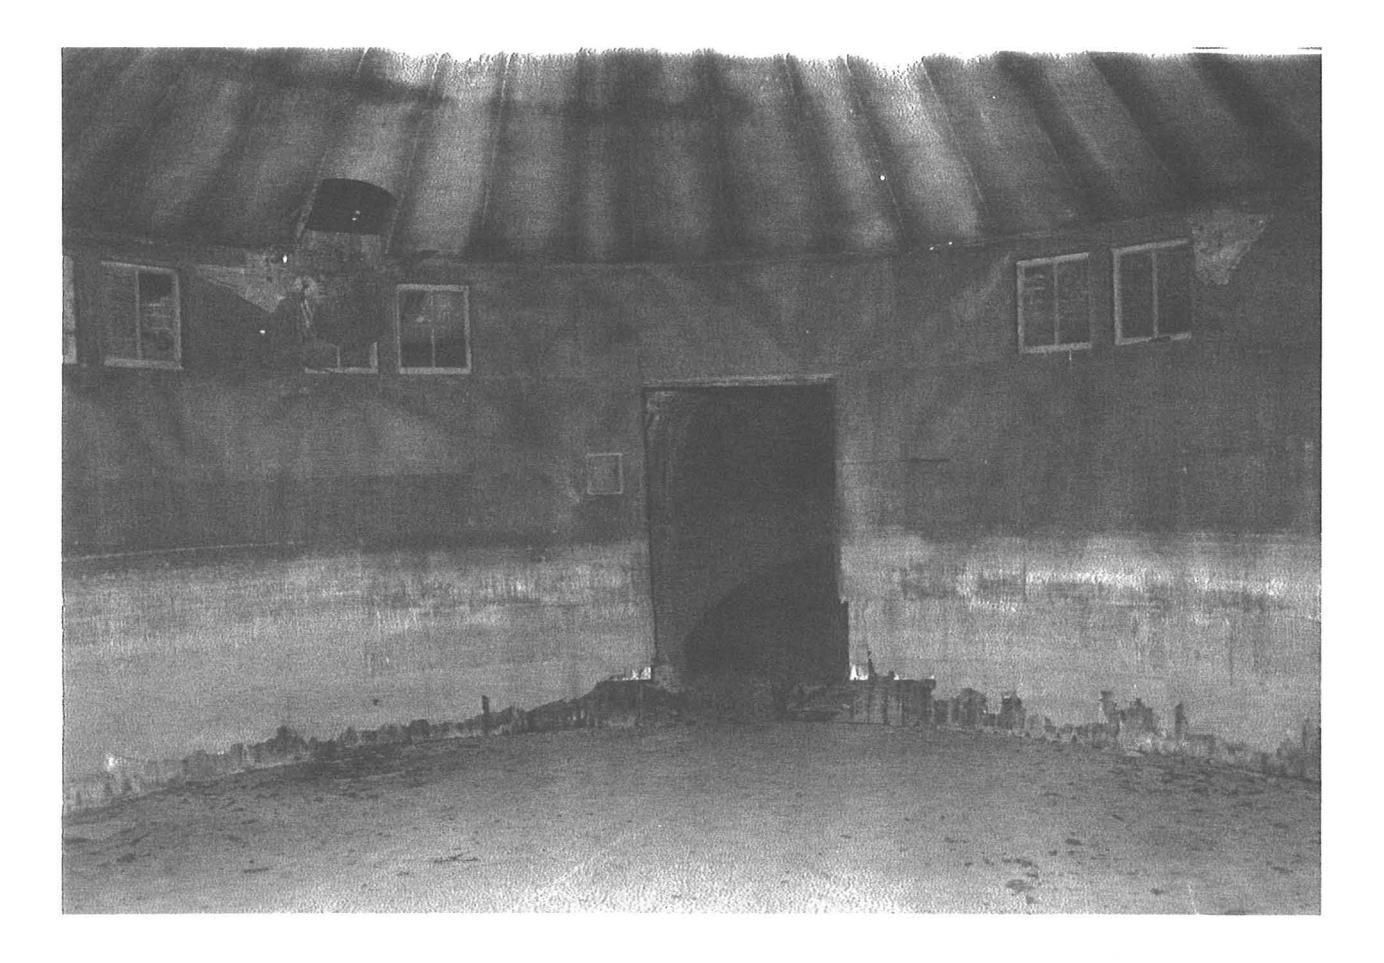
486 PLATE 16 - INNER ROOM, INTERIOR FROM NORTH

Timber frame, rafters 120 x 50mm section, at a 14° pitch. Details of the roof's construction are obscured by a lining of zinc sheet covering its interior (Plate 16), but from the little that can be seen it appears similar in construction to the roof in the adjoining NG Washing House (N544). That building has a series of radial rafters, linked by two concentric rings of purlins. At their outer ends the rafters are bracketed to the internal face of the inner room wall. At the internal apex of the roof is a zinc disc, covering the circular base for the ventilation chimney, now replaced by a low zinc cap. The exterior surface of the roof is boarded radially and clad externally with preformed interlocking segments of zinc sheet. Non-ferrous nails are used throughout.

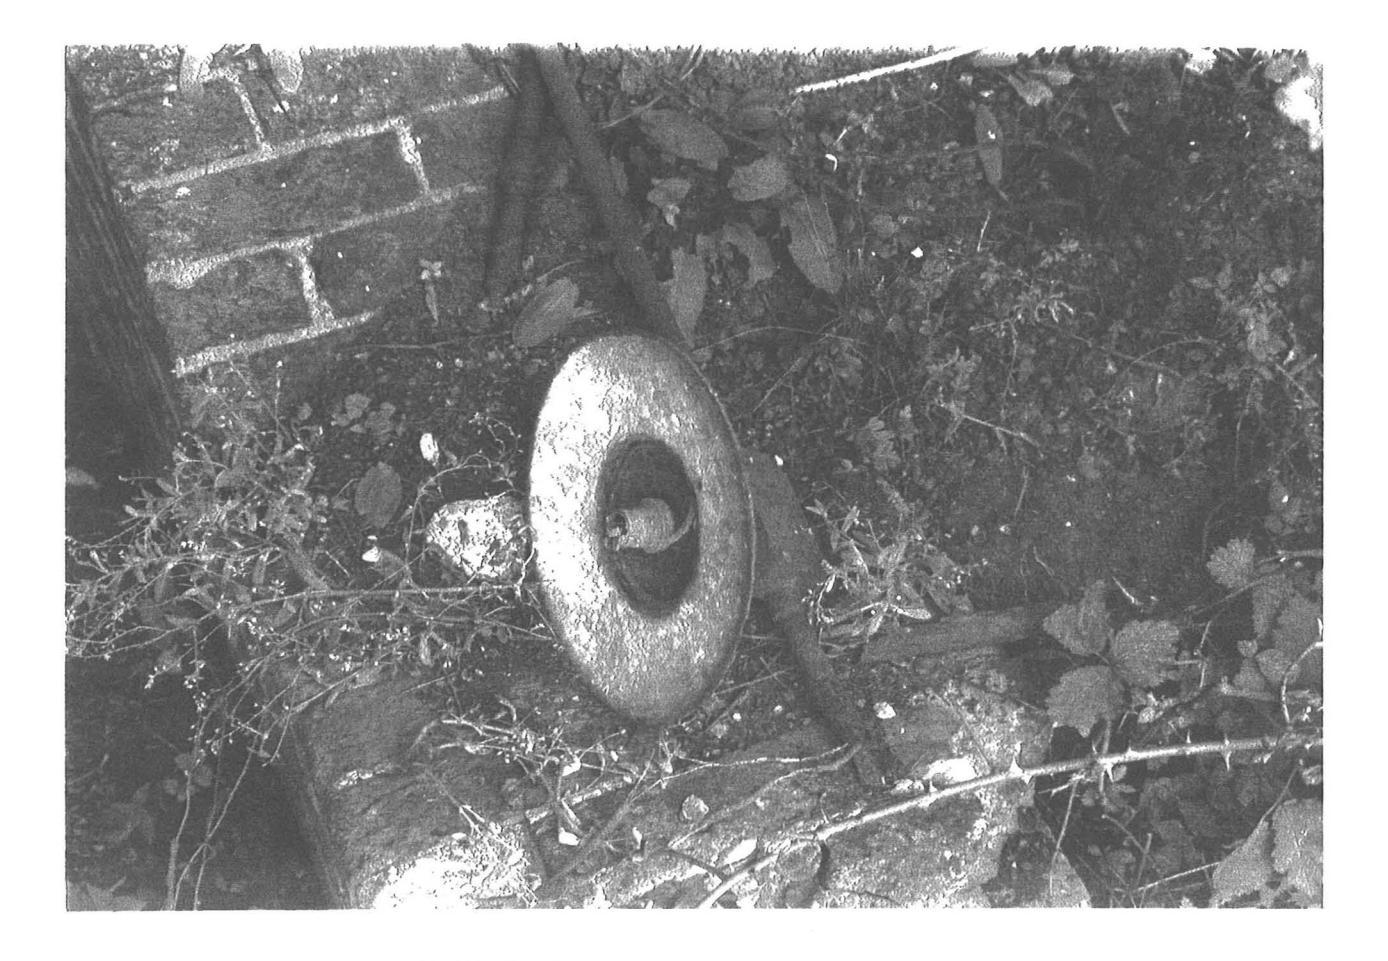
486 PLATE 18 - LIGHT FITTING FROM PASSAGE (NO LONGER IN-SITU)

*Tunnel Lighting:* The access tunnel was lit at two points, one just inside the entrance door, the other at the shoe room end. Each fitting consists of an iron plate 250mm diameter, bolted to the conduit. The underside of the plate is painted white, and there are points around its edge for clamping a protective glass globe. In the centre of the plate is screwed a brass bayonet bulb socket. Neither fitting remains in its original location (Plate 18).
