# WALTHAM ABBEY SOUTH SITE ROYAL GUNPOWDER FACTORY

# **BUILDING No. 486**

HISTORICAL SURVEY OF BUILDING NO. 486

# Mixing House 486, South Site, Waltham Abbey Royal Gunpowder Factory, Essex

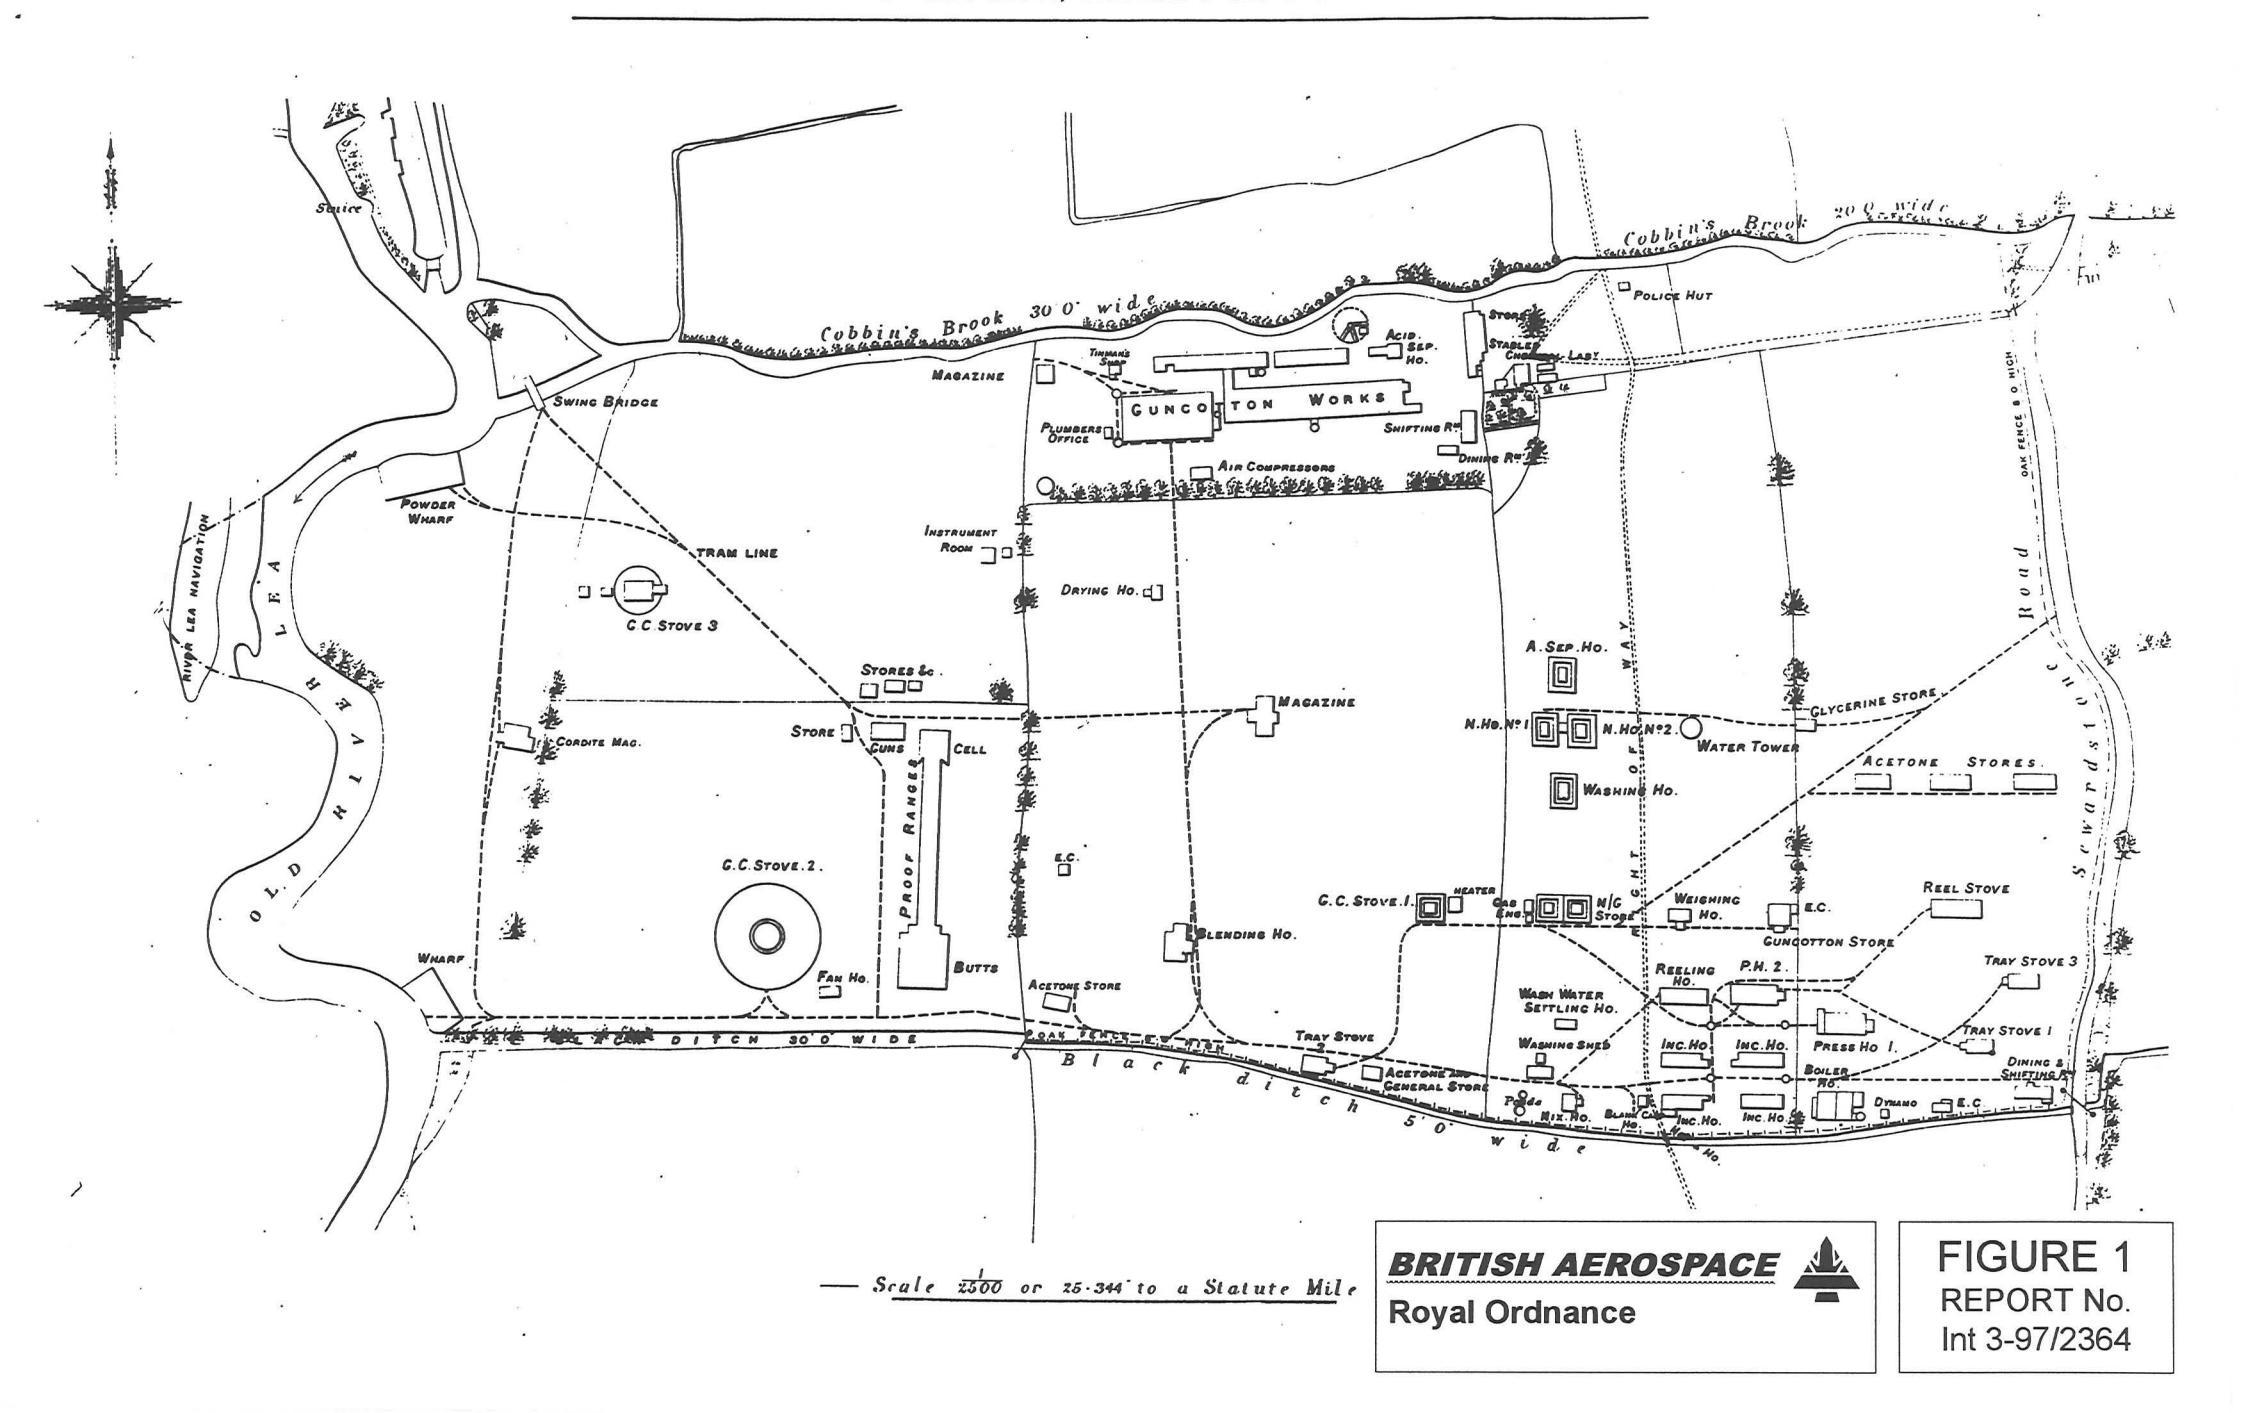
PLAN OF THE CORDITE FACTORY AT WALTHAM ABBEY, COMPRISING THE NITRO-GLYCERINE AND GUN COTTON FACTORIES.

Fig 1	Plan of Waltham Abbey South Site dating from between 1890 and the	
	1894 explosion on Quinton Hill showing the N/G Stores at the centre o	f
	the Cordite factory. [c.f. Plate 1]	
Fig 2	Plan of Waltham Abbey South Site dating from after the 1894	
	explosion and showing the reconstructed Mixing House 486.	-
Fig 3	Location Map showing South East England, Waltham Abbey, South	
	and North Site and location of Mixing House 486 within South Site.	
Dwg No: 486/1	Overall plan of 486	
Dwg No: 486/2	Overall section through 486 and blast mound	
Dwg No: 486/3	Section through building 486	
Dwg No: 486/4	Section through access tunnel	
Dwg No: 486/5	Section through delivery tunnel

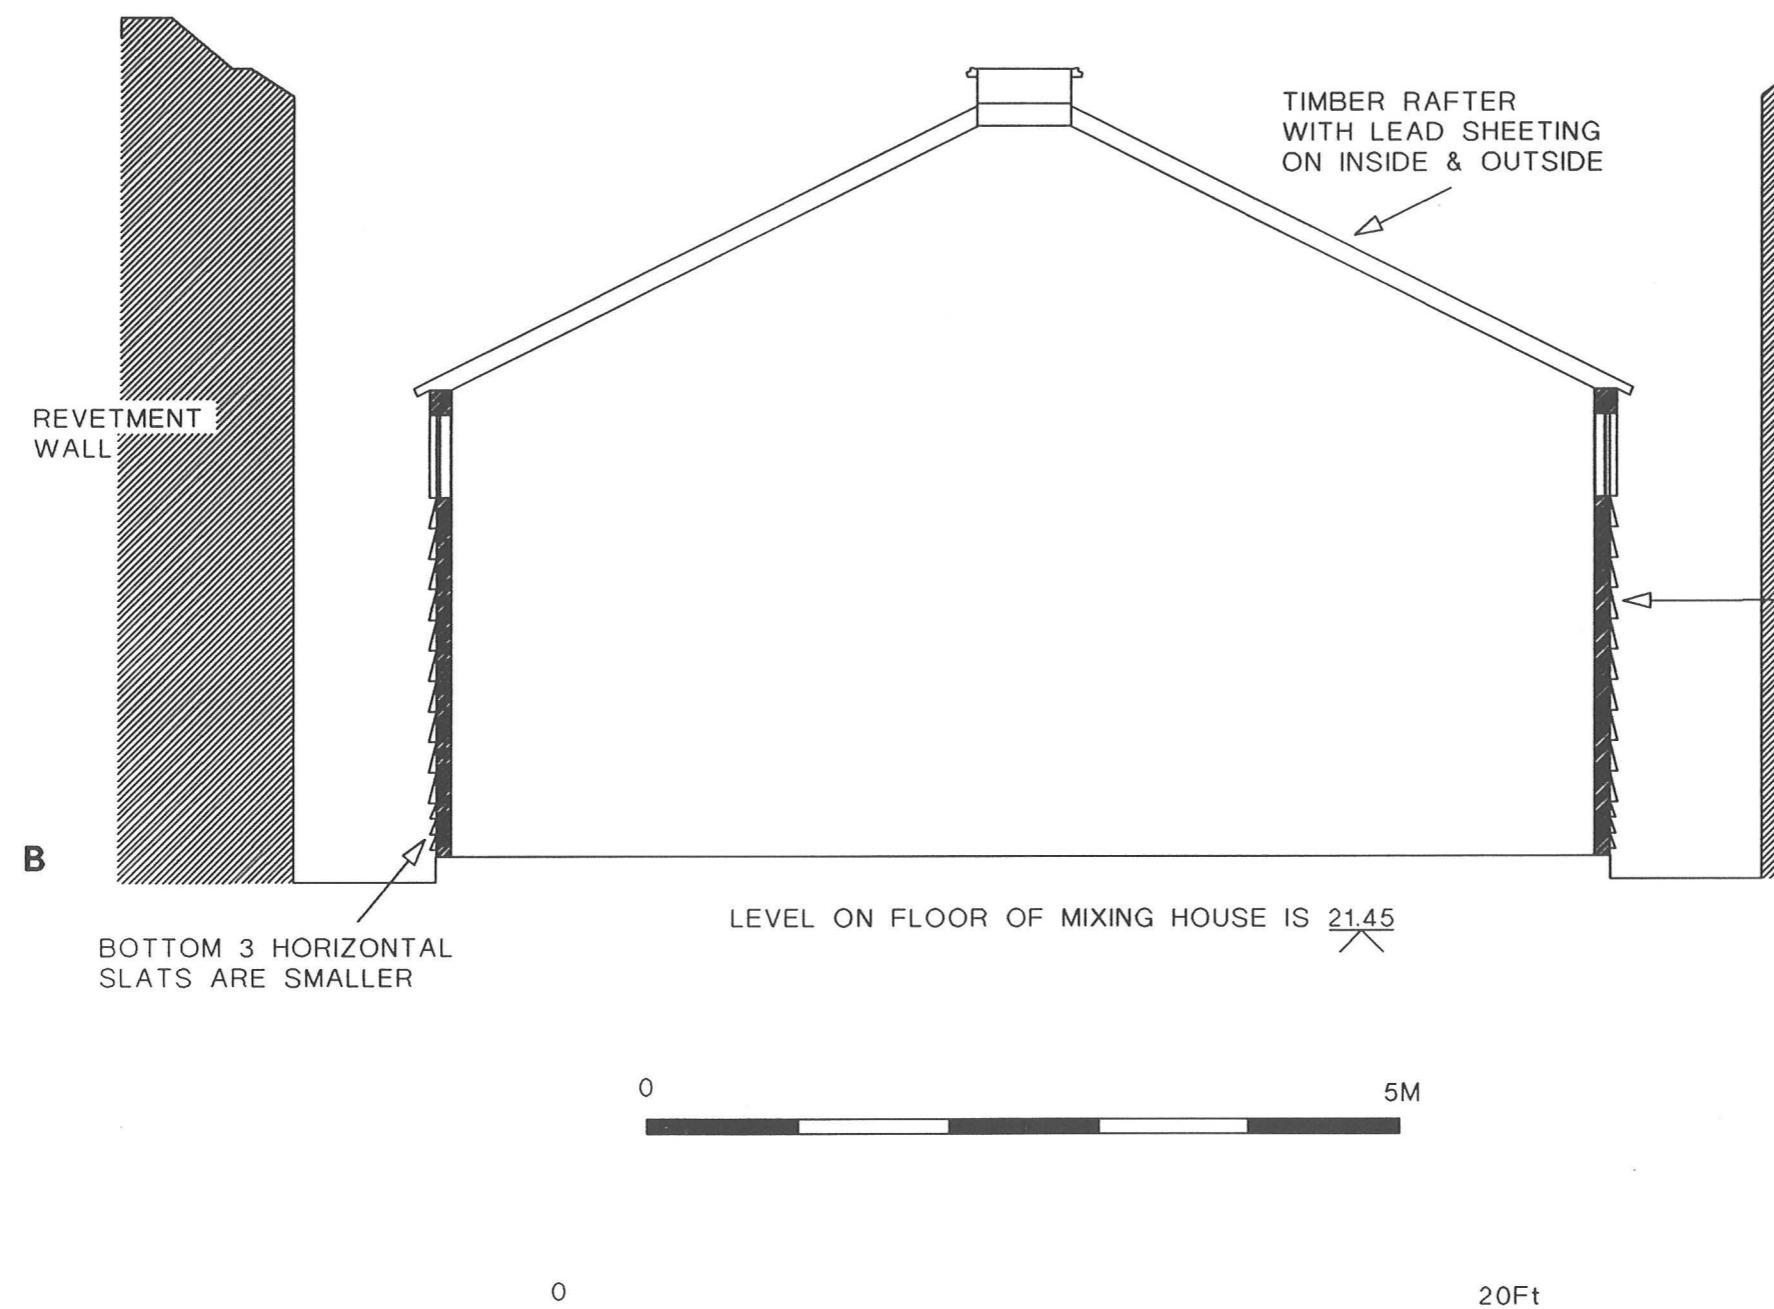
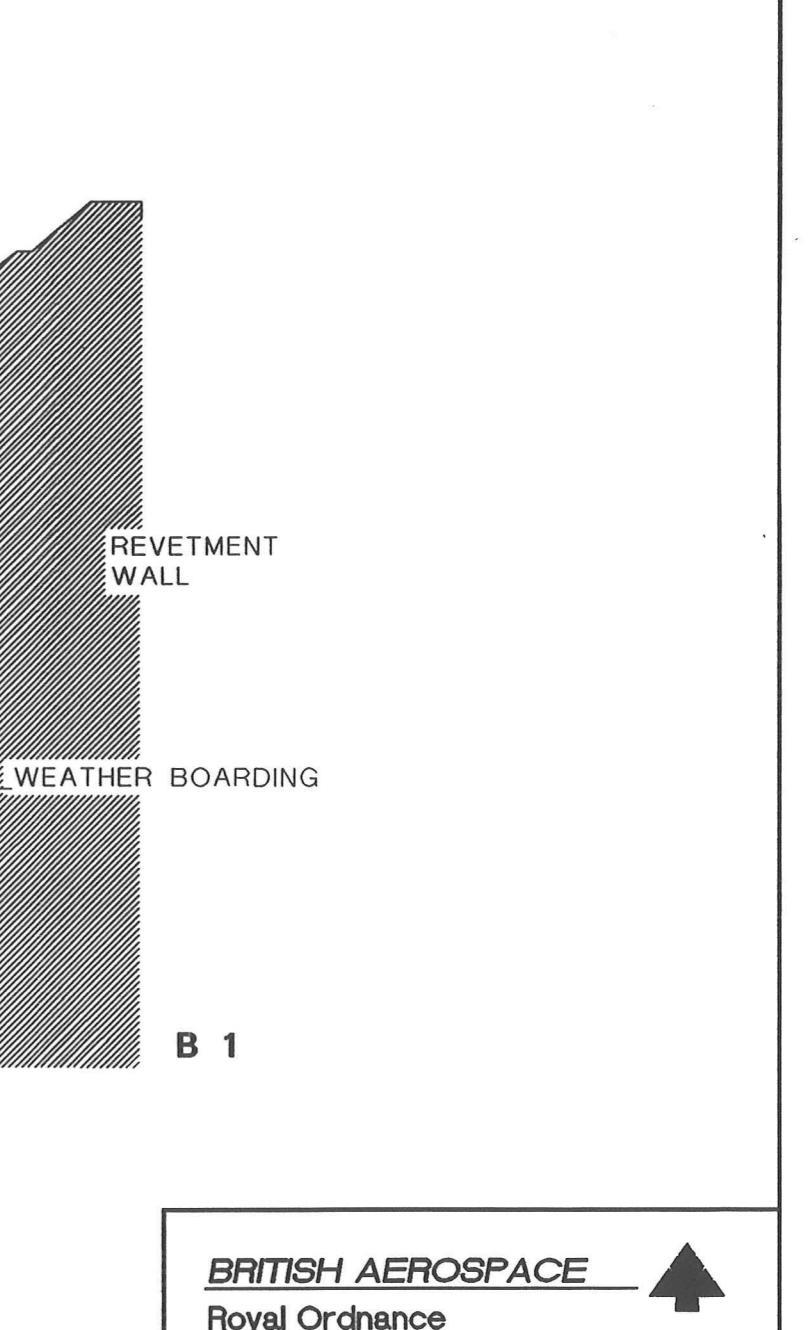
DWG No:486/3

**BUILDING No. 486** N.G. MIXING HOUSE

Section B-B1

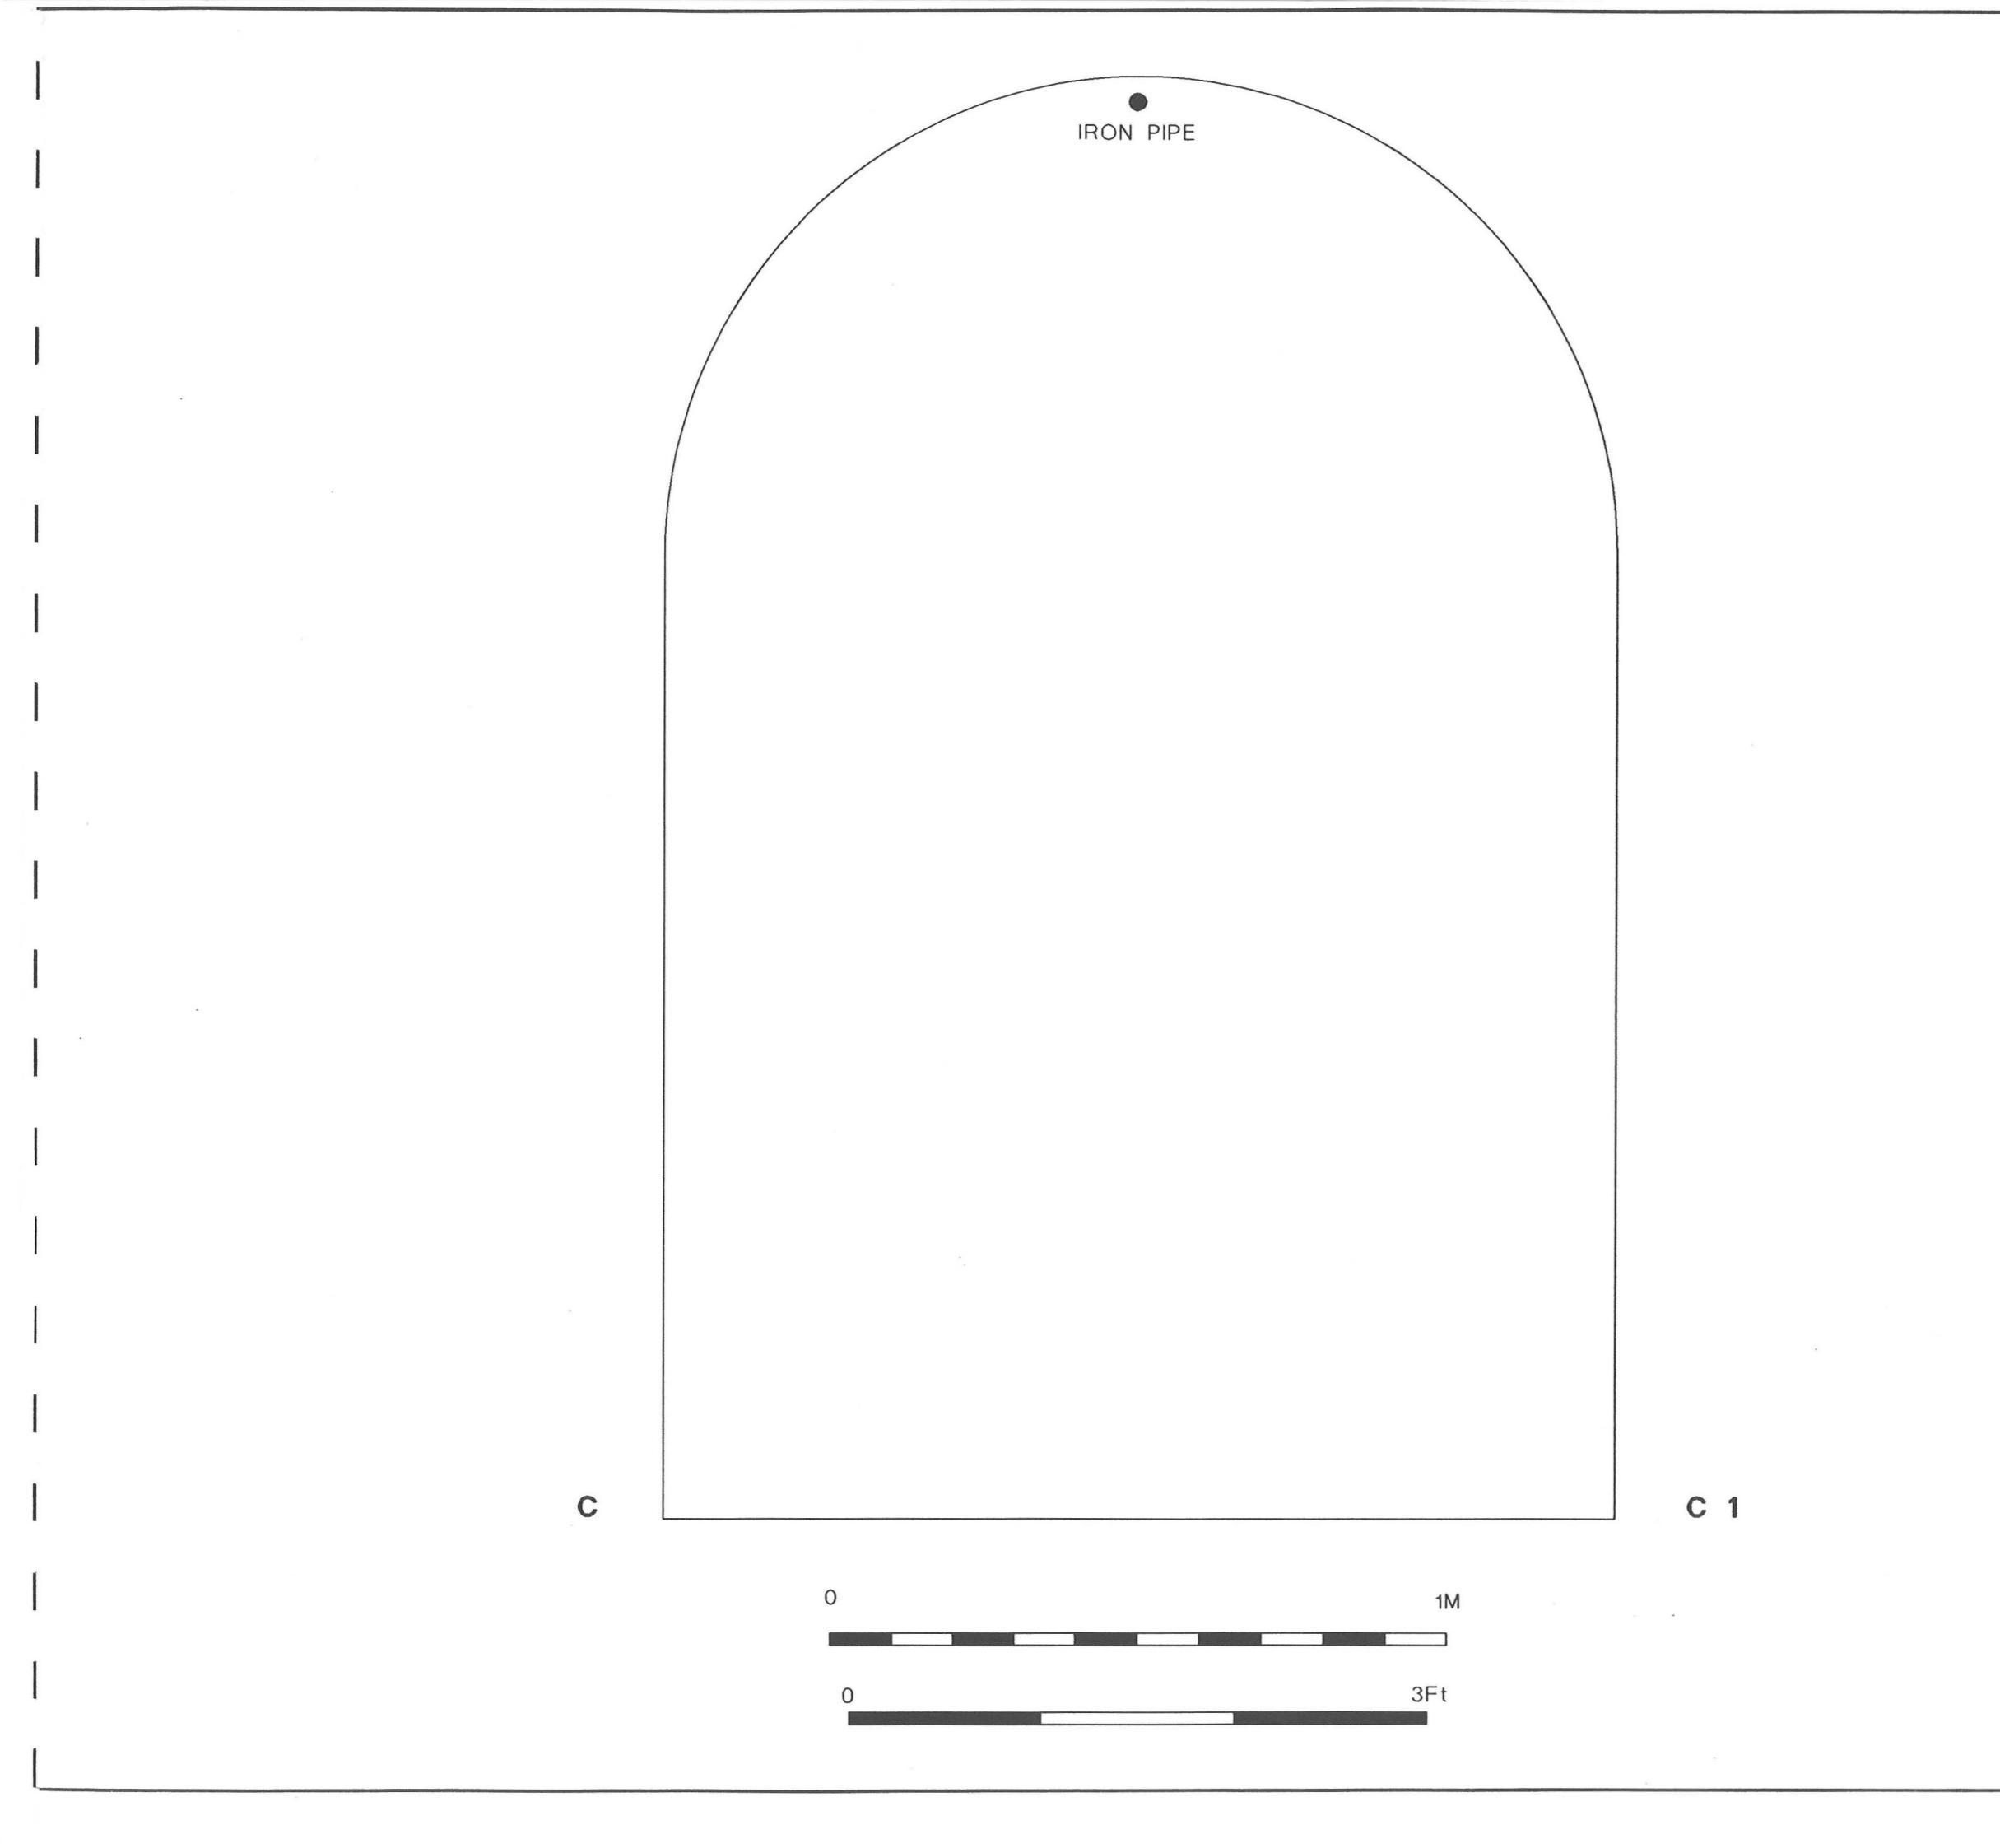
BRITISH AEROSPACE		
Royal Ordnance		
ROYAL GUNPOWDER MILLS		
WALTHAM ABBEY		
SOUTH SITE		
Drawing prepared by: Hertfordshire Archaeological Trust The Seed Warehouse, Maidenhead Yard, The Wash, Hertford. SG14 1PX.		
BUILDING No. 486		
N.G. MIXING HOUSE		
Access Tunnel Section C-C1		
SCALE: 1:10	Drawn By:KH,DR	
DWG No:486/4	DATE: 24.07.97
